Building Assessment Study for

**Martin Franklin Hanley House**  
City of Clayton

November 14, 2007

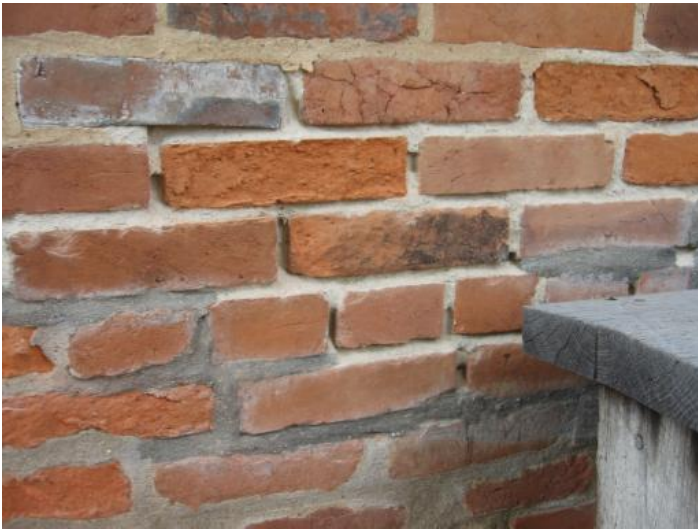
Detail at Typical Deteriorated Clay Masonry [TOP LEFT]

Detail at Typical Deteriorated Cement Tile Finish Roofing System [TOP RIGHT]

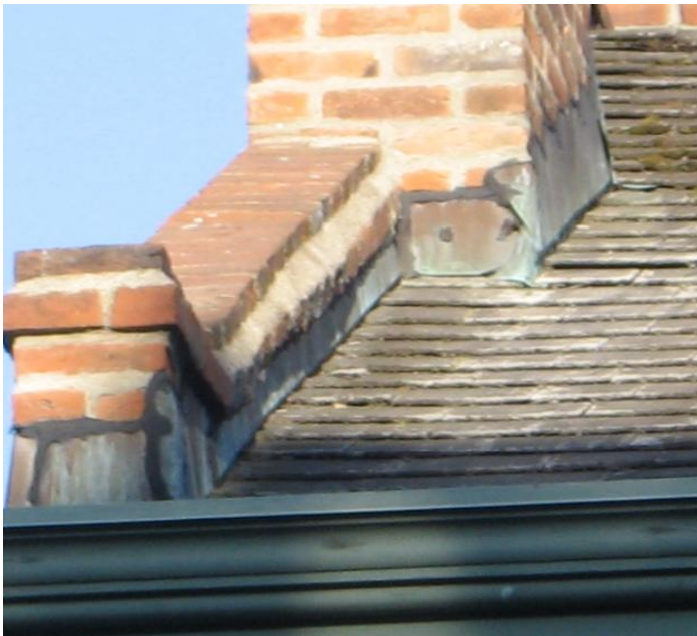
Roof Construction - Detail image to right shows missing cement roof tile at east facing field. Moss is visible in several areas of east facing roof, as are oddly spaced roof tiles.

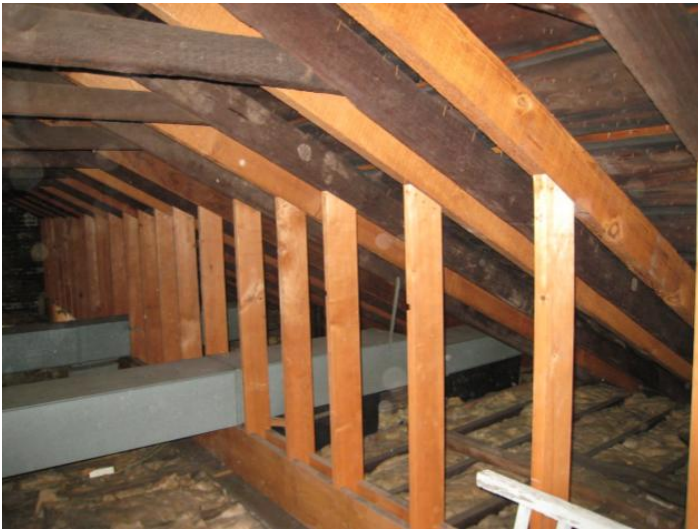
Roof Construction - Detail images show the existing roof system at the attic level. Ca.. 1855 rafters have been doubled [TOP LEFT], supported with vertical members, and bolstered by a double 2x12 beam running from north to south exterior bearing walls, while rafter vertices have been braced with plywood and the entire roof covered with 1/2" plywood [TOP RIGHT]. Given that existing roof rafters terminate directly on east and east exterior bearing walls, seismic bracing would be recommended to provide additional loading surface for existing rafters at the tops of masonry walls.

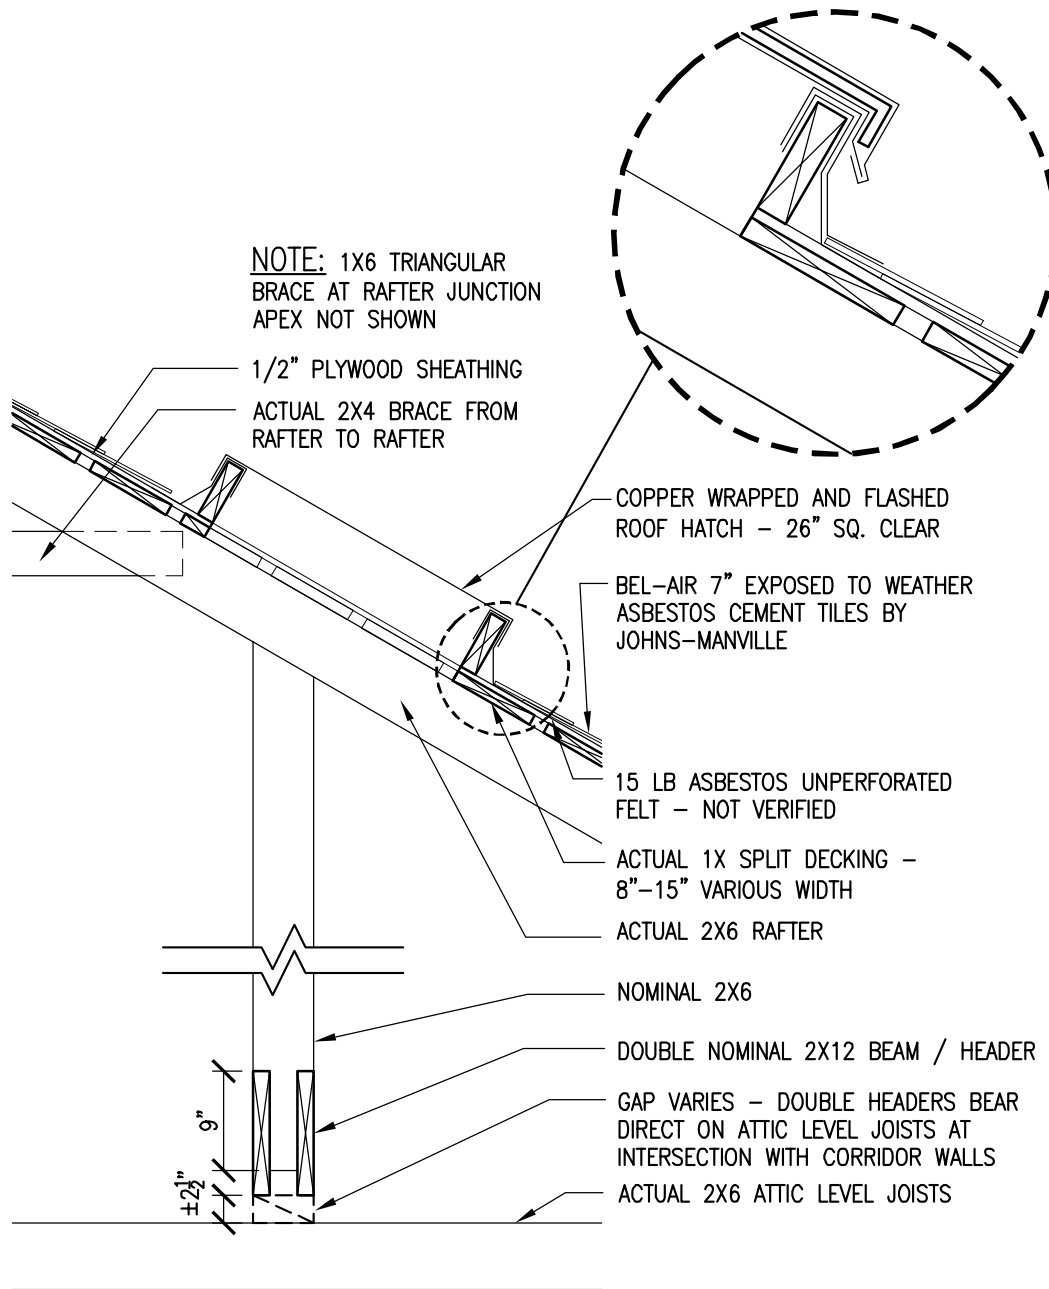
Roof Construction - Detail sketch [ABOVE] represents existing conditions of the Hanley House roof construction. Note the double 2x12 beam / header at the bottom of the sketch - new wood framing (including the double beam / header, 1/2" modern plywood sheathing, and 2x6 vertical posts at each rafter) were installed as a method of supporting the asbestos cement tile roof installed ca. 1969. This condition is visible in images from the interior of the attic on pages 66 thru 68 of the report - there is a direct correlation between addition of these beams and cracking in interior plaster on the first and second floors of the home.

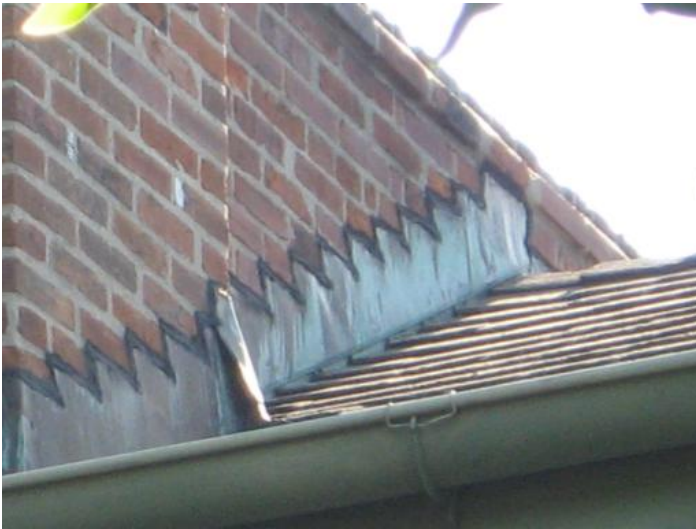
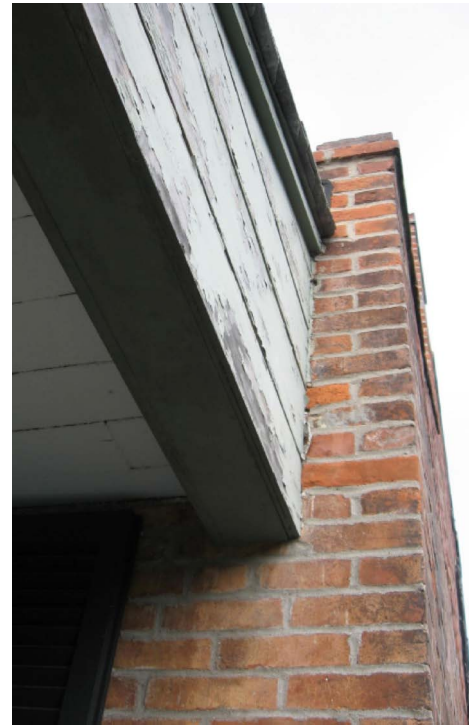
Roof Construction - Detail images show sheet metal step flashing to parapet walls and sealant joints [TOP LEFT], clay masonry parapet end-of-wall condition and wood trim [TOP RIGHT], typical roof hatch in west-facing roof field [BOTTOM RIGHT], and wood trim at box gutter with sheet metal pipe downspout. Note that hatch is covered and not accessible from interior at attic level.

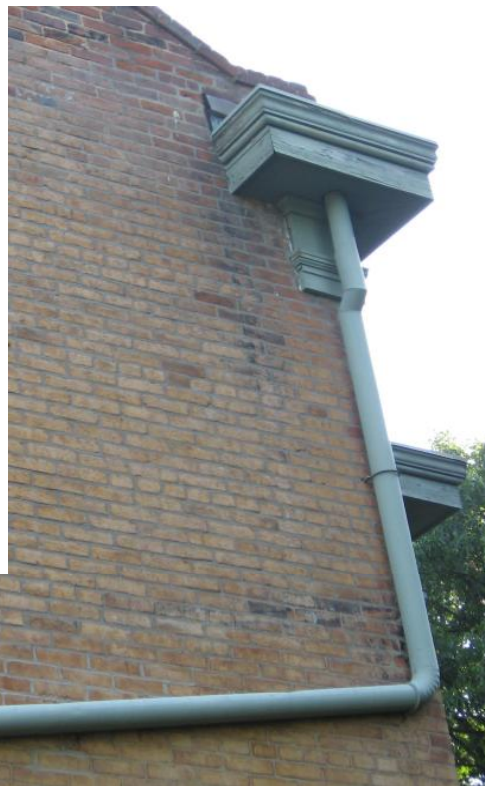
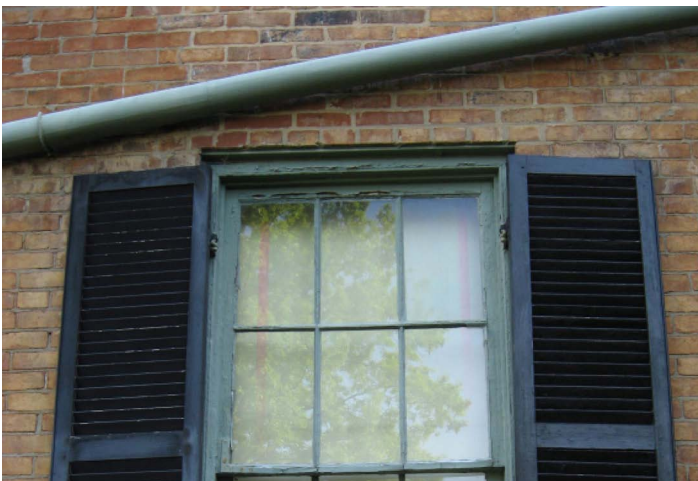
Deterioration of windows and walls at the south and north elevations appear to be due in measurable degree to failed seams and fittings in the downspouts - lintels and clay brick masonry demonstrate a high quantity of wear to due routine surface water erosion, and penetration of storm water that has frozen and thawed, causing movement damage.

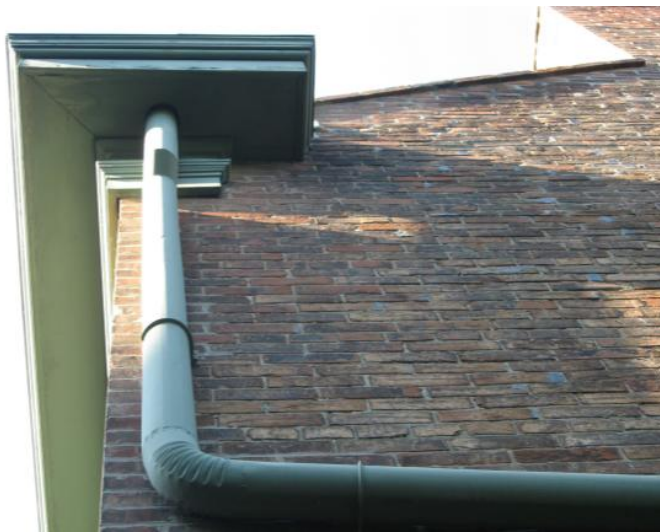
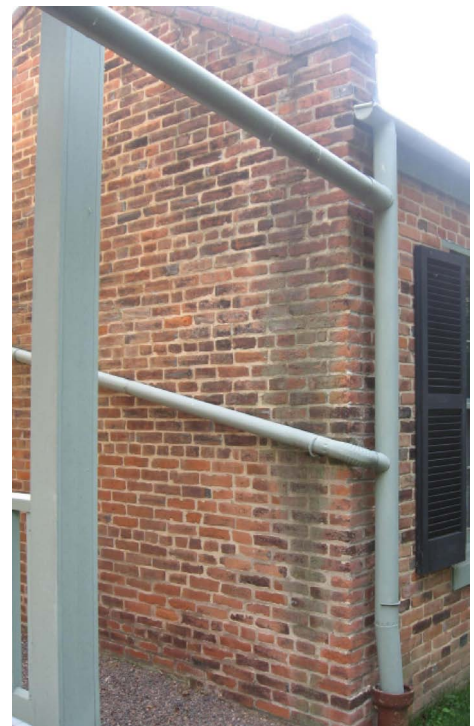
Sheet Metal Gutter and Downspouts - Detail images show routing of downspouts from box gutter (at Hanley House east) toward Summer Kitchen and termination at storm water boots and below-grade storm sewerage. Hung gutters [BELOW] are shallow but appear to be adequately sized.

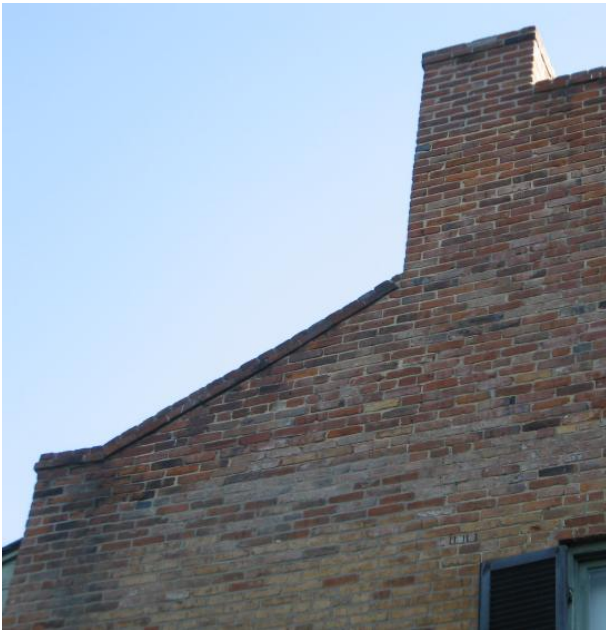
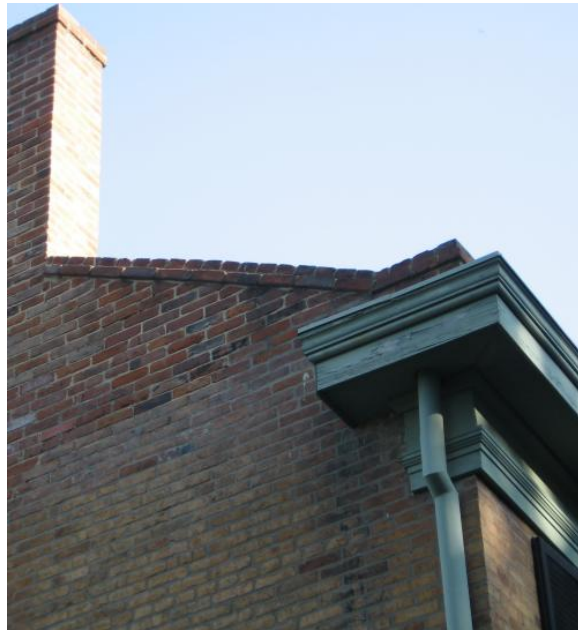
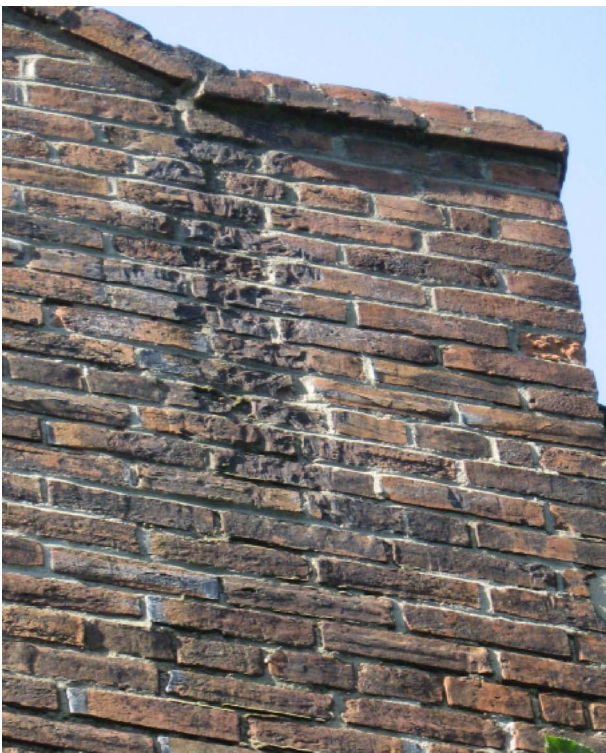
Exterior Clay Brick Masonry - Detail images depict varying states of existing clay brick masonry at typical high points, including SW and SE chimneys [TOP LEFT, TOP RIGHT], and NW corner at drip from parapet corbeling [LEFT].

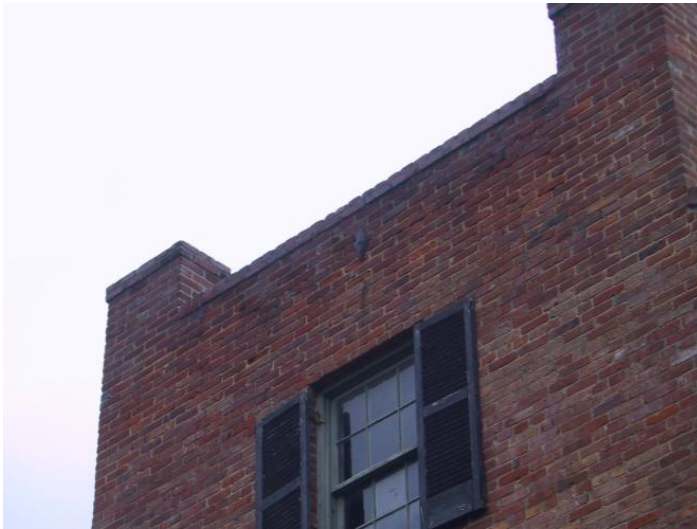
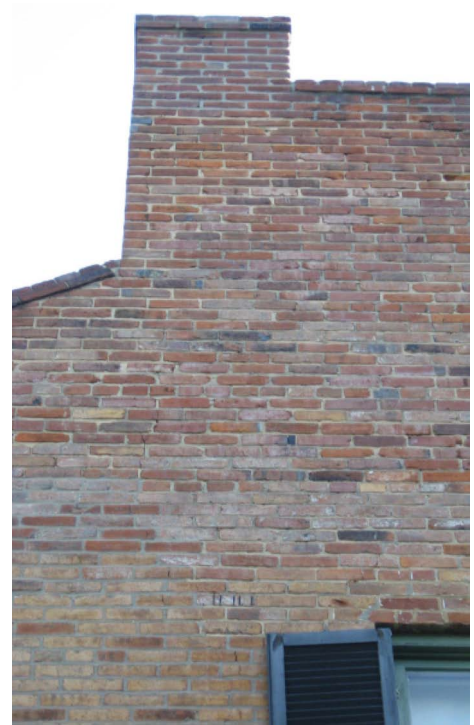
Exterior Clay Brick Masonry - Detail images depict the relationship of attic level fenestration and chimneys at partial north elevation [TOP LEFT], and long-run settlement cracking at SW chimney [RIGHT].

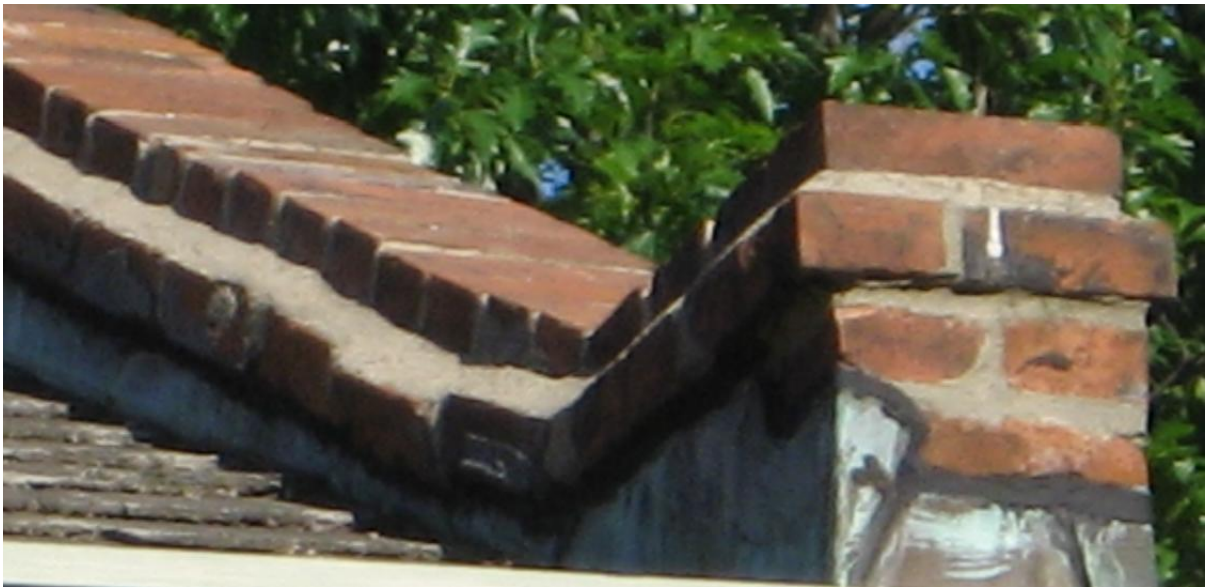
Exterior Clay Brick Masonry - Detail image depicts the design of masonry parapet cap [ABOVE] at Hanley House NE corner. Sheet metal step flashing engages back-side and end of parapet, with mortar wash applied from row-lock at top of parapet to first corbeled course. The undulating appearance of clay brick at the parapets suggests that they may have been repaired before.

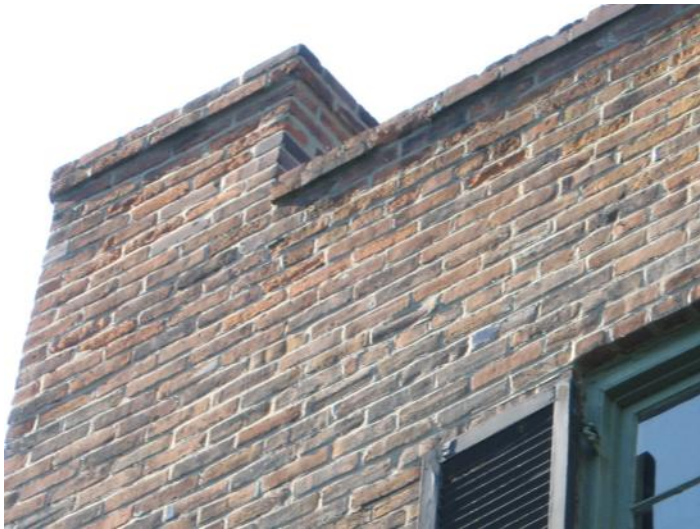
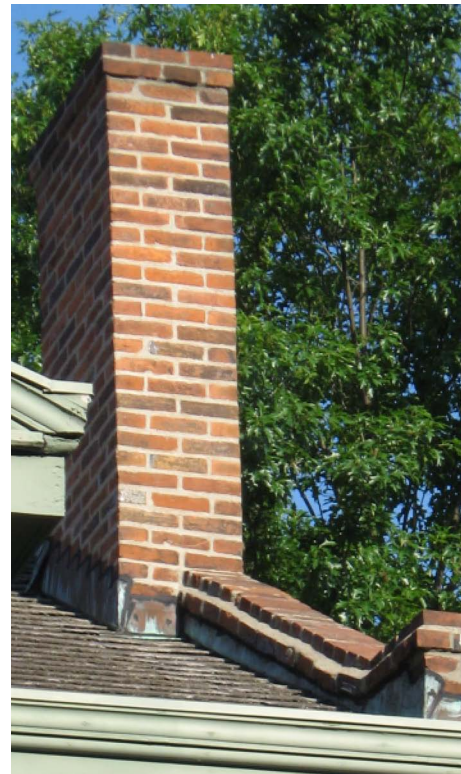
Exterior Clay Brick Masonry - Detail images depict the conditions of high points clay brick masonry at Hanley House north including north, west [ABOVE], east and south [RIGHT] faces of NE chimney. Note the appearance of brick units with spalled or pocked faces - these may be interior wythe brick which were original to the house, but which were relocated to the building exterior as a repair.

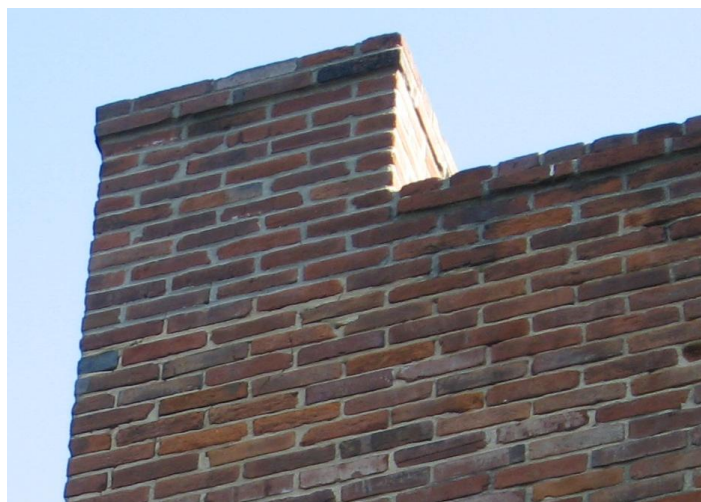
Detail images depict existing condition of clay brick masonry repaired ca. 1970 or after at SW chimney high points [ABOVE], and ceiling and beam pocket for roof at west porch second level [LEFT]. Note the contrasting color of mortar, and the relative depth of repaired joints.

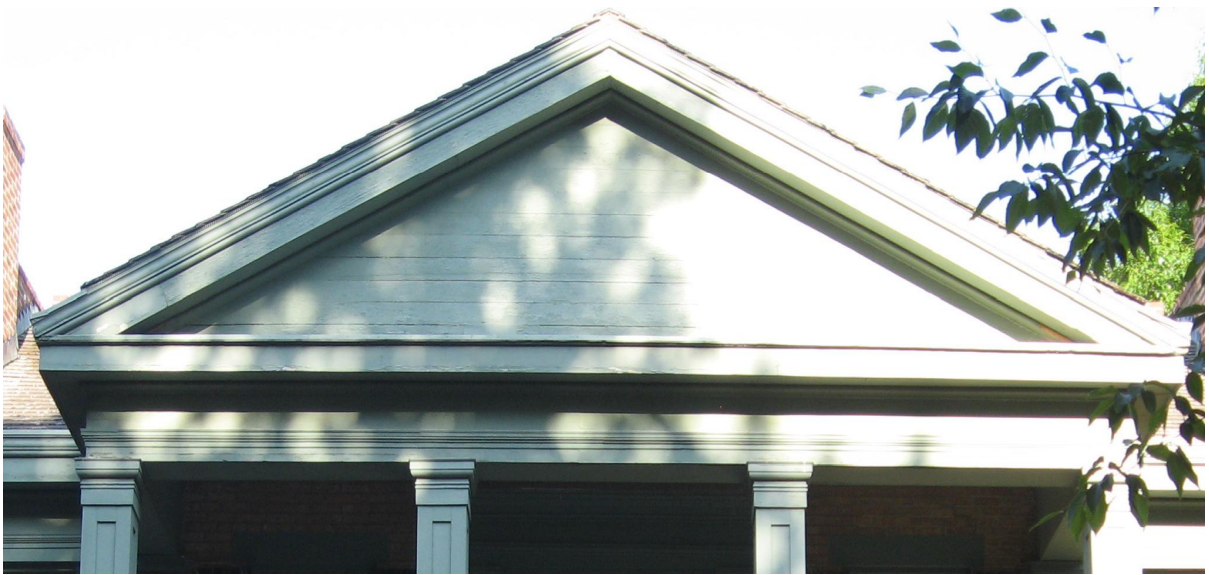
Exterior Wood Decks, Railings and Trim - Detail view to east facing gable and tops of columns at Hanley House east elevation [ABOVE], and north extent of gabled east porch roof [BELOW LEFT]. Deterioration of the substrate is masked by intricacy in the design of trim - cornice and banding is in need of patch repair or replacement, and new paint throughout. The gable sheathing at east face appears to have been repaired at least once since ca. 1970.

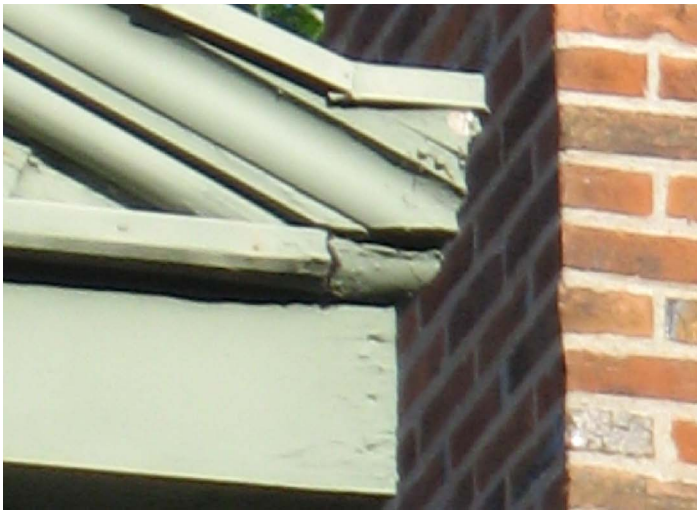
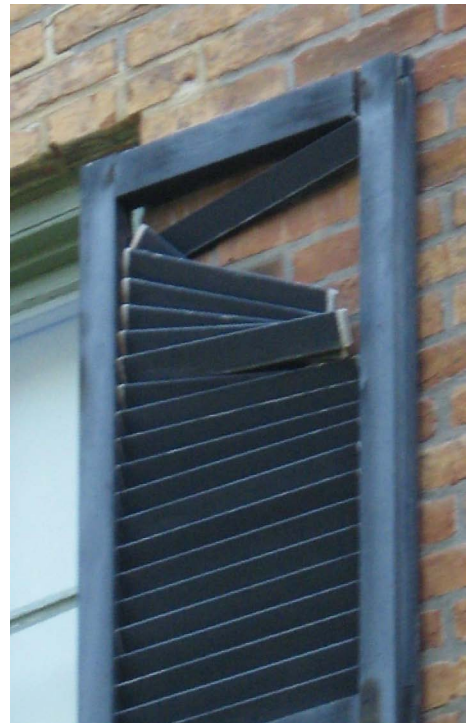
Exterior Wood Shutters - Detail view to example of extreme deterioration visible in existing wood shutters [RIGHT]. It is presumed that ca. 1970 renovations replaced some shutters in their entirety - this image depicts the condition of original (mortise-and-tenon) shutters with failing louvers, rotted stile and rail components, and failing finish.

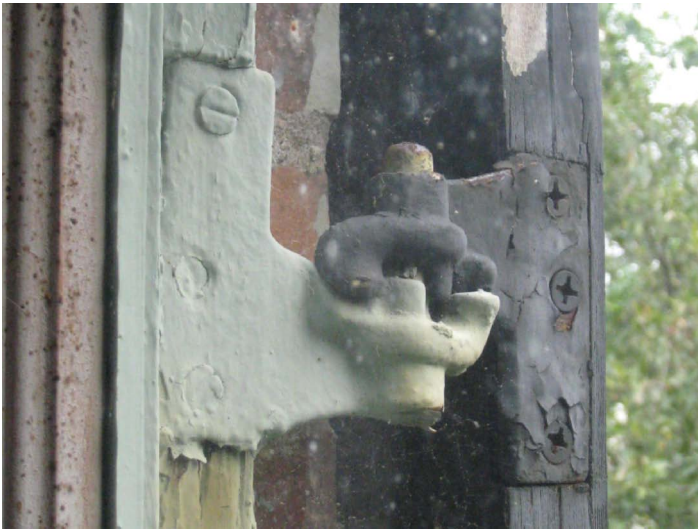
Exterior Wood Shutters - Detail images show various conditions of existing Hanley House shutters, including original position-holding hardware [ABOVE], typical replacement shutter [RIGHT], and extreme component and finish deterioration encountered on original shutters.

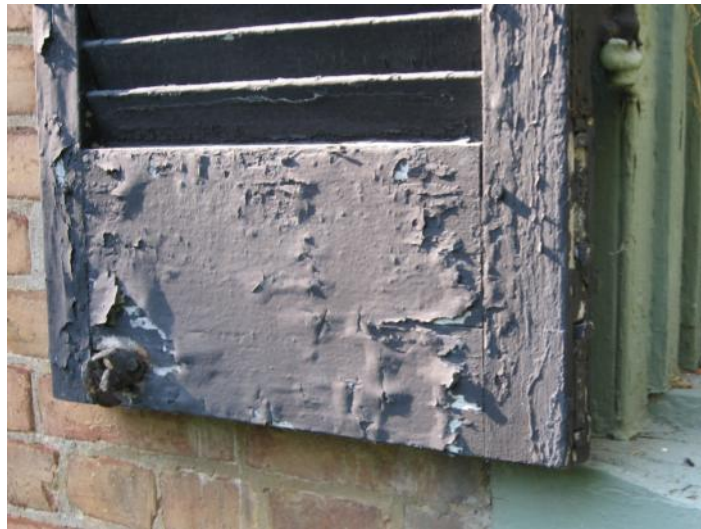
Detail image [LEFT] depicts the mortise-and-tenon construction method used to assemble original wood shutters at Hanley House - note desiccated and cracked condition of stile (vertical member), and off-set surfaces of the tenons as they appear at the left side of the stile.

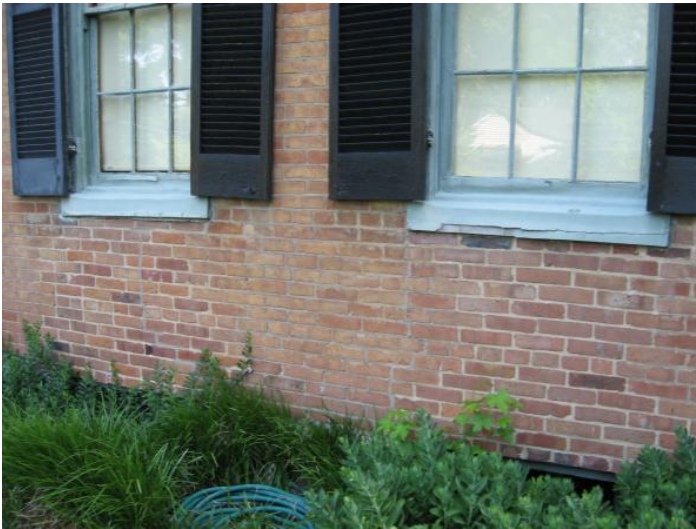
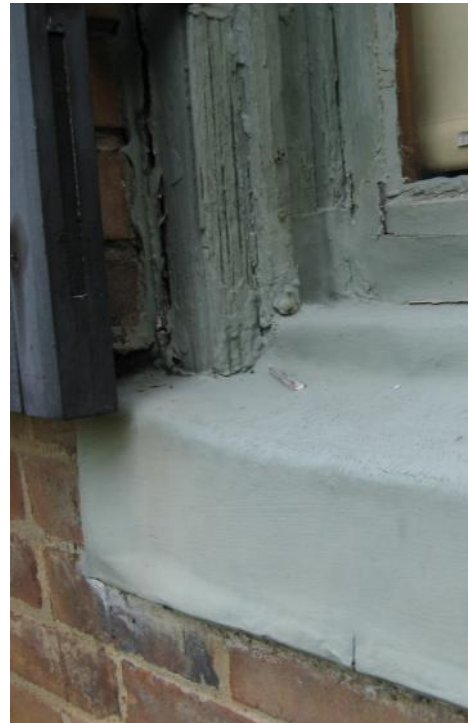
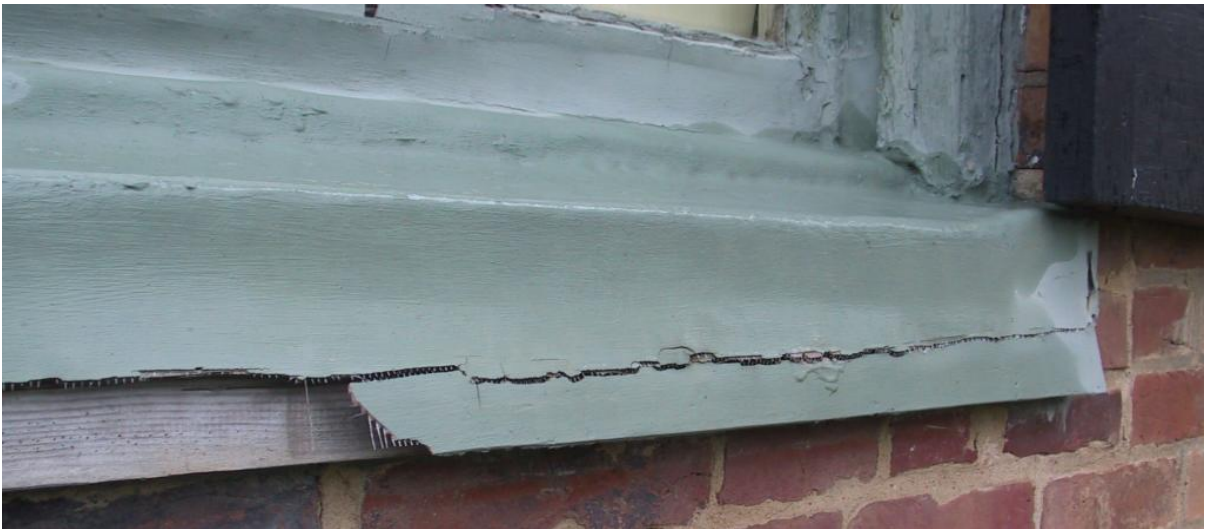
Exterior Wood Windows - View to first level window units at south side of Hanley House [ABOVE], and detail views to clad wood sill construction at south elevation [RIGHT, and BELOW]. Note the cracked and missing coverage of the cladding, and the saturated appearance.

Hanley House south elevation would logically have been the most impacted of all exterior surfaces by storms and adverse weather. This portion of the site has had the least amount of protection - either natural or man-made - from wind, rain, and sun. It has also been observed that storm water from the downspouts above routinely washes over the wall surfaces here (and at north elevation). Existing wood window units and frames have likely been rotted through due to trapped moisture.

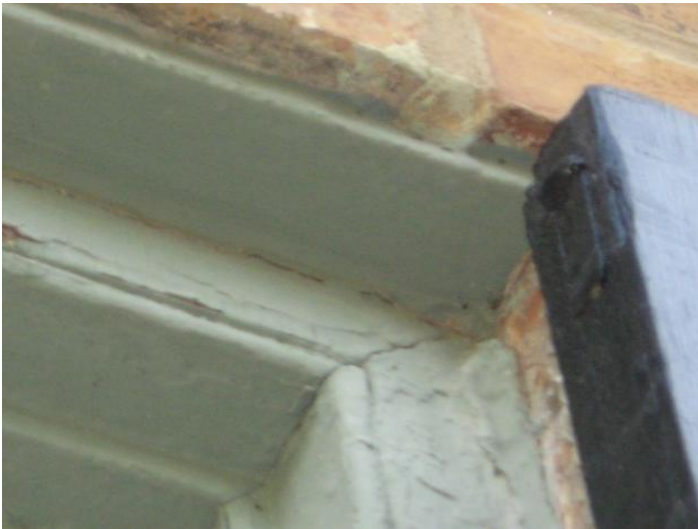
Exterior Wood Windows - Detail images show designs and conditions of various Hanley House lintels, including painted steel angle at first level south [ABOVE], and no apparent lintel with brick row-lock header at first level north [RIGHT]. Steel angle lintels do not appear to be original.

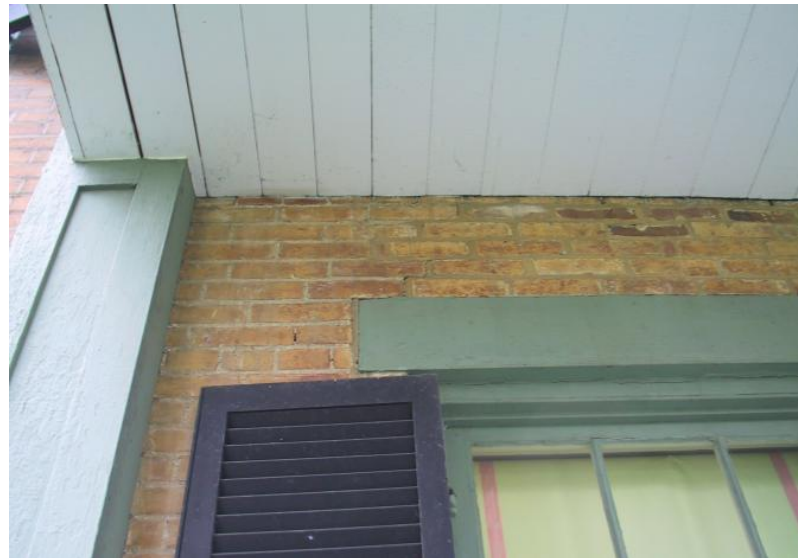
Exterior Wood Windows - Detail images show no apparent lintel with brick row-lock header at first level west [ABOVE LEFT], and painted wood timber at first level east [ABOVE RIGHT]. Although wood timber lintels (found only at the east elevation of Hanley House) appear to be original, they are at the end of serviceable life. This report would recommend that all windows not already supported by one be augmented by a concealed steel angle - said steel could be installed behind the exterior wythe of clay brick, and could be painted to match. All steel should be flashed to evacuate water.

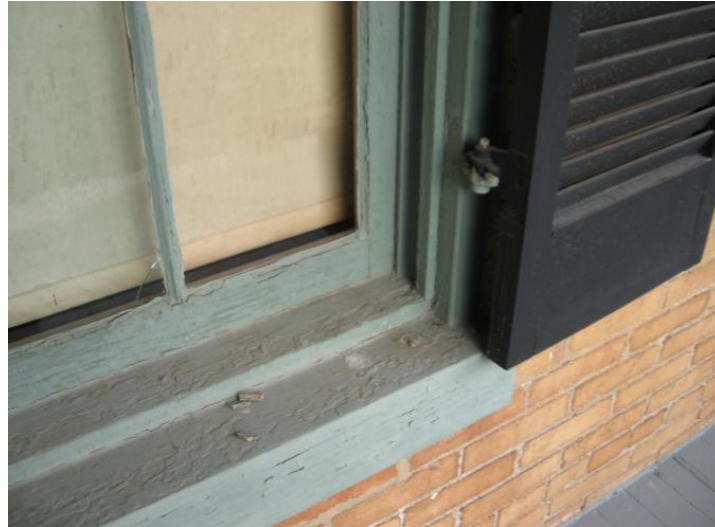
Exterior Wood Windows, Decks, Railings and Trim - Detail images depict various deteriorated conditions of windows and surrounding original trim at Hanley House, including typical window fenestration design at first level east under porch [LEFT], and typical sash and sill at second level west under porch [ABOVE].

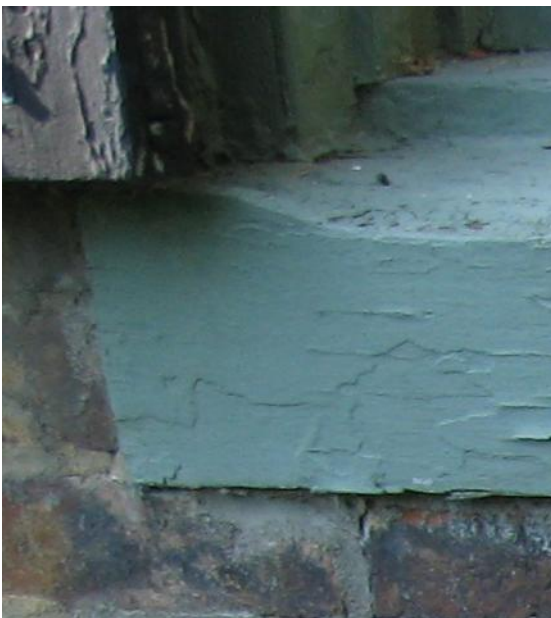
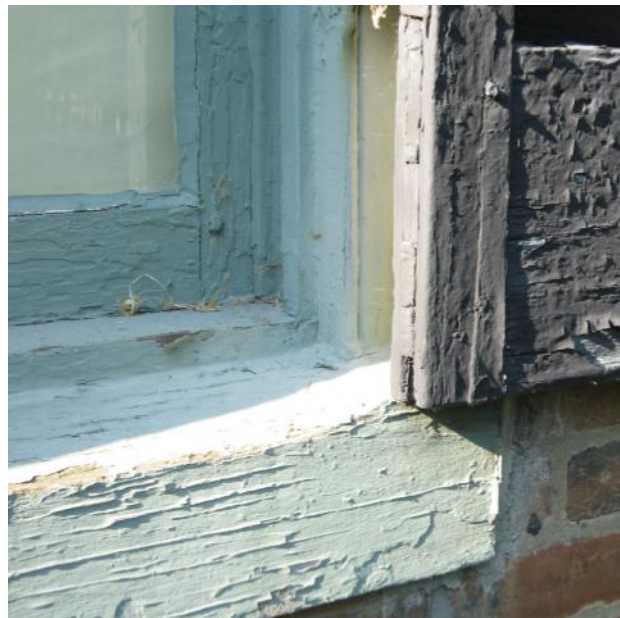
Detail images show typical conditions of sash, sill and shutter at first level north [ABOVE LEFT and RIGHT]. These sills are not clad like the south elevation sills, but their finish is failed and the likelihood of moisture having contributed to deterioration of the window units is high. Note design of trim end is scalloped - this flourish is typical at all north (and south equal) elevation sills.

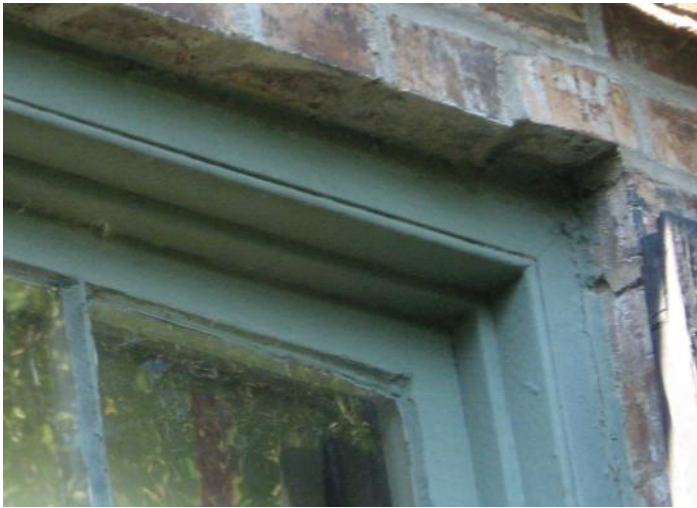
Exterior Wood Windows - Detail image shows design and condition of no apparent lintel with brick row-lock header at first level north [ABOVE] Hanley House. Note that brick header is off-set and bowed downward due to a lack of structural capacity - the brick above this typical opening is likely supported entirely by the wood window unit.

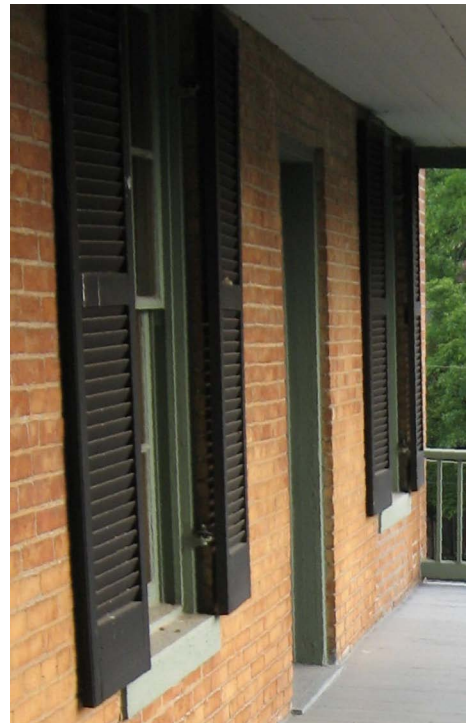
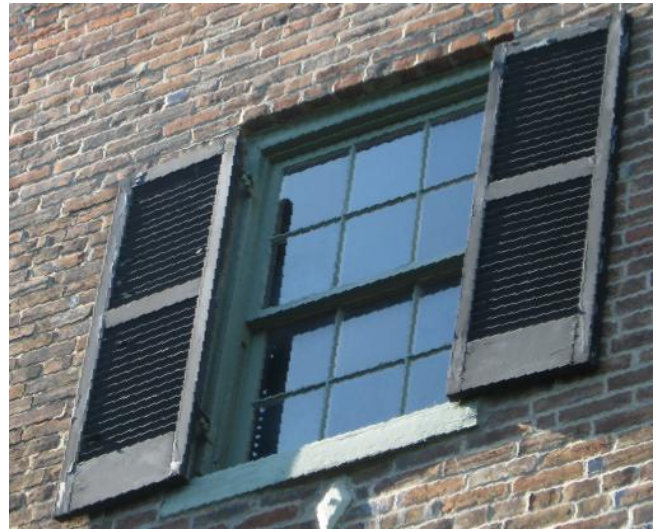
Exterior Wood Windows - Views to various Hanley House window conditions showing original and replaced sashes and glazing. Images include second level west fenestration and trim under porch [TOP LEFT], attic level north fenestration and trim [ABOVE RIGHT], and first level south fenestration and trim [ABOVE LEFT]. Note that all items in these views appear to be original except the sash frame at attic level north (with south being equal); glazing in these sash frames may be original.

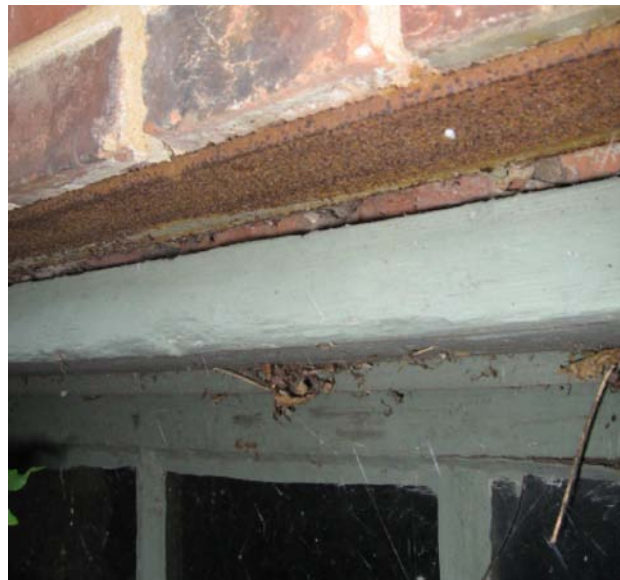
Exterior Wood Windows - Detail images show condition of typical clerestory units at Hanley House ground level [ABOVE LEFT and RIGHT]. Wood sills, jambs, and window sash frames appear to be rotten, with finishes failed and in need of replacement. Note that unpainted steel lintels were installed - possibly ca. 1970 - at the SW and both north clerestory openings. These lintels are serviceable, but are recommended to be ground and painted.

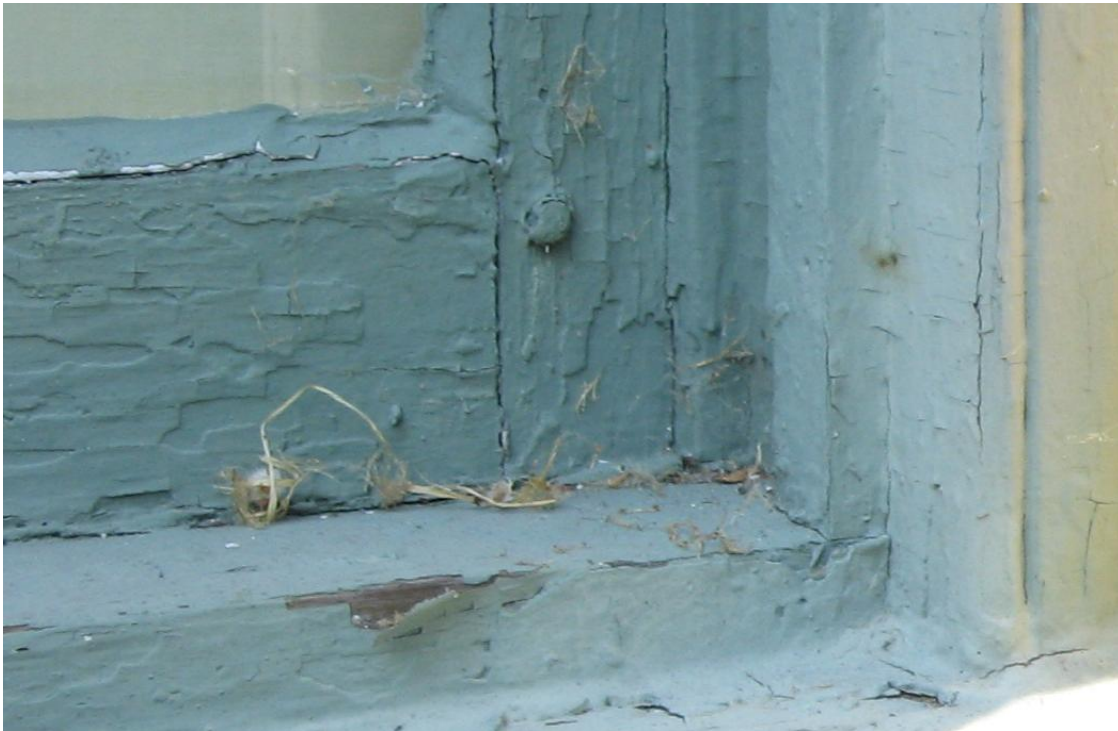
Exterior Wood Windows - Detail images show design and condition of window sashes and glazing at Hanley House, including typical deteriorated putty glaze and wood stile and rail of sash frame [ABOVE], and wood sash frame stile, frame jamb, and clad sill at south elevation [LEFT].

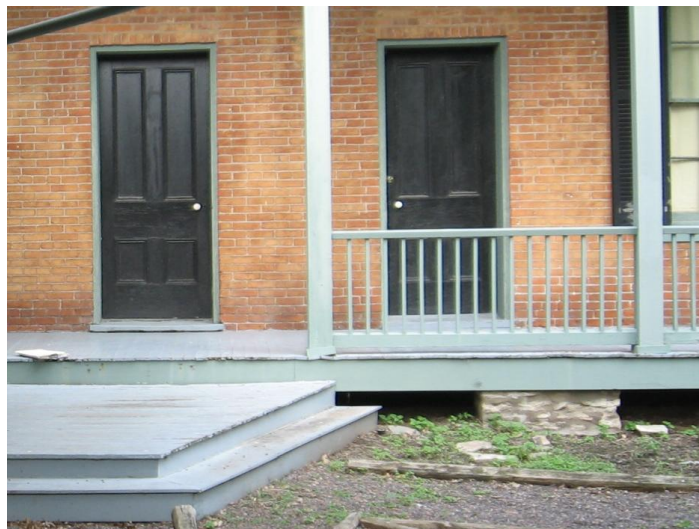
View to doors at first level west elevation [ABOVE]  
Detail image of typical exterior wood door condition [LEFT],  
showing original hardware, and failed finish on raised panel,  
stile-and-rail construction wood slab.

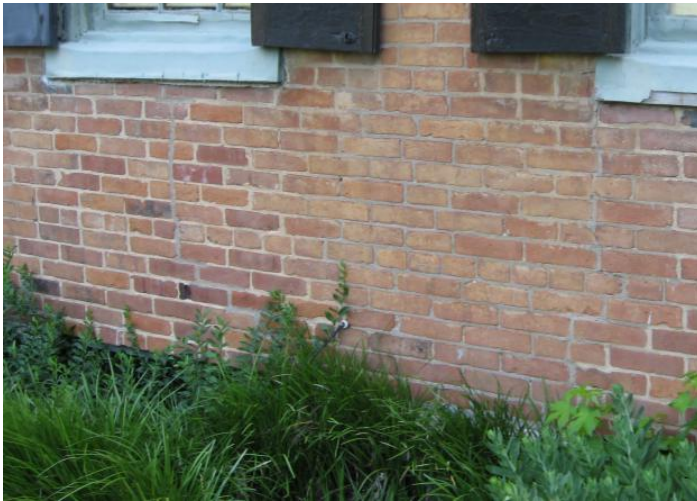
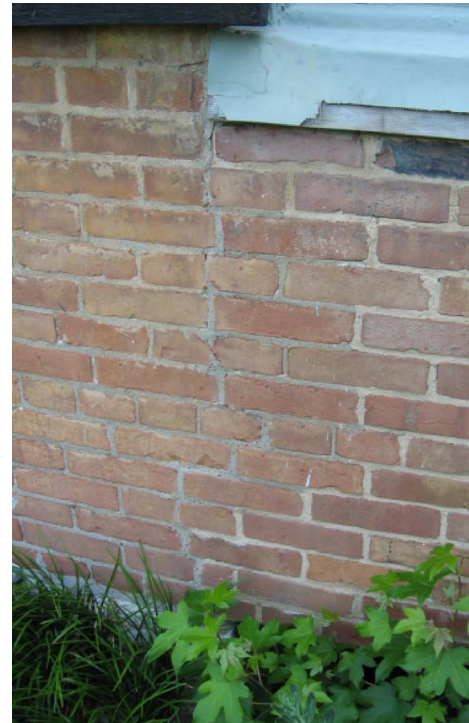
Exterior Clay Brick Masonry - Detail images depict the conditions of south facing clay brick masonry, including settlement cracks below first level fenestration [TOP LEFT and RIGHT], and long-run settlement cracking at SW corner [BOTTOM LEFT and RIGHT], extending from near stone foundation upward to parapet and SW chimney.

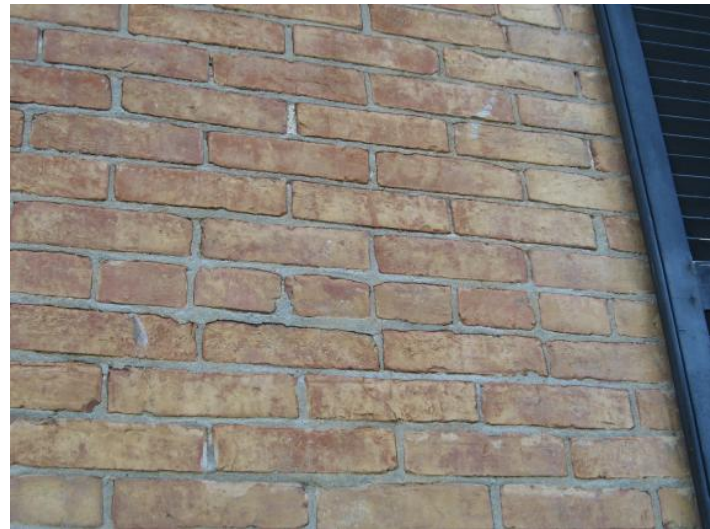
Note that south facing exterior clay brick masonry demonstrates a large variation in conditions - while some areas of wall are serviceable, there are several key faults which suggest movement in the multi-wythe brick masonry walls, with significant cracking of mortar joints and brick units.

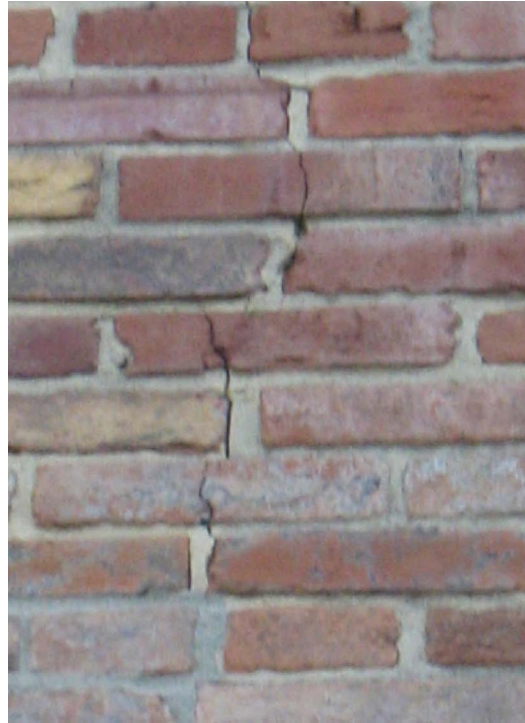
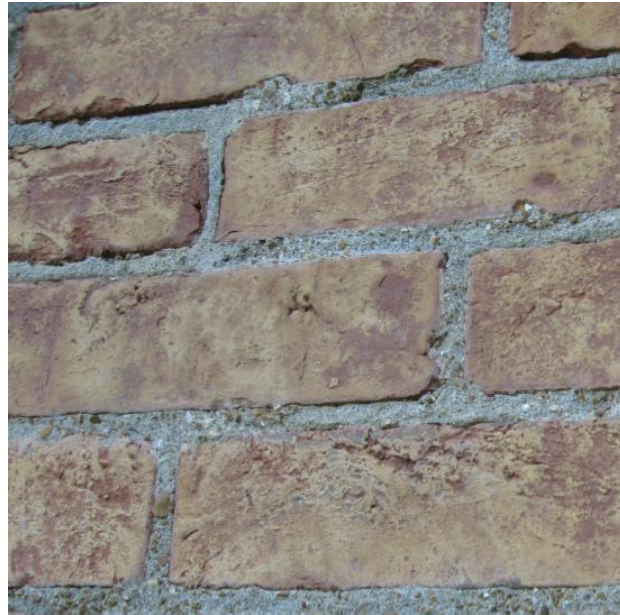
Detail view to typical south facing clay brick masonry [ABOVE and LEFT], showing deteriorated and non-serviceable mortar conditions. Note that tuckpointed mortar joints are cracked and open at the perimeter of most brick units, and likely allow a substantial amount of storm water to infiltrate the wall construction. Replacement mortar appears to have been installed in shallow depths, and in a design that was much harder than the original dry-press, hand-made brick units - thus resulting in spalled and chipped faces, missing mortar segments, and even cracked bricks.

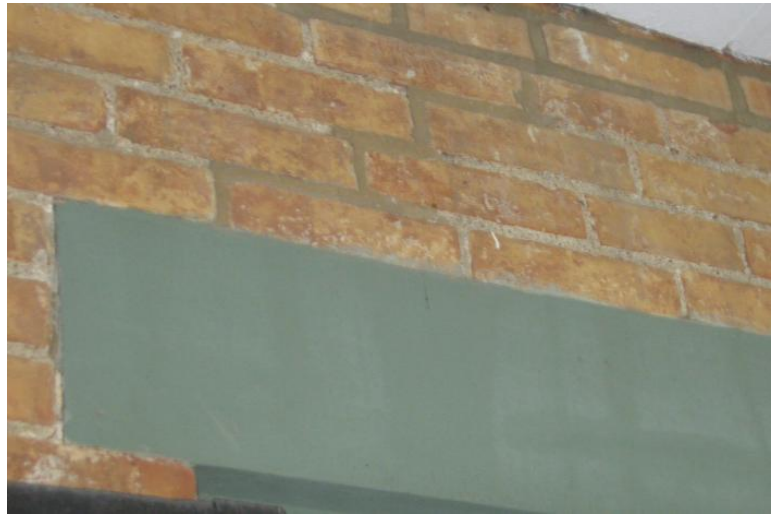
Exterior Clay Brick Masonry - Detail images depict the conditions of east facing clay brick masonry, including patch replacement brick [LEFT], settlement cracks below first level fenestration at wood timber lintel [TOP RIGHT], field joint failure at tuckpointed mortar [BOTTOM LEFT], and settlement cracking at NE corner below first level fenestration [BOTTOM RIGHT].

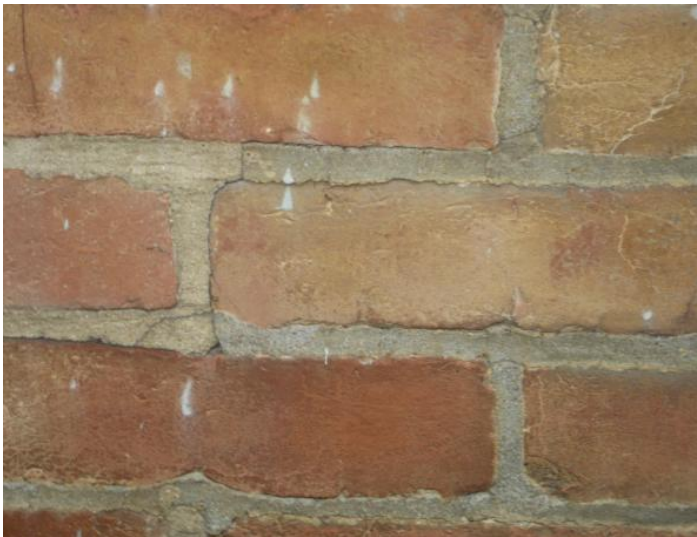
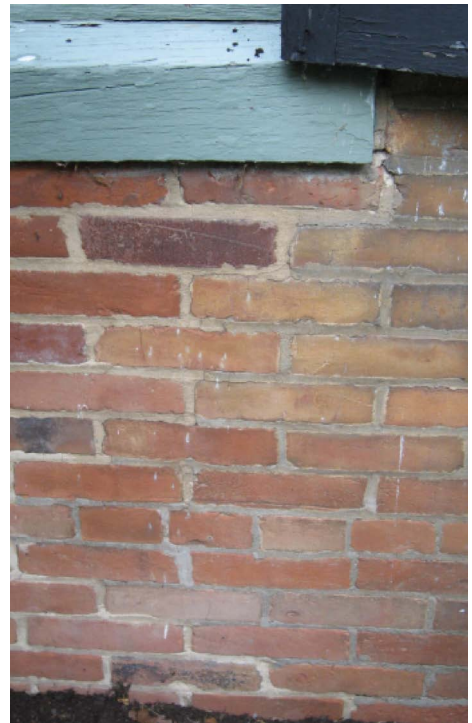
Detail view to typical east facing clay brick masonry [ABOVE and LEFT], showing deteriorated and non-serviceable mortar conditions. Note that replacement mortar appears to have been installed in shallow depths, and in varying colors, hardnesses, and joint dimensions.
