Building Assessment Study for

**Martin Franklin Hanley House**  
City of Clayton

November 14, 2007

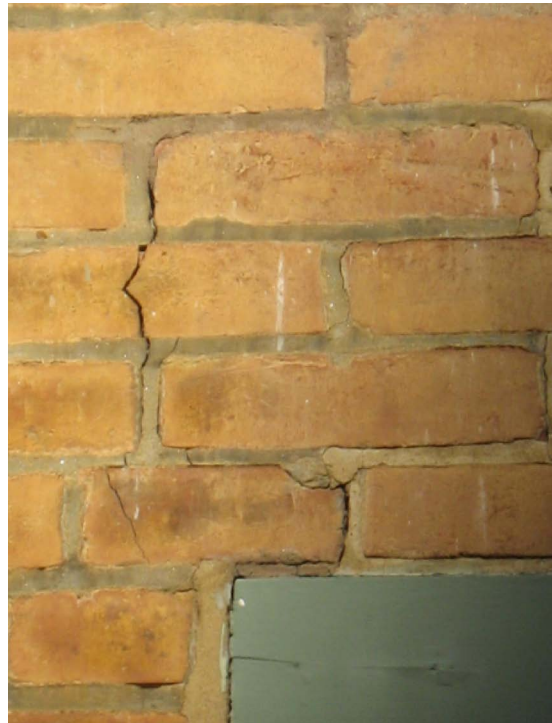
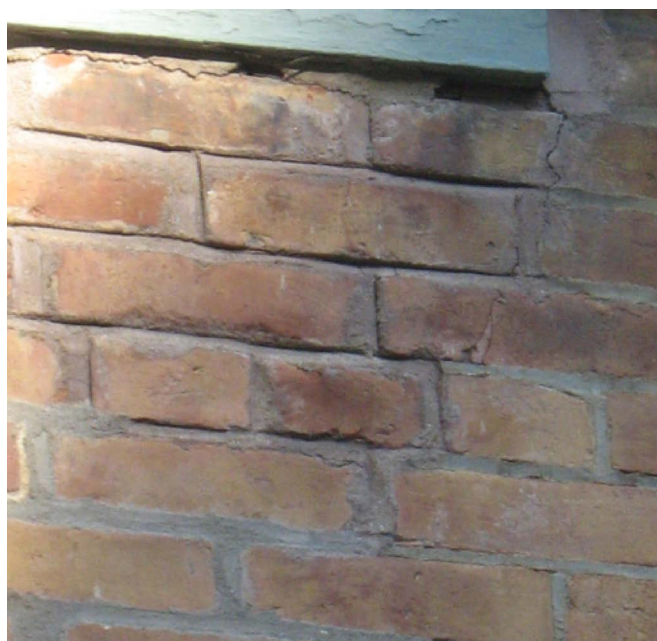
Detail view to east facing settlement crack in clay brick masonry [ABOVE LEFT], showing abandoned crack monitor device. Note that tuckpointed mortar joints at some areas of the east have been installed in a tooled (canted) profile - this is different than virtually all other (flush) joints.

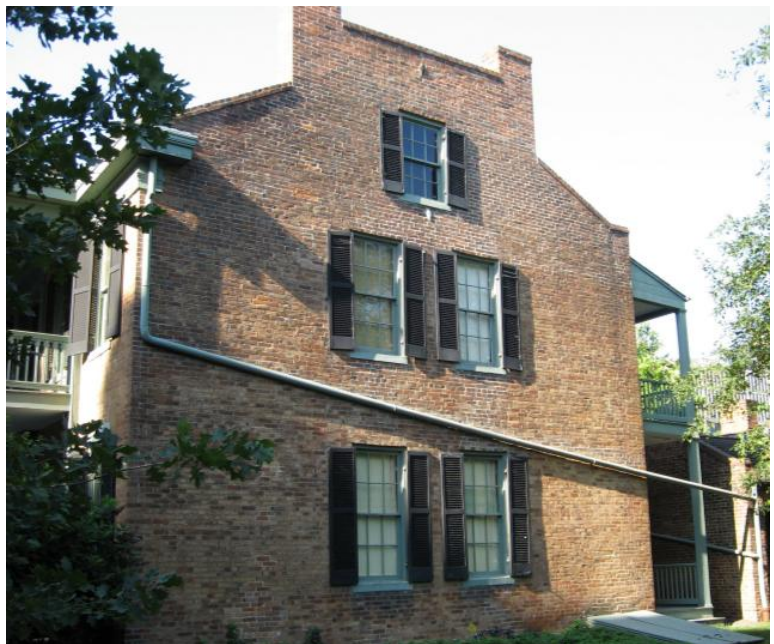
View to North Elevation [ABOVE]  
Detail view to east most settlement crack at north [LEFT]

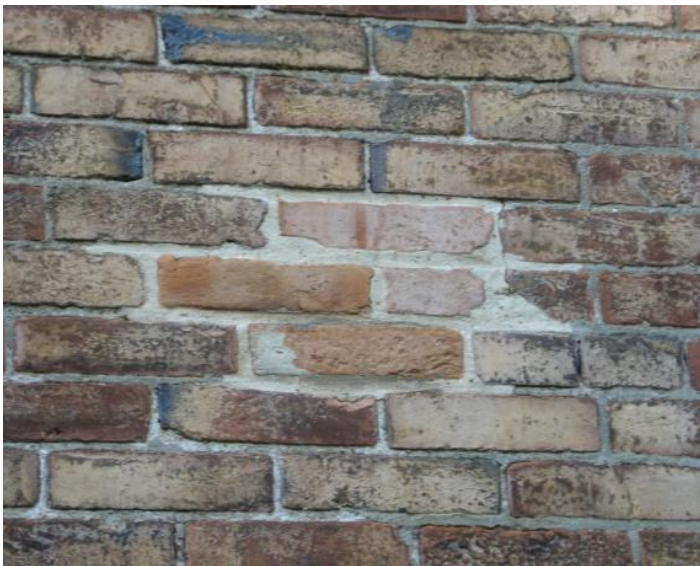
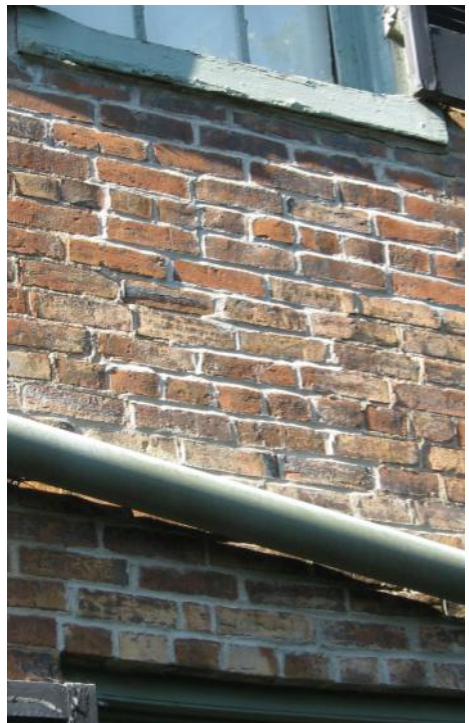
Detail images showing limited tuckpointing repair at brick masonry field [ABOVE] and between first and second level fenestration on north side [RIGHT].

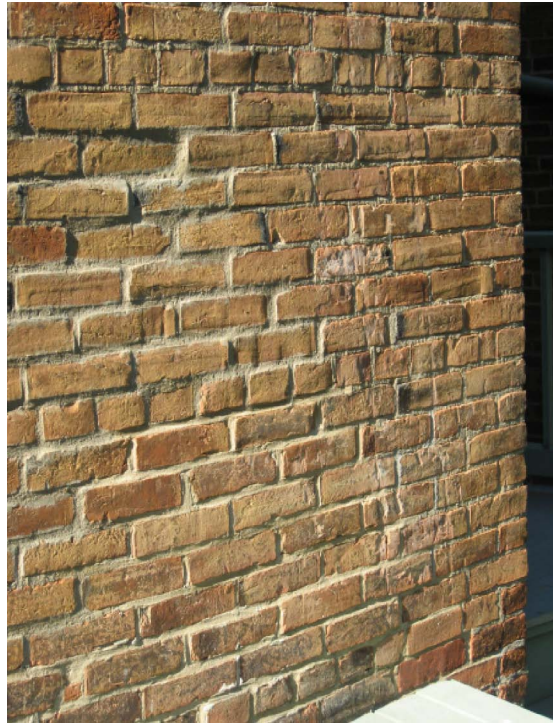
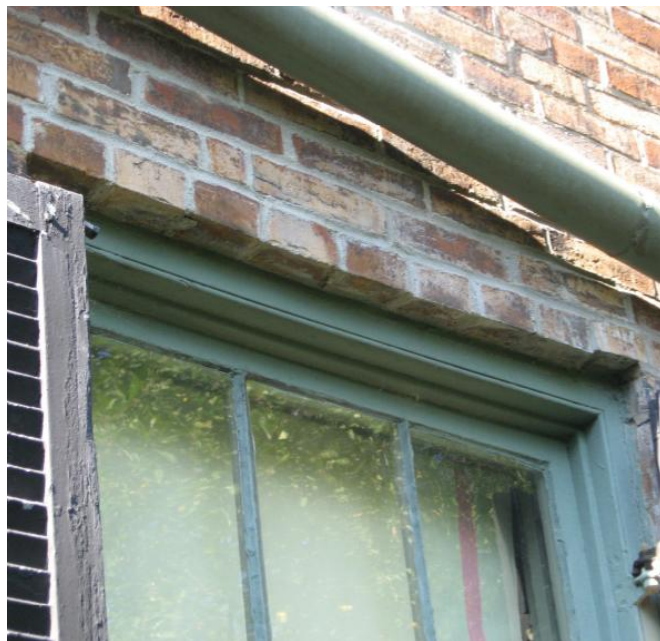
Detail image [ABOVE RIGHT] depicts degree to which ca. 1970 renovations are expected to have addressed deteriorated clay brick above first level window heads at north.

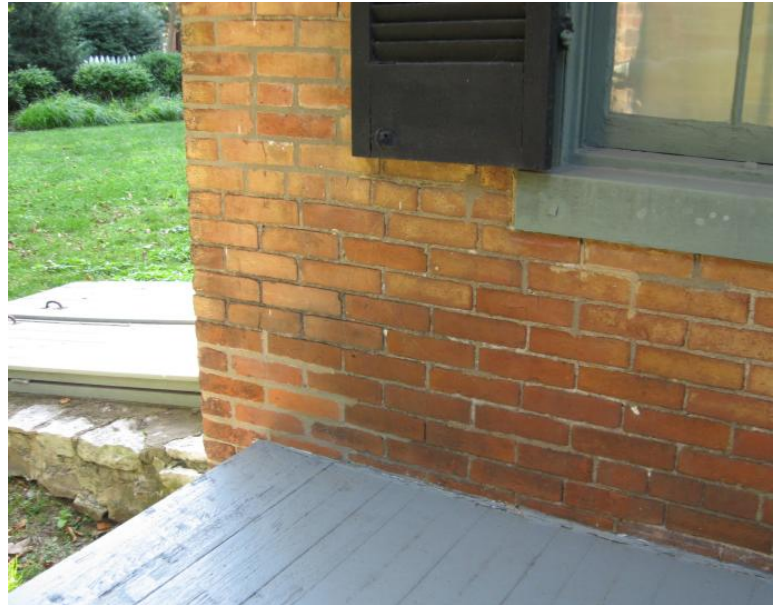
Exterior Clay Brick Masonry - Detail images depicting the condition of west facing clay brick masonry, including below second level west porch [LEFT], and at NW corner [ABOVE].

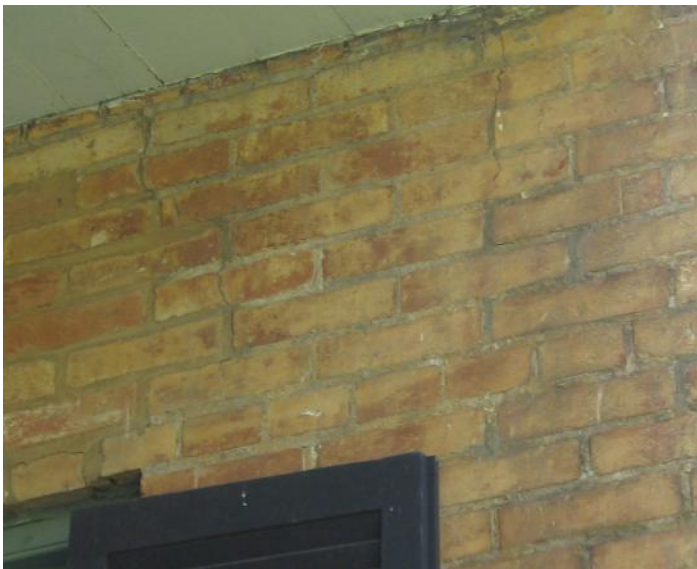
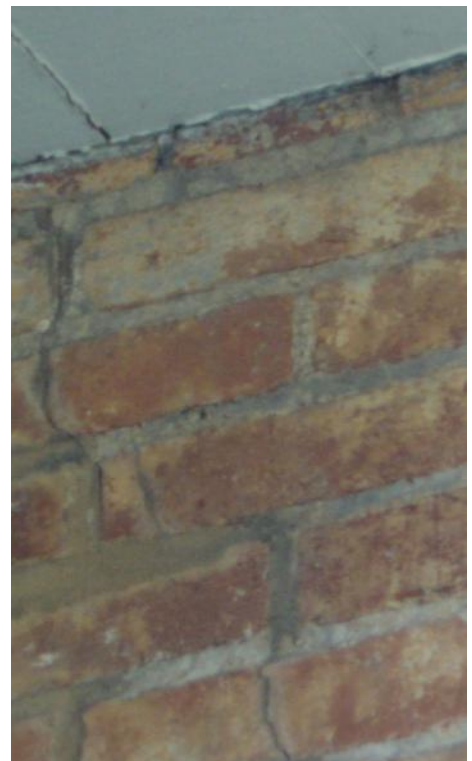
Detail images showing limited tuckpointing repair at west facing brick masonry field [ABOVE and RIGHT]. Due to the varied color of mortar and the cracks having re-opened, it is recommended that ca. 1970 mortar repairs in settlement cracks be replaced with sanded sealant.

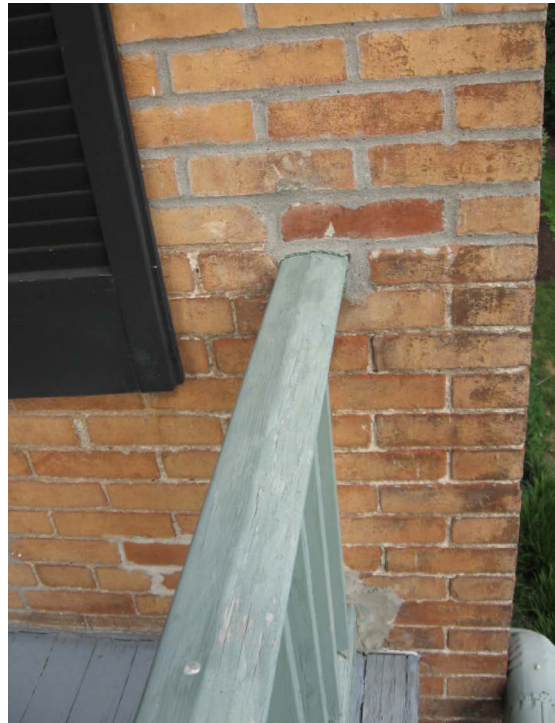
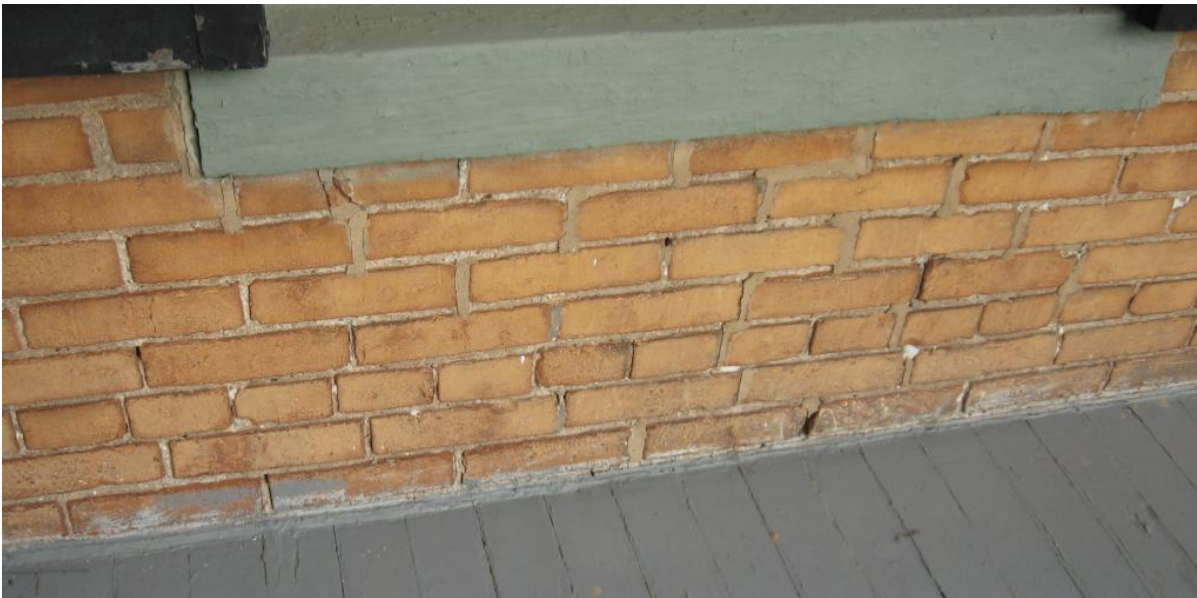
Detail image depicting the condition of west facing clay brick masonry immediately above first level west porch floor [above]. Note quantity of open, failed, and missing mortar joints below window sill. Despite protection provided by the west porch overhang, this area demonstrates continued movement and deterioration of exterior clay brick masonry, and should be repaired.
