Martin Franklin Hanley House  
 7600 Westmoreland Avenue  
 Clayton, Missouri 63105  
 LG Project No. 07268.002

Existing  
 Conditions  
 Assessment  
 16 July 07

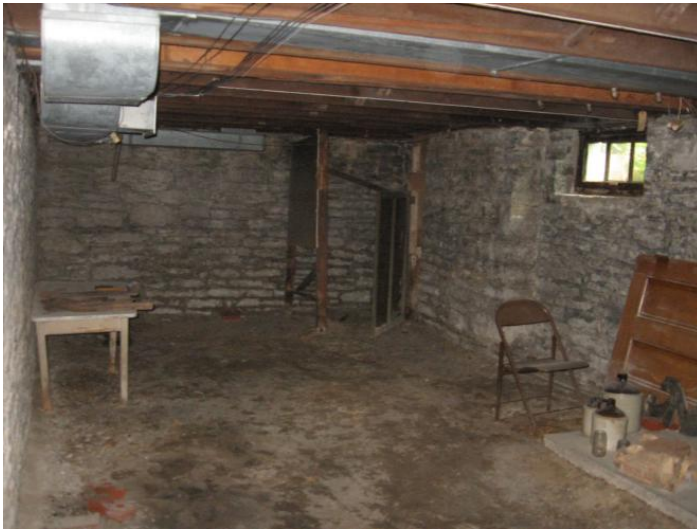
Detail images showing interior view to stone masonry foundation at south dirt floor area, including wood framing and trim members [RIGHT and BELOW RIGHT], and evidence of water infiltration through stone at west center door west jamb [BELOW LEFT].

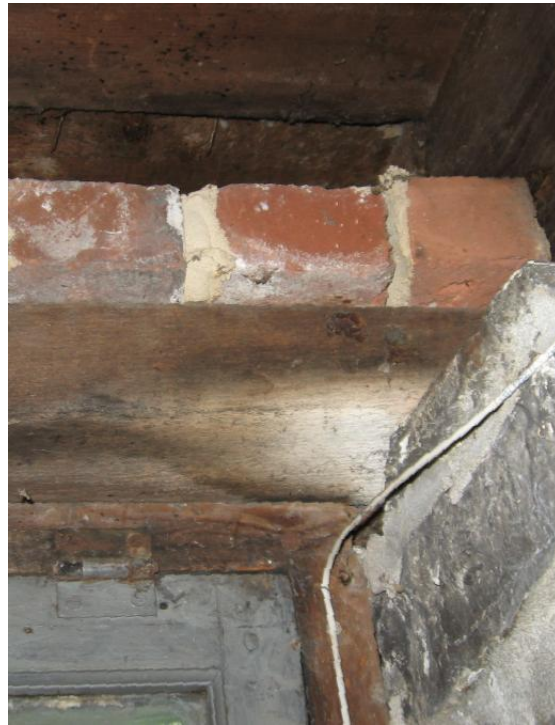
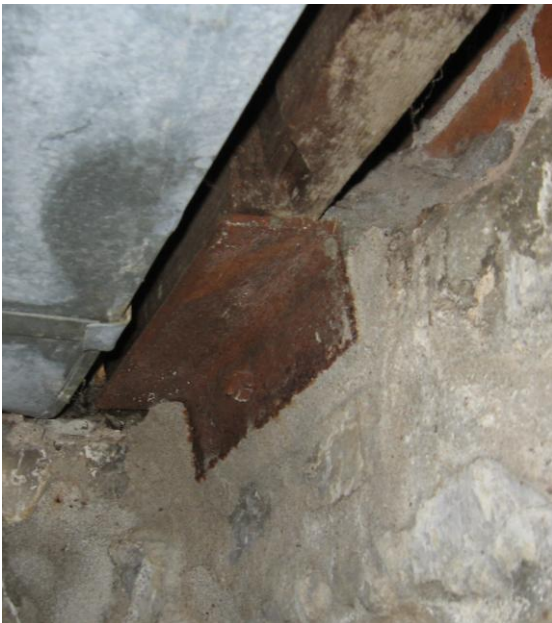
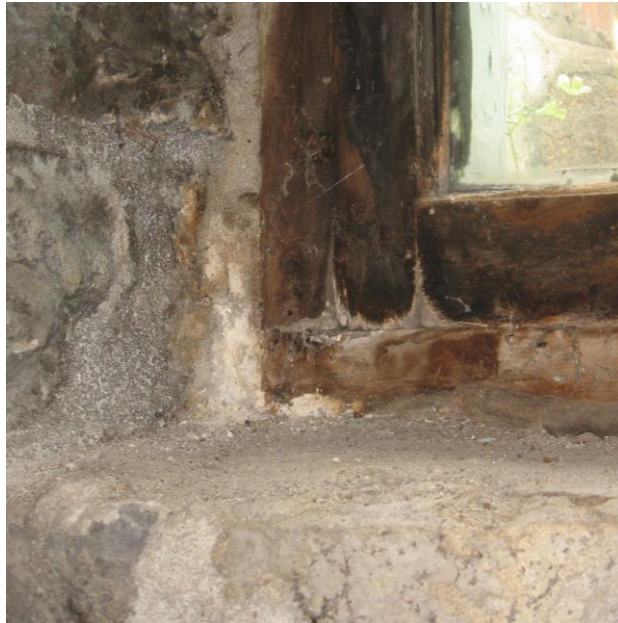
Interior Stone Masonry - Detail images depicting the condition of stone masonry foundation system, including head of west center door and lintel [ABOVE] to south dirt floor area, and at typical clerestory window head [RIGHT].

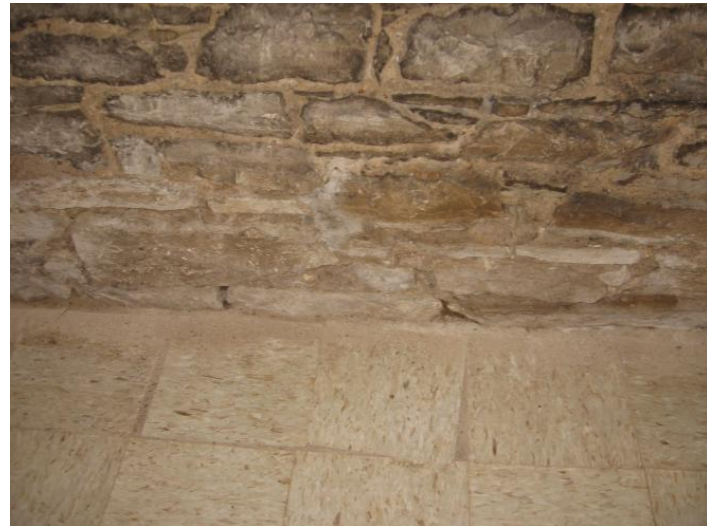
Existing interior stone masonry in lower level [ABOVE and BELOW TWO], and entry door to janitor's closet in lower level [RIGHT] - note low clearance of ceiling to top of modified door frame.

Interior stone masonry wall conditions at the central corridor in the home's lower level suggest that hydrostatic pressure has forced ground water through the stone foundation walls (original) and concrete floor slab (ca. 1969) in this area.

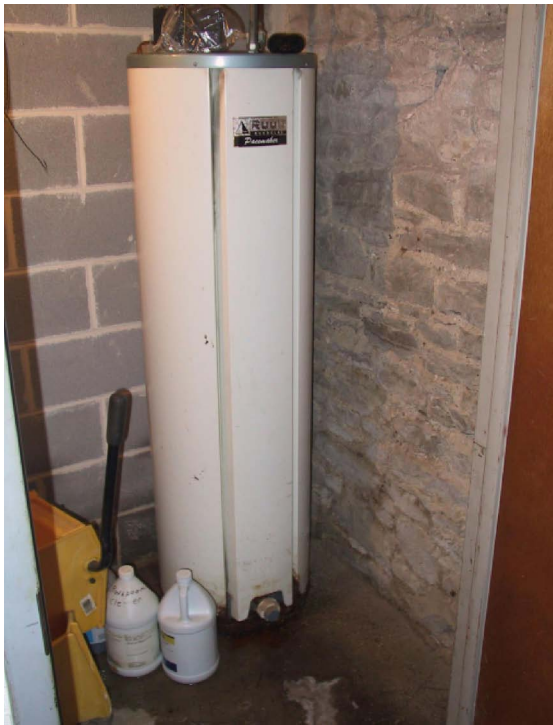
Existing ground level utility closet [ABOVE and LEFT] - note deteriorated domestic water heater and detritus on ground. The electric water heater has corroded through its tank, and is no longer serviceable.

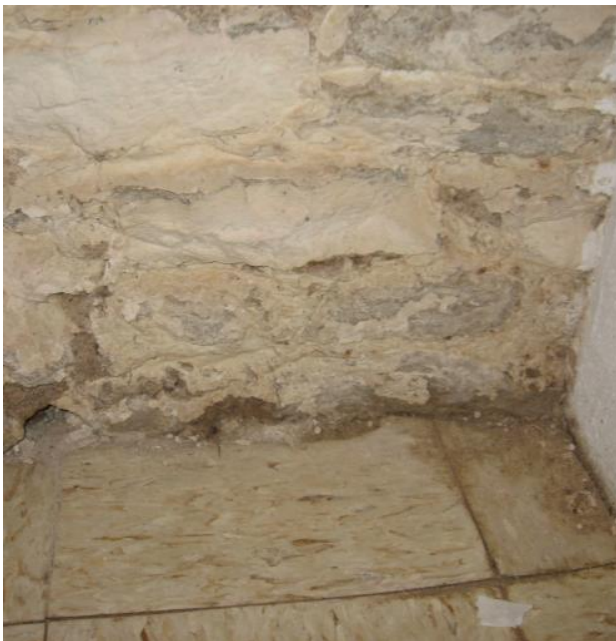
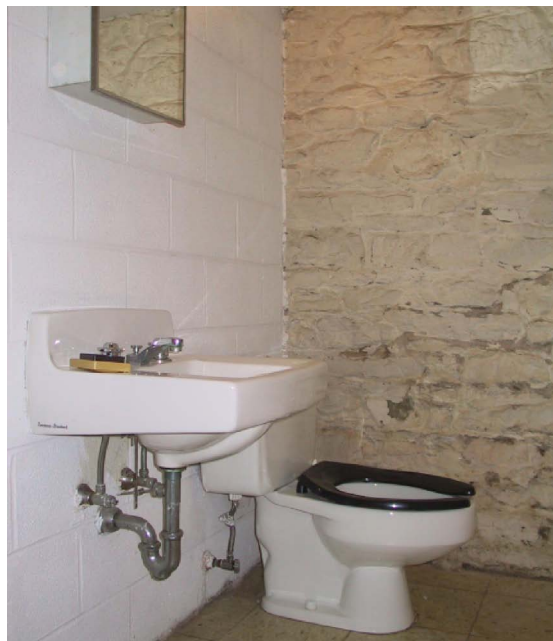
Existing ground level toilet [ABOVE LEFT and ABOVE RIGHT]. It appears that hydrostatic pressure has forced ground water through the stone foundation wall and up through the floor slab in this area. It is believed that the below-floor plumbing may no longer be serviceable.

| 6. | New underfloor plumbing and toilet facility - <i>this would eliminate a code deficiency, but would be a moot point if additional construction were to be proposed which would include toilet facilities; a variance might also address these items.</i> | \$ included below |

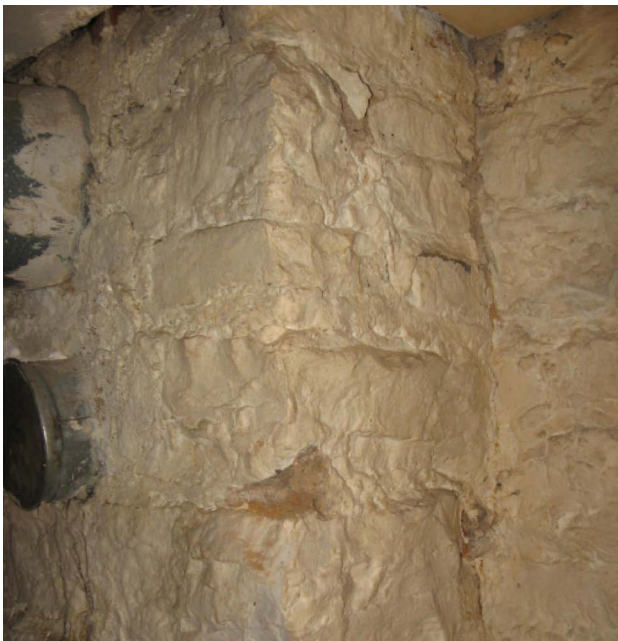
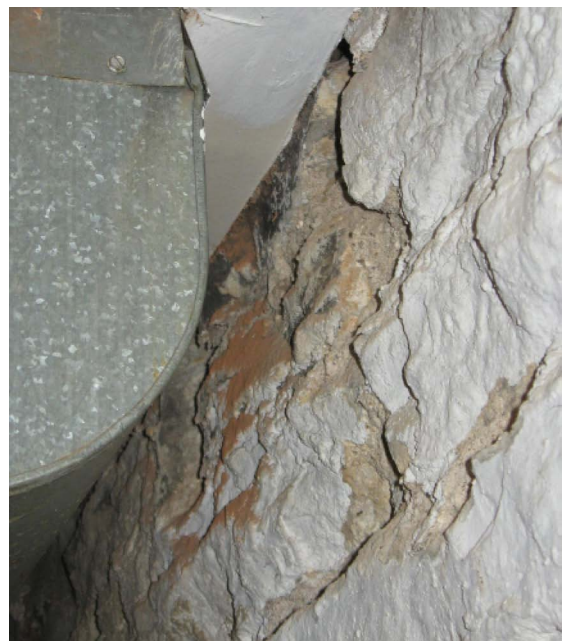
Interior Stone Masonry - Detail images depicting the condition of stone masonry foundation system, including settlement cracking at NE flue base and east wall [ABOVE LEFT and RIGHT].

2. Cut-out and install sealant at settlement cracks and faults at SW, NE corners
3. Cut-out and tuckpoint / repair the parapet and high-points clay masonry

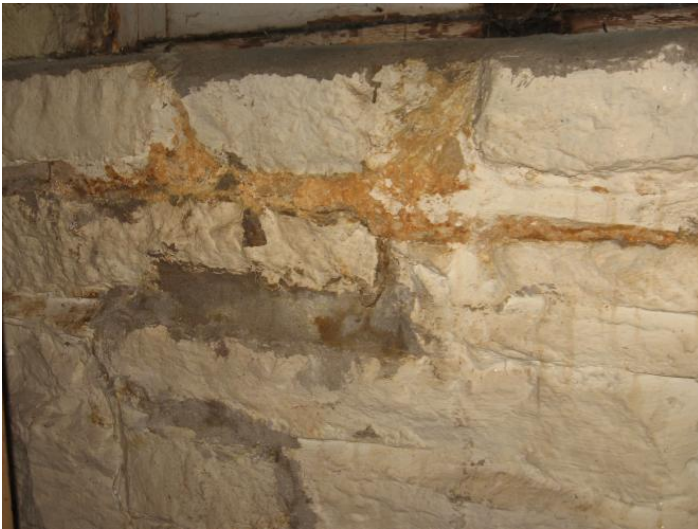
Interior Stone Masonry - Detail images depicting the condition of stone masonry foundation system, including settlement cracking at north wall [ABOVE LEFT], and view to masonry stair conditions at ground level cellar entry [RIGHT].

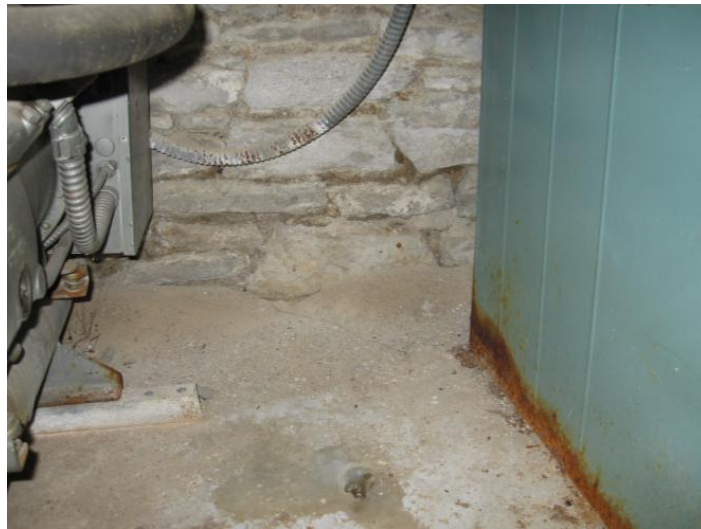
Detail images depicting the condition of stone masonry foundation system, including washed out mortar joints and effloresced stone units in mechanical room west wall [LEFT and ABOVE RIGHT]. Note the quantity of detritus on the floor, as well as the rusted base of HVAC equipment.

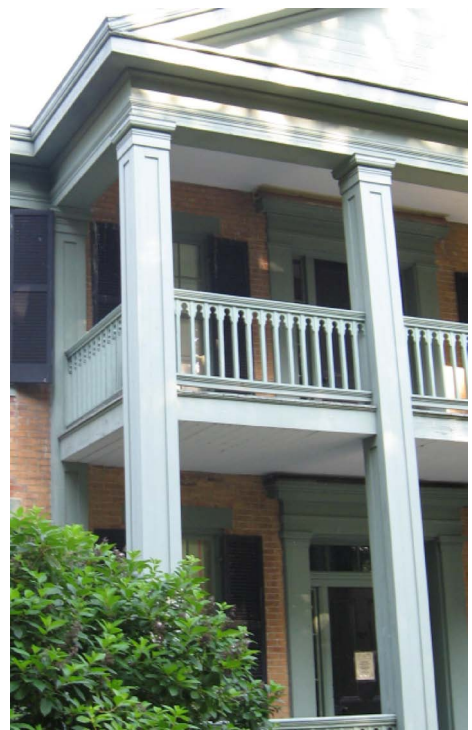
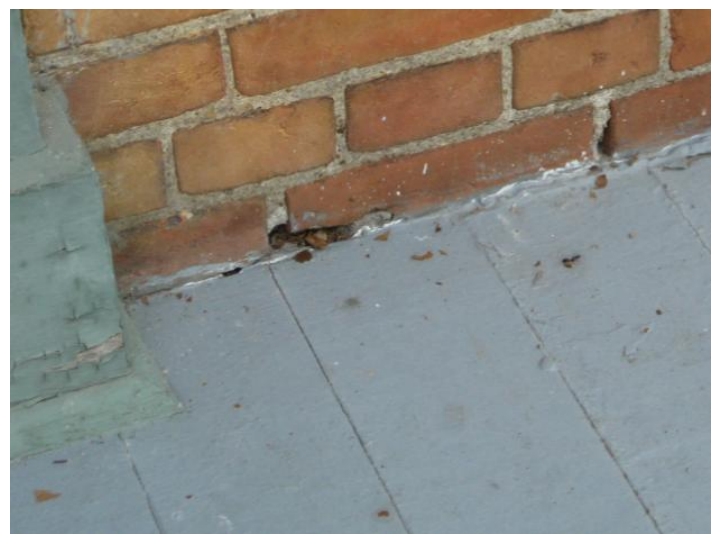
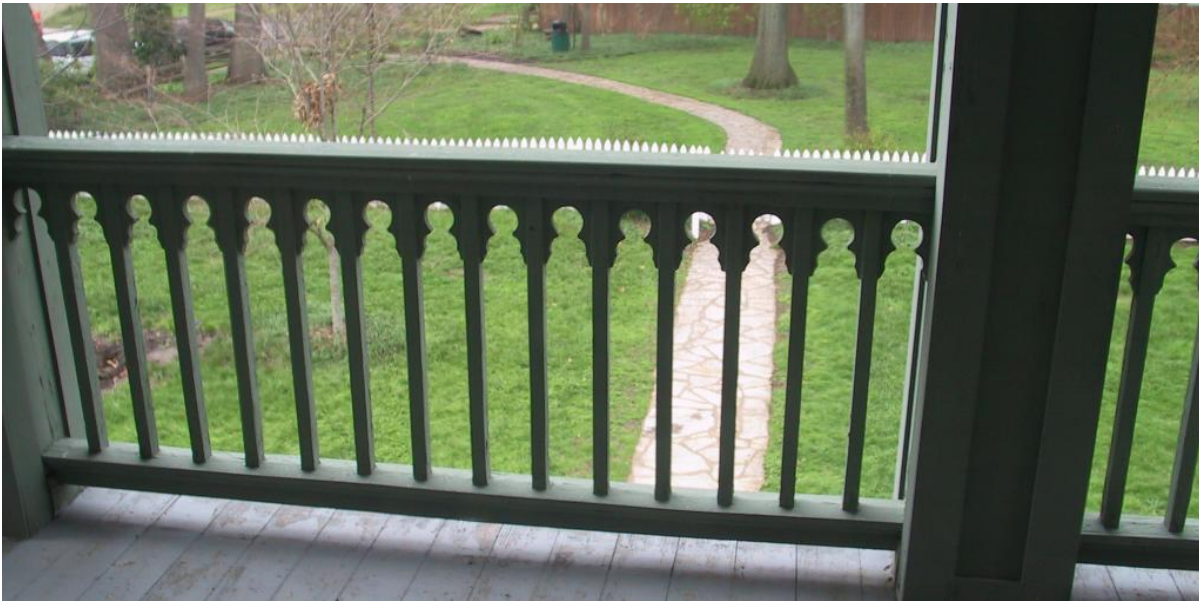
Exterior Wood Decks, Railings and Trim - Detail images depicting the condition of wood decking, trim, railings, and juncture to brick masonry at east two-level porch.

Exterior Wood Decks, Railings and Trim - Detail images depicting the condition of wood decking, trim, railings, and juncture to brick masonry at east two-level porch. At a minimum, this report would recommend the refurbishment of all wood carpentry items to include new finish.

Whereas stripping and painting of the exterior wood decks and railings might go a long way to preserving these various trim pieces, this report is aware that both the east and the west porches are not original to the house; rather, they are understood to have been rebuilt in the ca. 1970 package of renovations and were designed to replicate original construction. Given the presence of lead-based paint, and taking into account the cost of labor and abatement services, the recommendation to address these items is therefore to replace them fully.

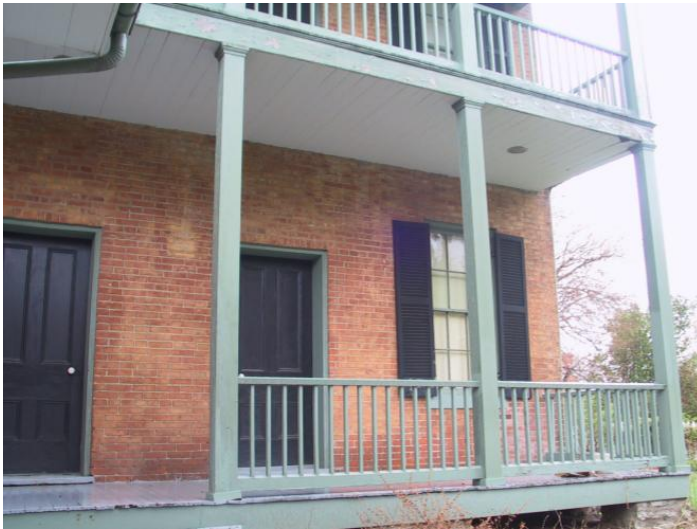
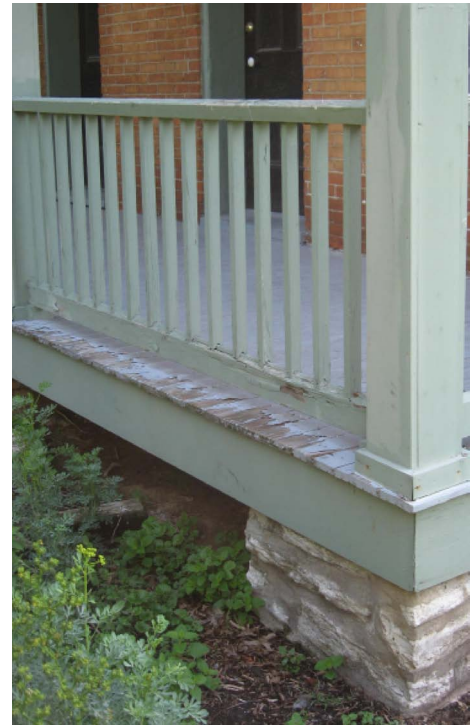
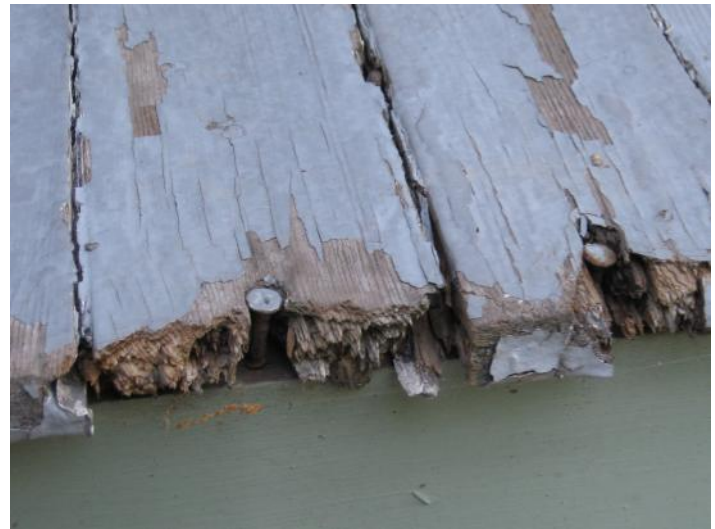
Exterior Wood Decks, Railings and Trim - Detail images depicting the condition of wood decking, trim, railings, and juncture to brick masonry at west two-level porch.

Detail images depicting the condition of wood decking, trim, railings, and juncture to brick masonry at west two-level porch. It is the understanding of this report that both the east and west porches were reconstructed ca. 1970.

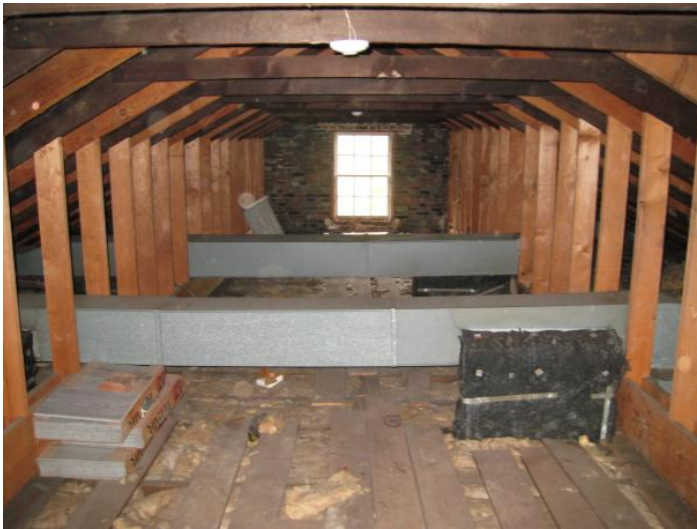
View to south showing existing attic conditions - seismic bracing would be recommended to provide additional loading surface for existing rafters at the tops of masonry walls.

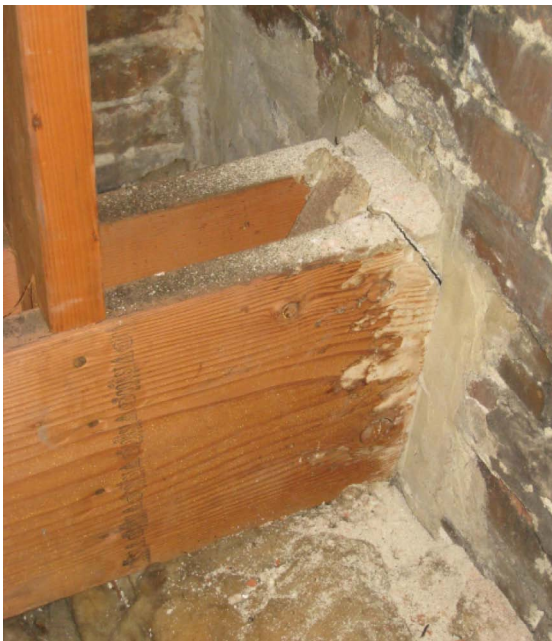
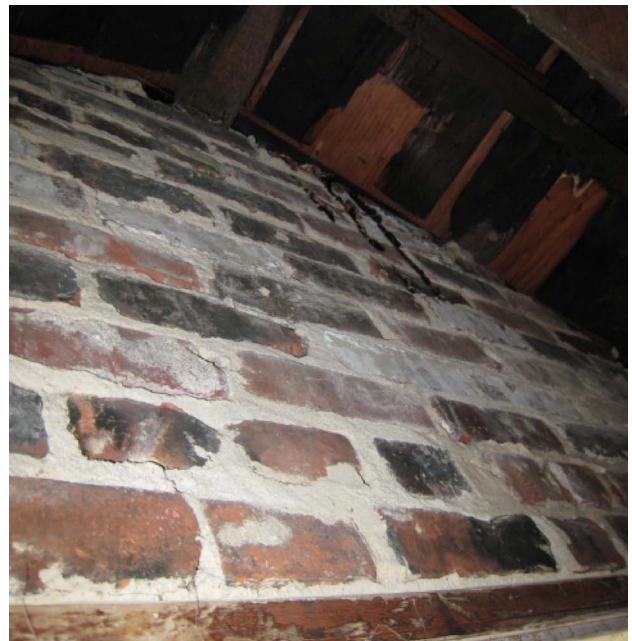
Roof Construction - Detail images show the existing roof system at the attic level, including typical double 2x12 beam running from north to south exterior bearing walls [BOTTOM LEFT], and interior masonry conditions at attic level [BOTTOM RIGHT].

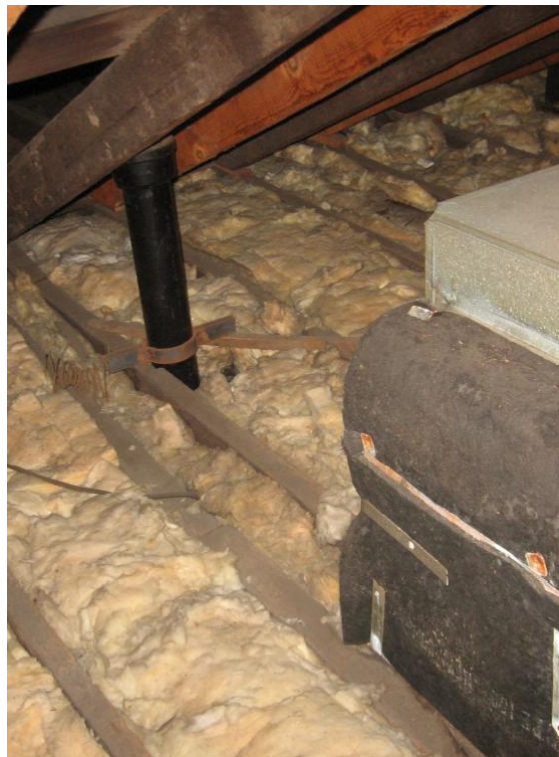
Detail image of obstructed roof hatch from attic level interior - hatch was likely concealed during ca. 1970 renovation work, and would be recommended for re-opening to perform future maintenance and / or roof replacement work.

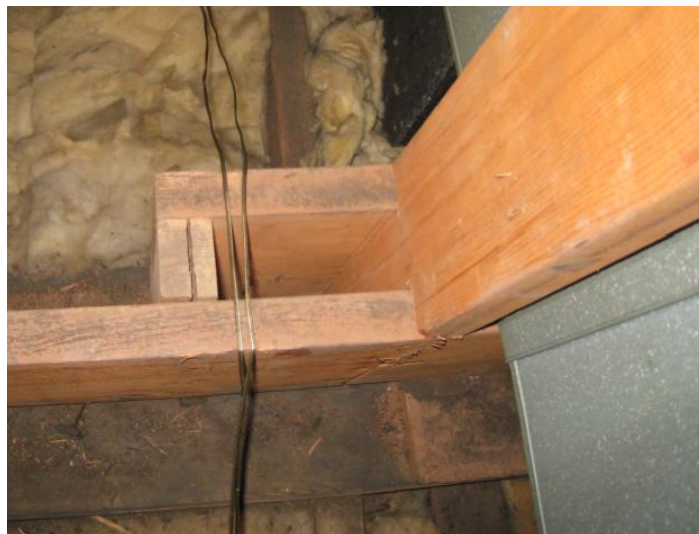
Roof Construction - Detail images show the existing roof system at attic level, including splice in typical double 2x12 beam running from north to south exterior bearing walls, and interior masonry conditions at attic level [TOP LEFT and ABOVE].

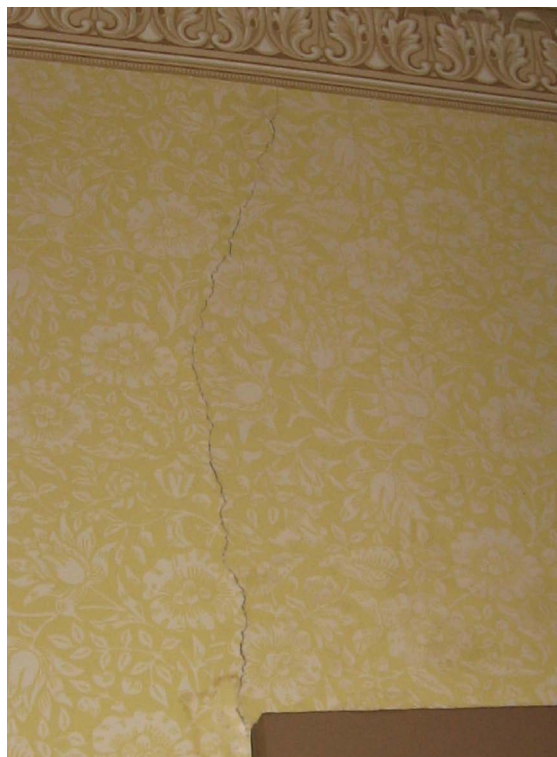
Deterioration of plaster at typical interior wall, believed to be due primarily to trapped condensation on sheet metal ducting and from metal supply air diffuser. There are also several cracks and areas of gassed plaster throughout Hanley House's interior which have been caused by structural movement, and by the routine and unchecked infiltration of storm water [ABOVE LEFT and ABOVE RIGHT].

8. New supply air methodology - *in addition to full replacement of HVAC system, construction of clouds in each of the Second level ceilings to better distribute and mix supply air*
9. Alternative new HVAC distribution system(s) - *in lieu of a typical HVAC system, a Small Diameter High Velocity (SDHV) system could be considered - see appendix this item.*

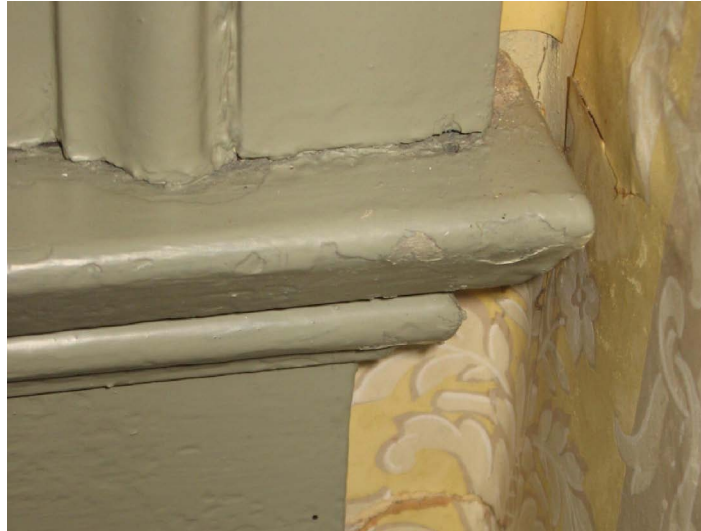
Detail image of interior plaster deterioration, including SW corner of Hanley House on face of flue adjacent to closet [ABOVE LEFT], and typical settlement cracking from corners of fenestration on first level [RIGHT].

It should be noted that, although indirectly related to the roof, the cracking of interior plaster at corridor walls on the first and second floor levels is attributable to the ca. 1970 added structural members, which placed a load on the tops of these partitions but provided no column or other mechanism to transfer the weight of the roof downward to the foundation.

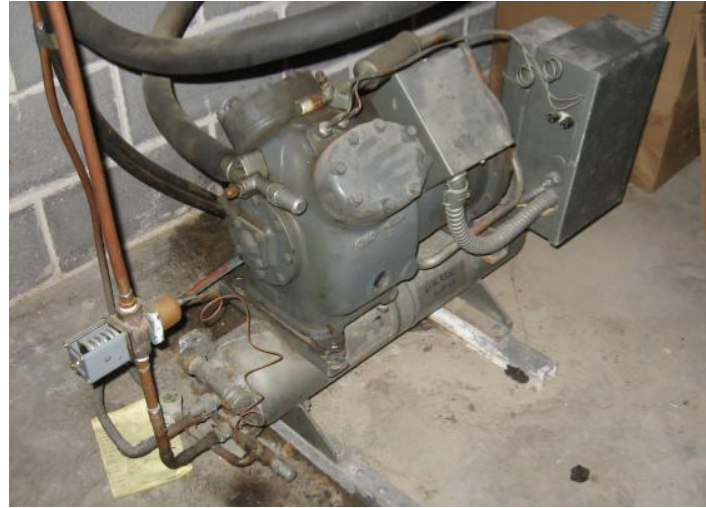
Detail views to typical existing furnace [LEFT] and water cooled condenser [ABOVE] units in ground level mechanical room, and existing typical floor drain in mechanical room [BELOW LEFT] for discharge of cooling water. These units are at the end of their serviceable life - it is the recommendation of this report that these units be replaced.

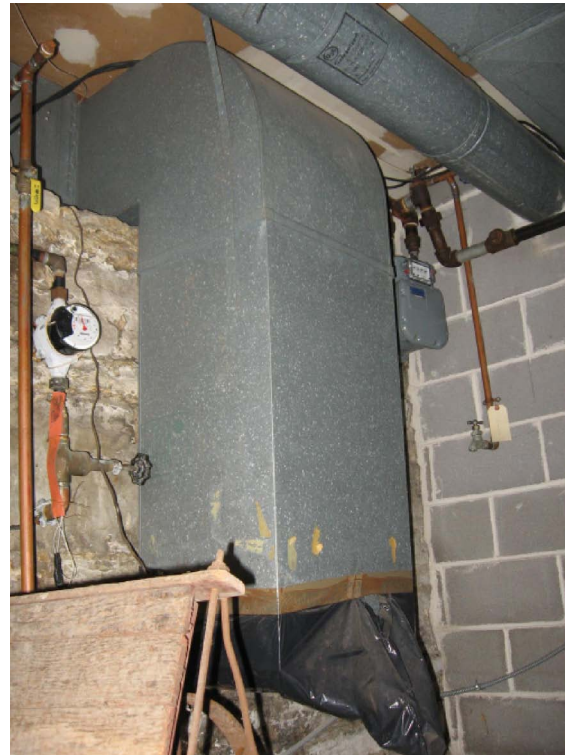
Mechanical (HVAC) Systems - Detail view to existing sheet metal combustion air ducting design [RIGHT] - this is likely to be considered a code violation if the Hanley House is significantly renovated and operated as a museum structure.

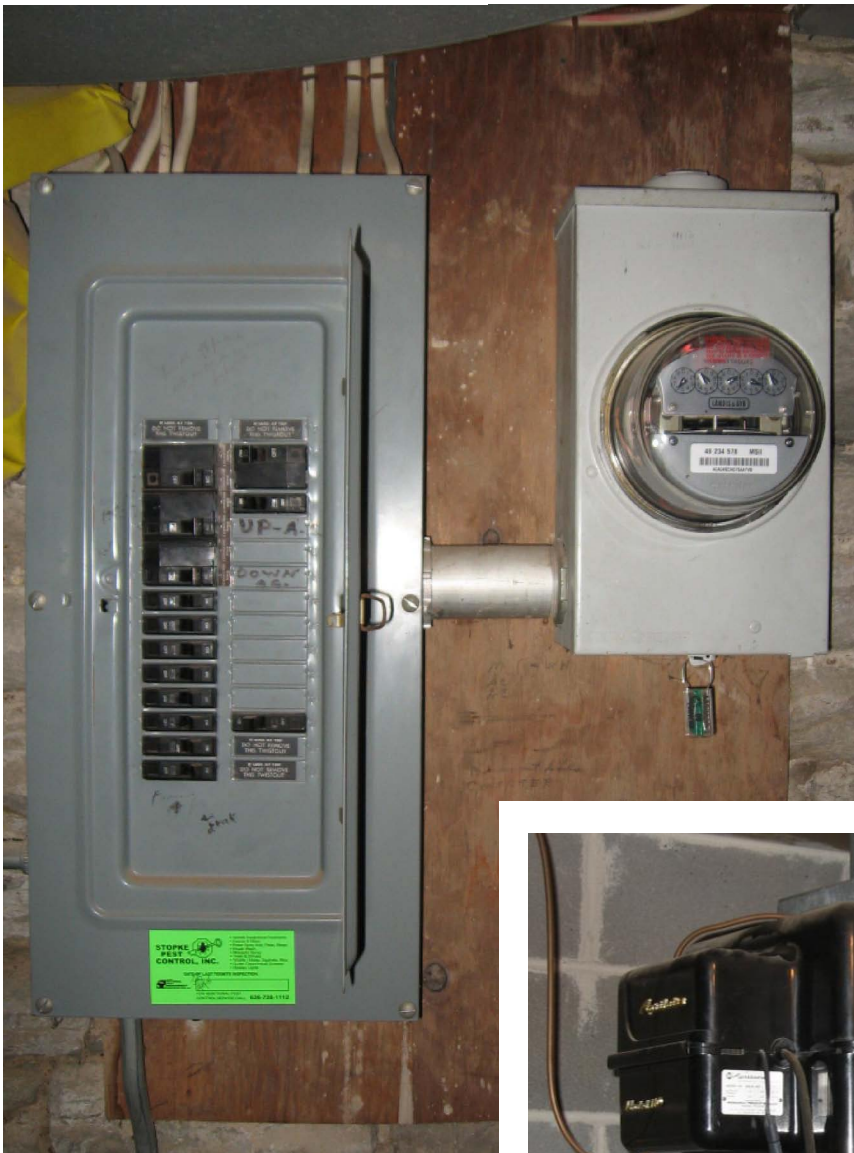
Electrical Distribution Panel and Circuitry - Detail view to existing non-code complying panel and meter [LEFT], and abandoned conduit in ground level west wall [ABOVE].

| 3. | New electrical service and distribution - <i>this would eliminate electrical code deficiencies of a missing main disconnect, as well as aluminum and cloth covered conductors</i> | \$ 51,153.62 |

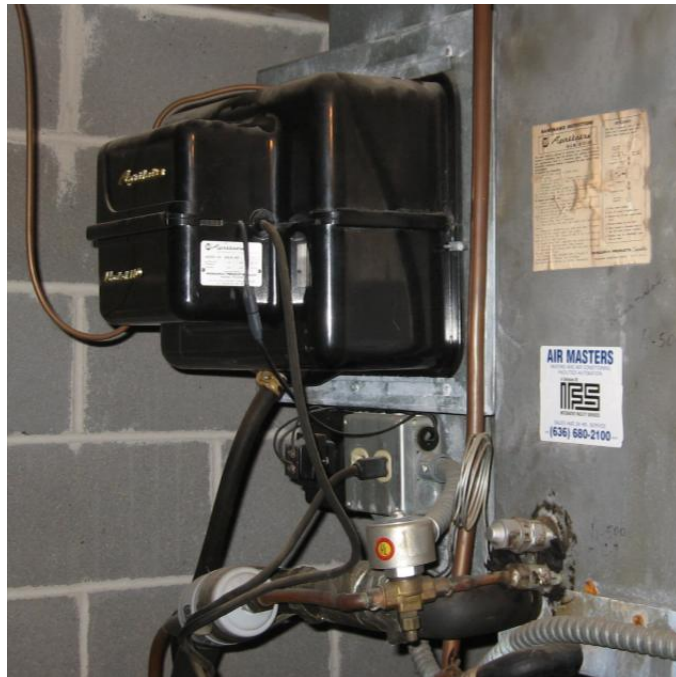
Mechanical (HVAC) Systems - Detail view to existing non-functioning humidifier unit [RIGHT].

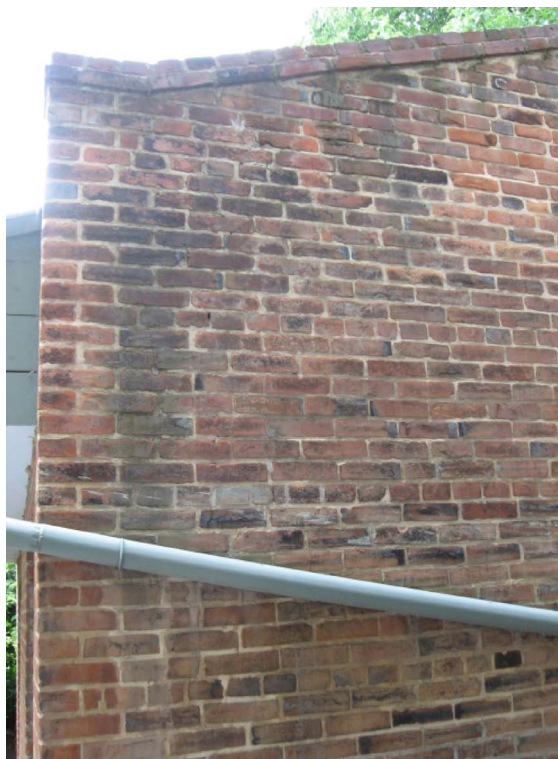
Existing gutter system and downspouts.

Part and parcel to any scope of roof replacement at the Hanley House site, it would be advisable to verify and repair the gutter and downspout, and sheet metal flashing systems. The logic being that the new roof would far outlive the existing but older flashings. When a leak or fault would develop in the future, it would be somewhat indistinguishable whether the penetration of storm water was due to deteriorated flashings or failed roof materials (or both). Assuming a well-installed and maintained roof system, more than likely a leak or fault would be due to the flashing no longer being serviceable. The cost and ease of replacing the flashings while the roof is being replaced make this a recommended scope of work.

Unfortunately, the degree to which repair might be required on the sheet metal gutter and downspout is difficult to establish without some destructive demolition. So, for purposes of this report, and after multiple observations during various weather conditions, a more conservative approach has been taken: the recommendation is based on assuming a full replacement of the flashings at the roof and masonry parapet wall, measurable repair to the box gutter, and full replacement of the round-pipe downspout system (to include relocated seams and installation of concealed clean-outs at each side of the main house and outbuilding).

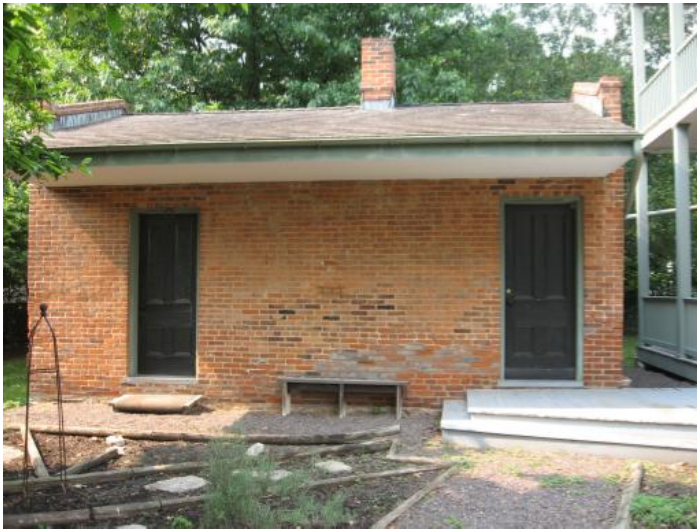
South Elevation Summer Kitchen - Detail image to right shows settlement crack at south end east parapet wall, while detail image below shows typical failed mortar joints at middle SE corner.

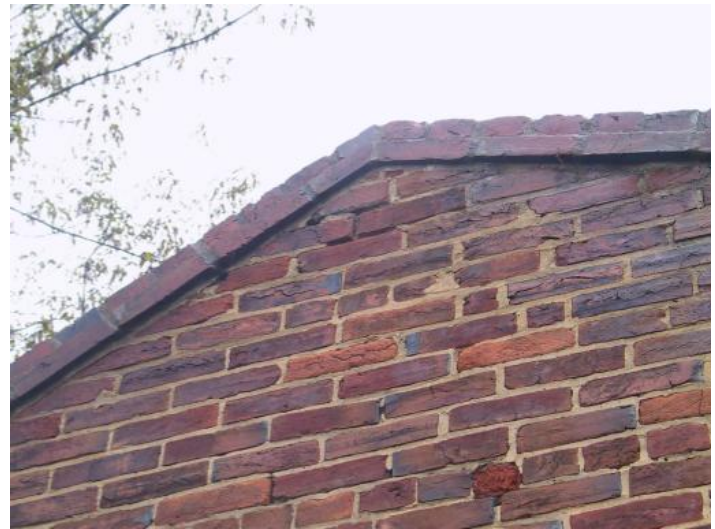
North Elevation Summer Kitchen - Above detail image shows deterioration of clay brick masonry due to impact from lawn sprinkler - masonry units are discolored and joints are failing. Detail image to left shows typical rotted wood cladding at eave and gutter.

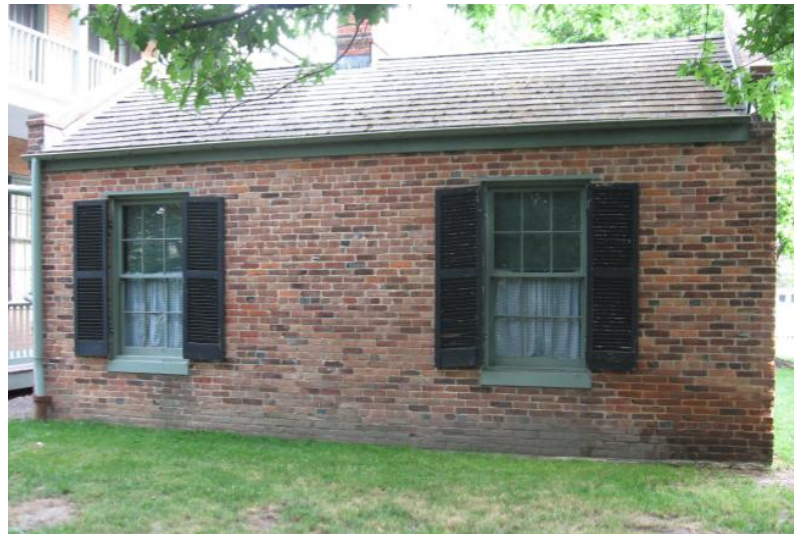
Exterior Windows and Wood Trim - Various images depicting wood shutters in need of repair at the Summer Kitchen.

The shutters at Hanley House are a mixture of original units that have been repainted over time, and new units (presumably fabricated and installed ca. 1970). The replacement shutters are noted as not having replicated the mortise-and-tenon construction of the original shutters, and not matching the dimensions of the originals entirely. This report would therefore recommend replacement of all replica shutters, and conservation of all existing original shutters.

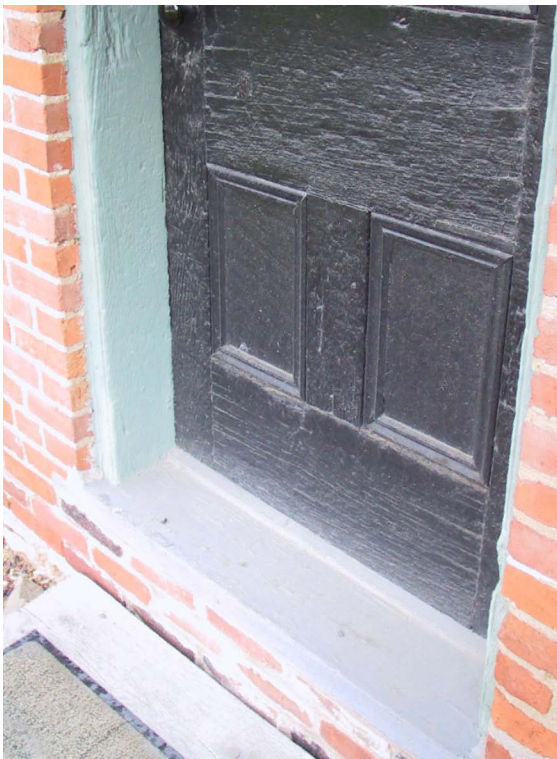
Stone foundation cracked and in need of repair.
