Building Assessment Study for

**Martin Franklin Hanley House**  
City of Clayton

November 14, 2007

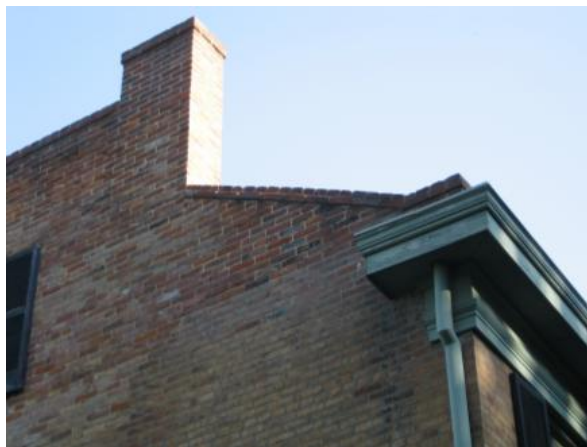
Southeast Parapet and Box Gutter

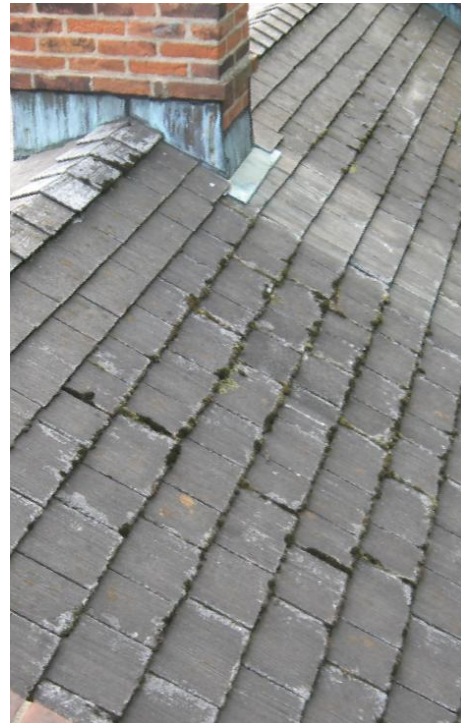
Detail at Typical Deteriorated Cement Tile Finish Roofing System [TOP RIGHT]

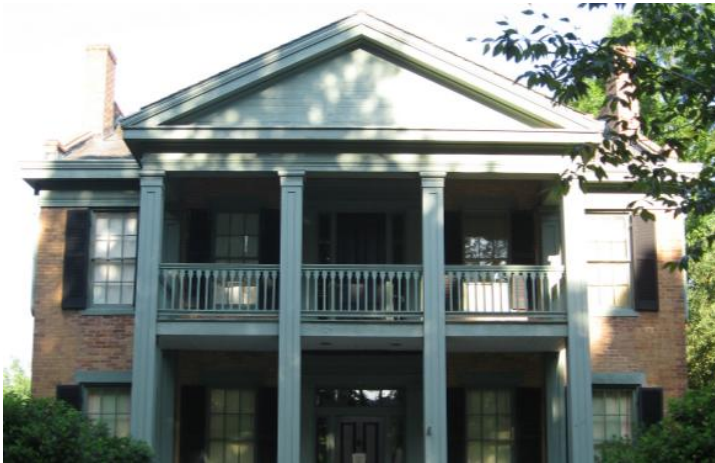
Roof Construction - East elevation [LEFT] shows orientation of roof pitch with box gutter and gable design. Detail images to right and below depict typical relationship between masonry bearing walls, projected parapets, chimneys (four such), sheet metal flashings, and cement tile finish roof. Note arrangement of low parapet wall as termination for roof system.

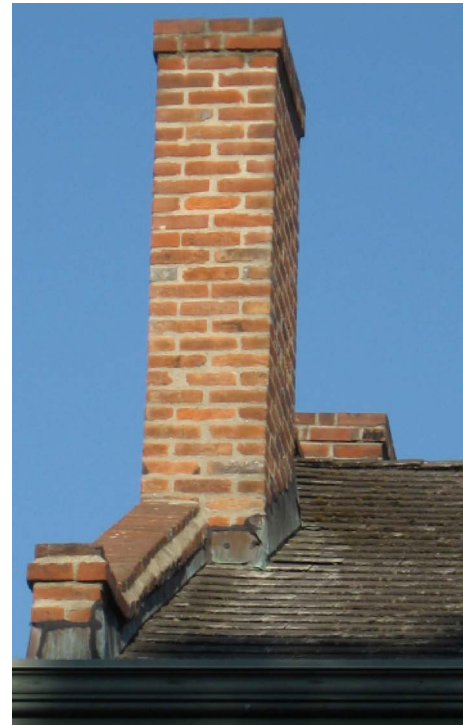
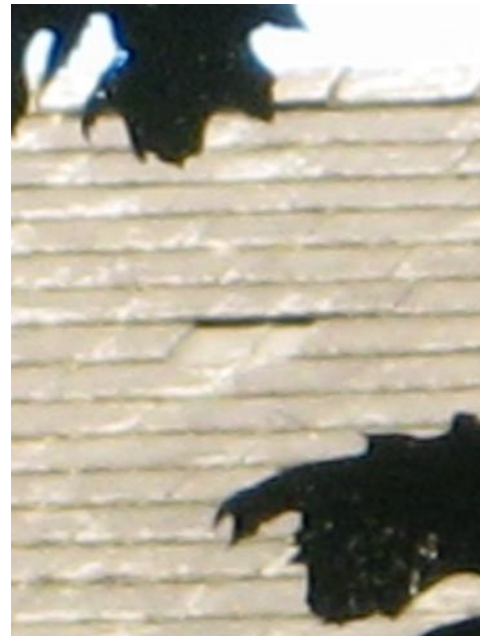
Roof Construction - Detail image to right shows missing cement roof tile at east facing field. Moss is visible in several areas of east facing roof, as are oddly spaced roof tiles.

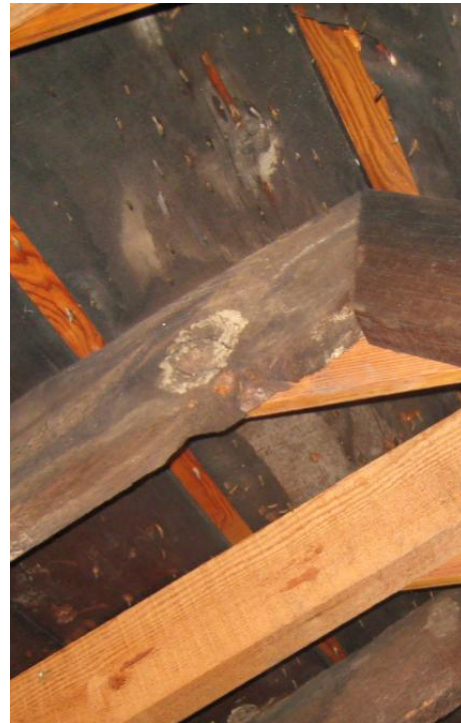
Roof Construction - Detail images show the existing roof system at the attic level. Ca.. 1855 rafters have been doubled [TOP LEFT], supported with vertical members, and bolstered by a double 2x12 beam running from north to south exterior bearing walls, while rafter vertices have been braced with plywood and the entire roof covered with 1/2" plywood [TOP RIGHT]. Given that existing roof rafters terminate directly on east and east exterior bearing walls, seismic bracing would be recommended to provide additional loading surface for existing rafters at the tops of masonry walls.

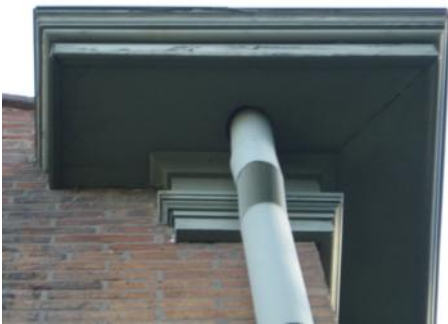
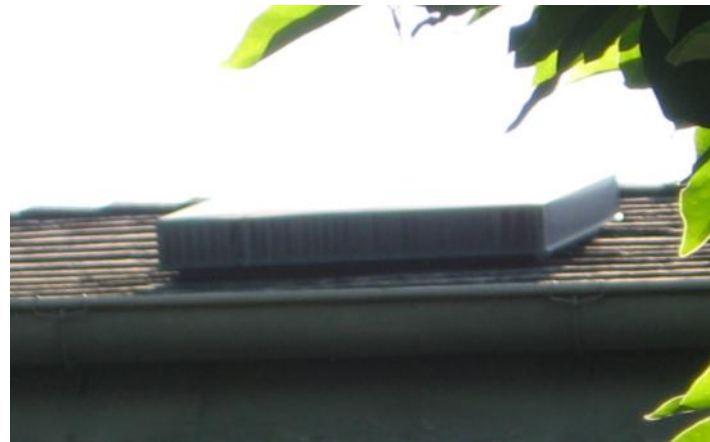
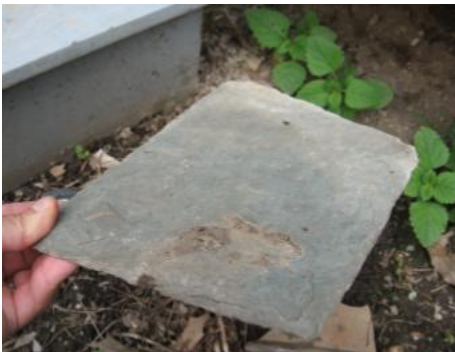
Detail image [LEFT] shows failed slate tile found at grade, west elevation of Hanley House. This was likely used to patch a failed cement tile during the past thirty or so years. It should be noted that slate tiles are significantly heavier than cedar shakes and cement tiles, and so should not be used to patch large areas of the Hanley House roof without a more thorough understanding of existing roof framing design and load capacity.

Sheet Metal Gutter and Downspouts - Detail images show transition from sheet metal-lined box gutter to sheet metal pipe downspouts at building east [RIGHT], and relationship of downspouts to windows at partial South elevation. Discoloration on brick suggests that at least one different sheet metal downspout design has been used at the south (and north equal) elevation.

It should be noted that although the sheet metal-lined box gutter (east) and hung gutter (west) sizes and downspout diameter are believed to be adequate for drainage of Hanley House's roof, the locations of elbows, seams, and fittings appear to seriously diminish the capacity of this storm water drainage system.

Further, there is no capacity of clean-out of accumulated debris from the downspouts, nor for the relief of ice.

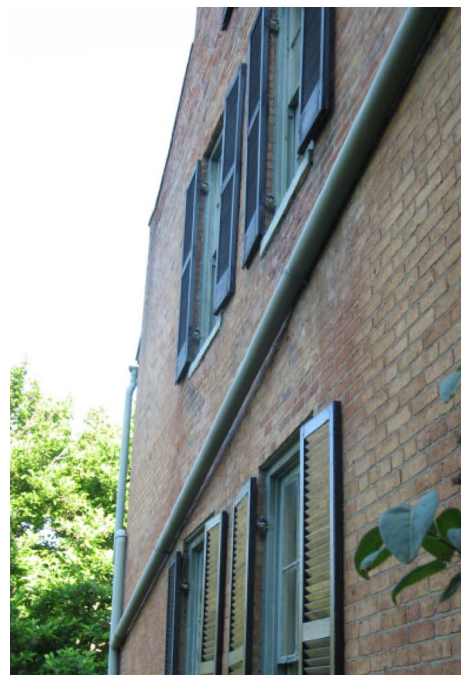
Deterioration of windows and walls at the south and north elevations appear to be due in measurable degree to failed seams and fittings in the downspouts - lintels and clay brick masonry demonstrate a high quantity of wear to due routine surface water erosion, and penetration of storm water that has frozen and thawed, causing movement damage.

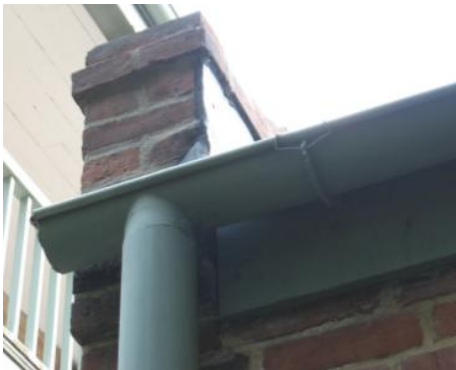
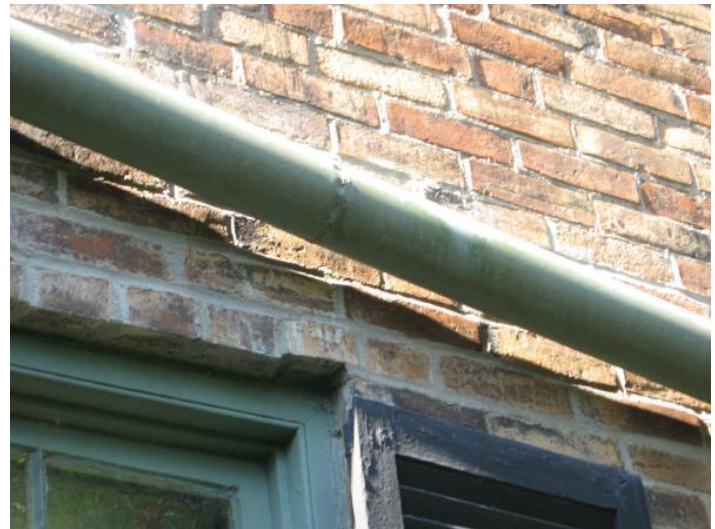
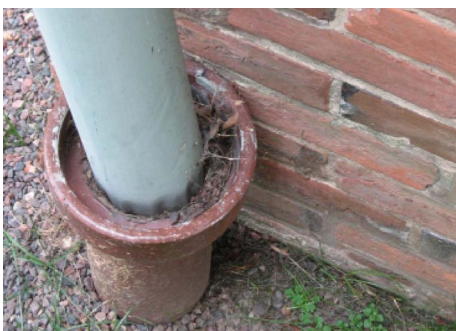
Drainage of storm water from the Hanley House and Summer Kitchen roofs is compounded not only by the lengthy, twisted routing from initial collection to final sewerage, but also by the quantity of disposal. It is presumed that historic authenticity directed only 2 such storm water boots [LEFT]

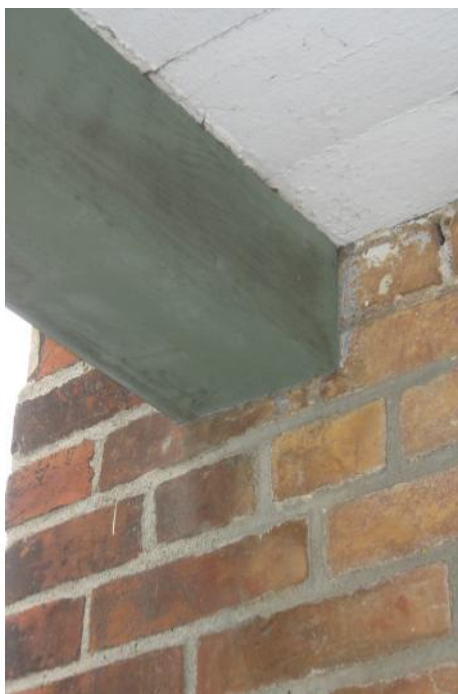
Detail images depict existing condition of clay brick masonry repaired ca. 1970 or after at SW chimney high points [ABOVE], and ceiling and beam pocket for roof at west porch second level [LEFT]. Note the contrasting color of mortar, and the relative depth of repaired joints.

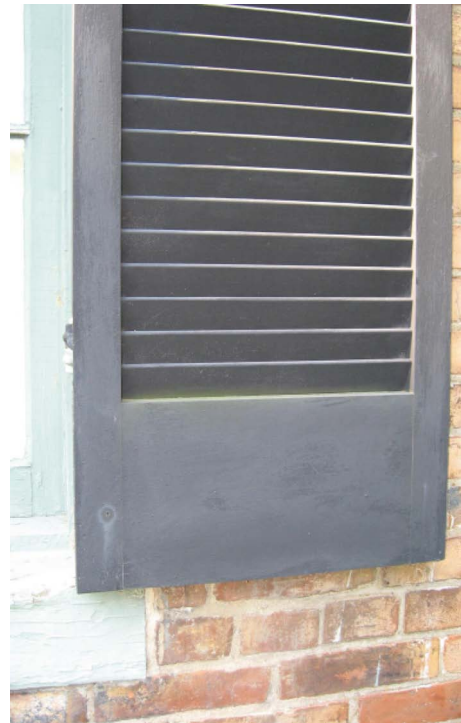
Exterior Wood Shutters - Detail images show various conditions of existing Hanley House shutters, including original position-holding hardware [ABOVE], typical replacement shutter [RIGHT], and extreme component and finish deterioration encountered on original shutters.

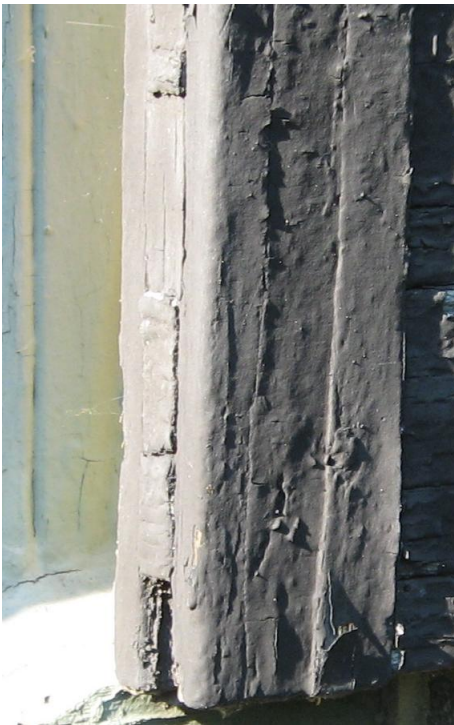
Detail image [LEFT] depicts the mortise-and-tenon construction method used to assemble original wood shutters at Hanley House - note desiccated and cracked condition of stile (vertical member), and off-set surfaces of the tenons as they appear at the left side of the stile.

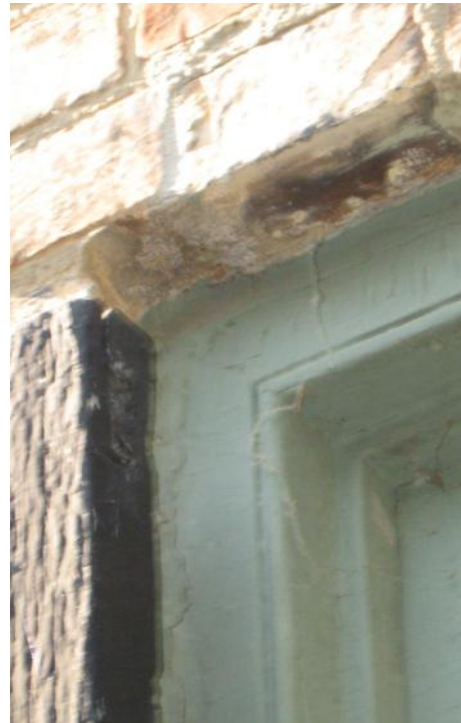
Exterior Wood Windows - Detail images show designs and conditions of various Hanley House lintels, including painted steel angle at first level south [ABOVE], and no apparent lintel with brick row-lock header at first level north [RIGHT]. Steel angle lintels do not appear to be original.

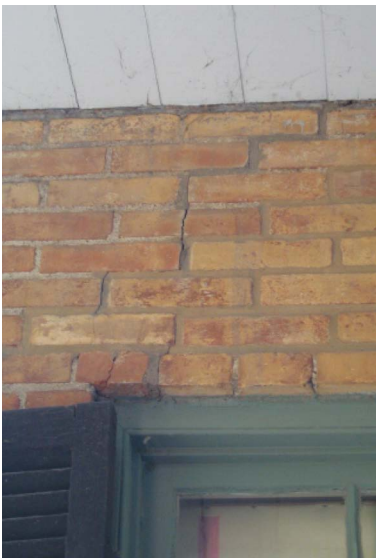
Exterior Wood Windows - Detail images show no apparent lintel with brick row-lock header at first level west [ABOVE LEFT], and painted wood timber at first level east [ABOVE RIGHT]. Although wood timber lintels (found only at the east elevation of Hanley House) appear to be original, they are at the end of serviceable life. This report would recommend that all windows not already supported by one be augmented by a concealed steel angle - said steel could be installed behind the exterior wythe of clay brick, and could be painted to match. All steel should be flashed to evacuate water.

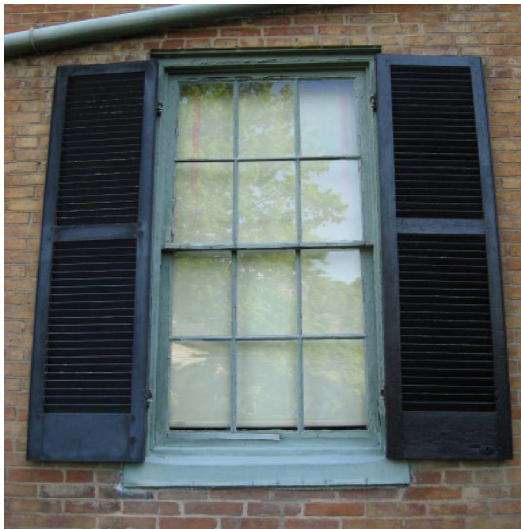
Exterior Wood Windows - Views to various Hanley House window conditions showing original and replaced sashes and glazing. Images include second level west fenestration and trim under porch [TOP LEFT], attic level north fenestration and trim [ABOVE RIGHT], and first level south fenestration and trim [ABOVE LEFT]. Note that all items in these views appear to be original except the sash frame at attic level north (with south being equal); glazing in these sash frames may be original.

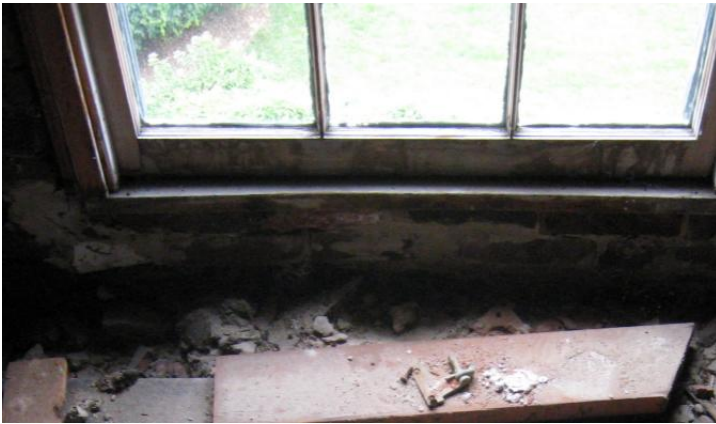
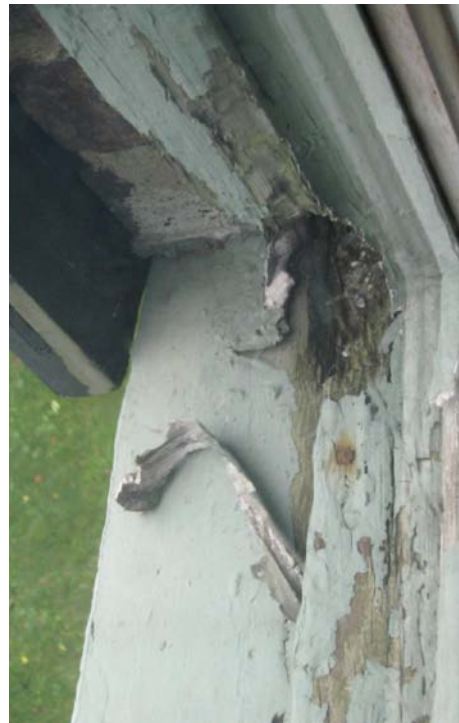
Exterior Wood Windows - Detail images show typical condition of window units and trim at Hanley House attic level [ABOVE and RIGHT]. Wood sills, jambs, and window sash frames appear to be rotten, with finishes failed and in need of replacement. Evidence in the attic at both north and south ends suggest that original glass panes were re-glazed into replacement sashes - possibly ca. 1970. Also, there are glazed shutters abandoned in the attic which may once have been employed to vent and close the attic at each end.

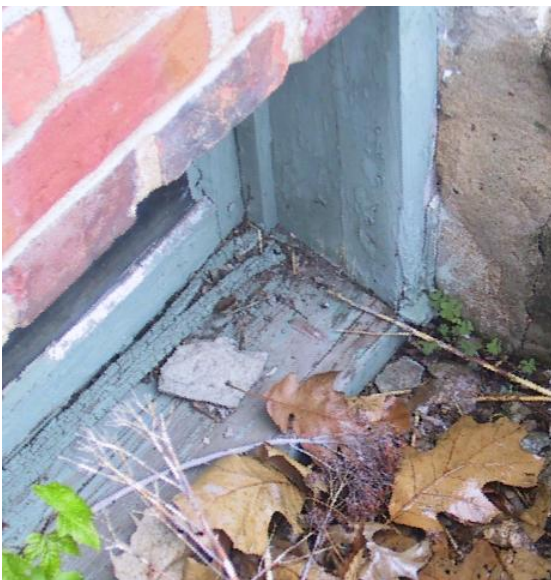
Exterior Wood Windows - Detail images show condition of typical clerestory units at Hanley House ground level [ABOVE LEFT and RIGHT]. Wood sills, jambs, and window sash frames appear to be rotten, with finishes failed and in need of replacement. Note that unpainted steel lintels were installed - possibly ca. 1970 - at the SW and both north clerestory openings. These lintels are serviceable, but are recommended to be ground and painted.

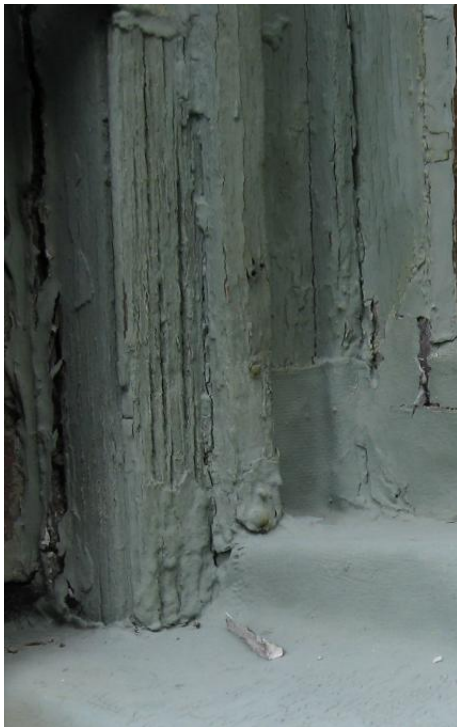
Exterior Wood Windows - Detail images show design and condition of window sashes and glazing at Hanley House, including typical deteriorated putty glaze and wood stile and rail of sash frame [ABOVE], and wood sash frame stile, frame jamb, and clad sill at south elevation [LEFT].

It would be recommended that any effort to conserve or replace windows at Hanley House make use of a putty glaze for historical authenticity. In the course of refurbishing and conserving existing window units, though, the finishes to be removed - including existing putty glaze throughout and sill cladding at south side - are purported to all be asbestos- and / or lead-containing materials (refer to environmental survey report dated September 2006 for additional related information).

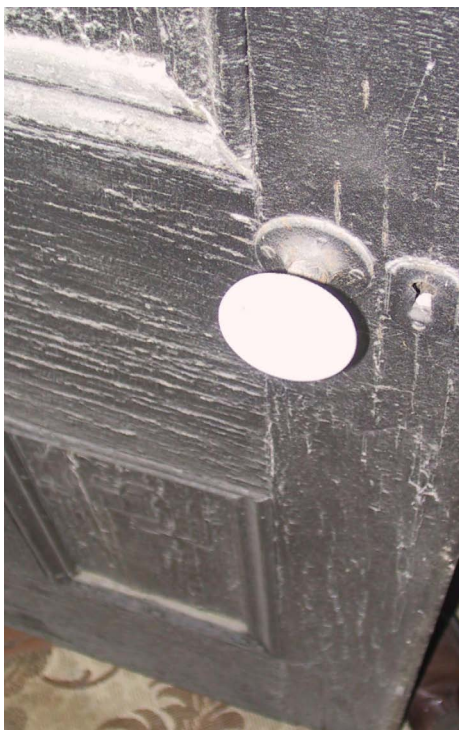
View to doors at first level west elevation [ABOVE]  
Detail image of typical exterior wood door condition [LEFT],  
showing original hardware, and failed finish on raised panel,  
stile-and-rail construction wood slab.

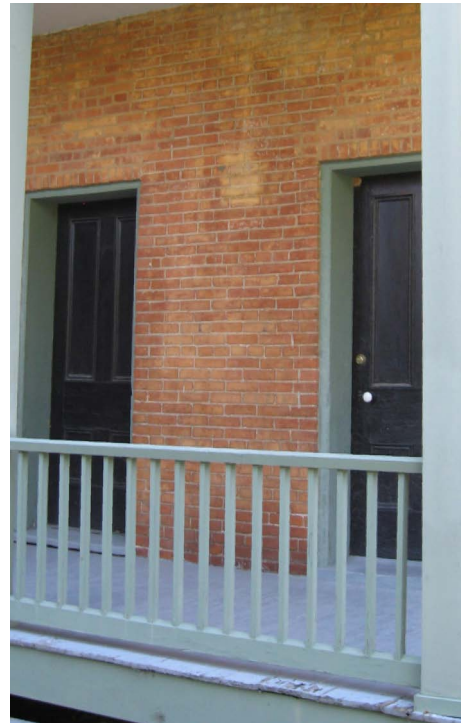
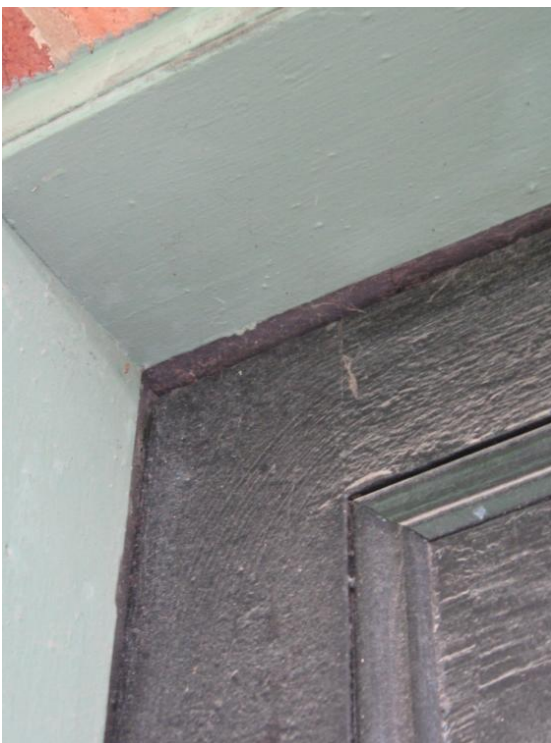
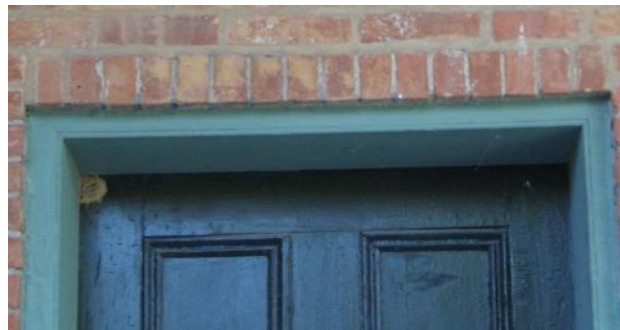
Detail images show typical wood exterior door design, including wood casing, trim and relationship to exterior clay brick masonry [ABOVE and LEFT].

Similar to the majority of windows at Hanley House, these door openings would benefit from the installation of some structural relief above, possibly through a steel angle lintel.

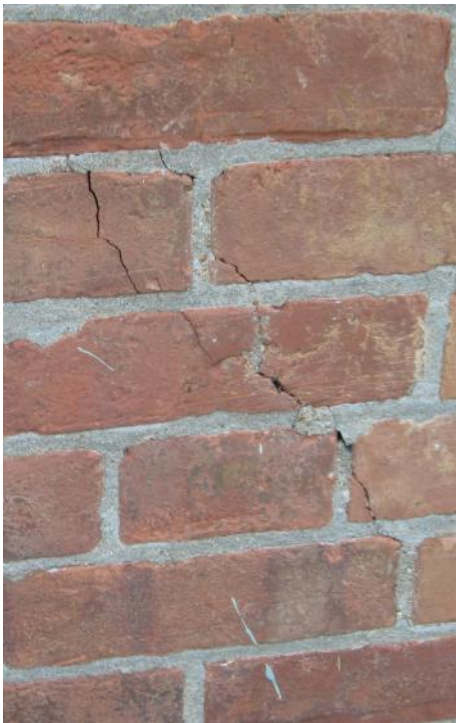
Exterior Clay Brick Masonry - Detail images depict the conditions of south facing clay brick masonry, including settlement cracks below first level fenestration [TOP LEFT and RIGHT], and long-run settlement cracking at SW corner [BOTTOM LEFT and RIGHT], extending from near stone foundation upward to parapet and SW chimney.

Note that south facing exterior clay brick masonry demonstrates a large variation in conditions - while some areas of wall are serviceable, there are several key faults which suggest movement in the multi-wythe brick masonry walls, with significant cracking of mortar joints and brick units.

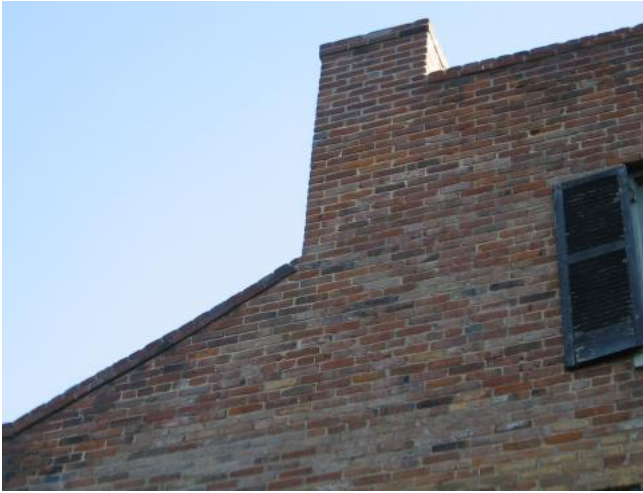
Detail view to long-run settlement cracking at SW chimney [TOP LEFT and RIGHT]. This is the most substantial sign that movement of the Hanley House structure has occurred, whether due to conflict between interior wood floor framing and clay brick exterior walls, or differential settlement of the stone foundation below.

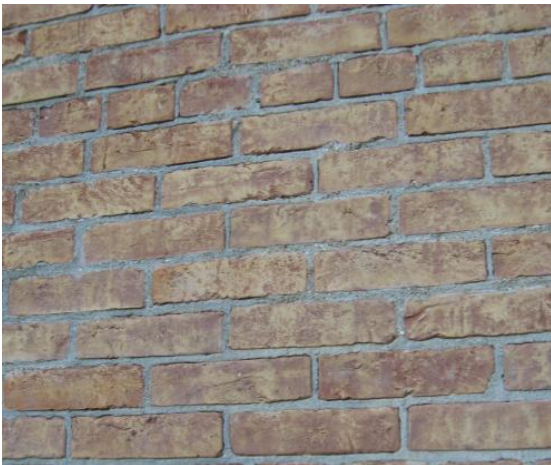
Detail view to typical south facing clay brick masonry [ABOVE and LEFT], showing deteriorated and non-serviceable mortar conditions. Note that tuckpointed mortar joints are cracked and open at the perimeter of most brick units, and likely allow a substantial amount of storm water to infiltrate the wall construction. Replacement mortar appears to have been installed in shallow depths, and in a design that was much harder than the original dry-press, hand-made brick units - thus resulting in spalled and chipped faces, missing mortar segments, and even cracked bricks.

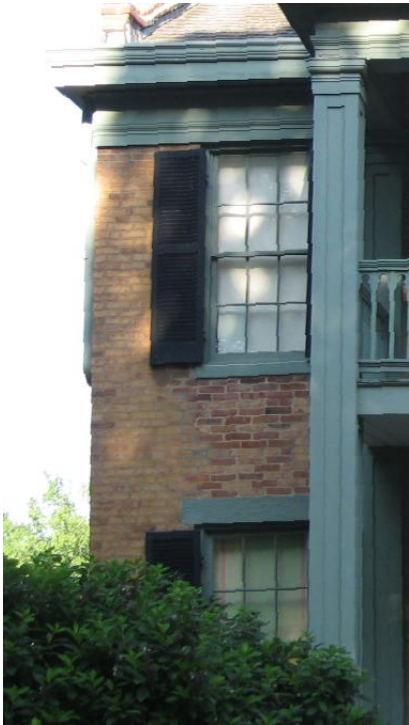
Exterior Clay Brick Masonry - Detail images depict the conditions of east facing clay brick masonry, including patch replacement brick [LEFT], settlement cracks below first level fenestration at wood timber lintel [TOP RIGHT], field joint failure at tuckpointed mortar [BOTTOM LEFT], and settlement cracking at NE corner below first level fenestration [BOTTOM RIGHT].

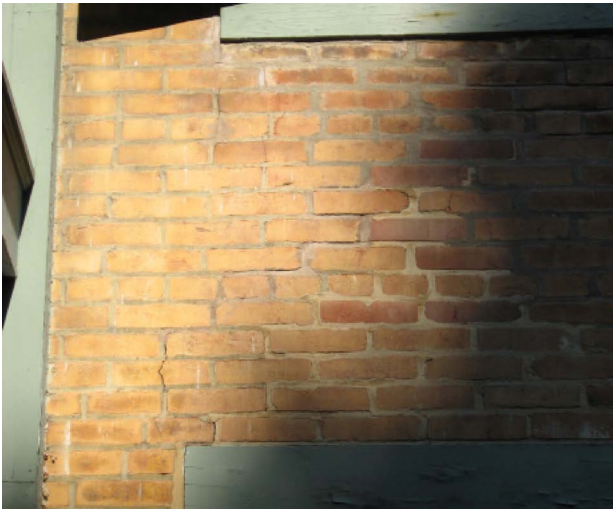
Exterior Clay Brick Masonry - Detail views to east facing clay brick masonry showing settlement cracking at north fenestration, first and second levels. Note that mortar joints and brick units have cracked through at north extent of east elevation immediately above foundation [BELOW LEFT].

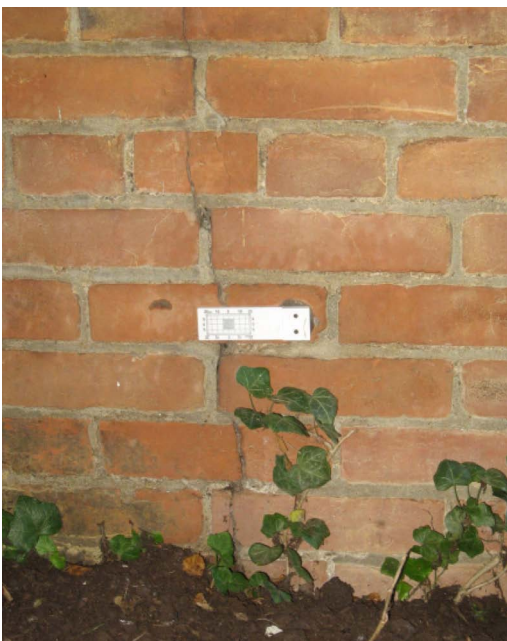
Detail view to east facing settlement crack in clay brick masonry [ABOVE LEFT], showing abandoned crack monitor device. Note that tuckpointed mortar joints at some areas of the east have been installed in a tooled (canted) profile - this is different than virtually all other (flush) joints.

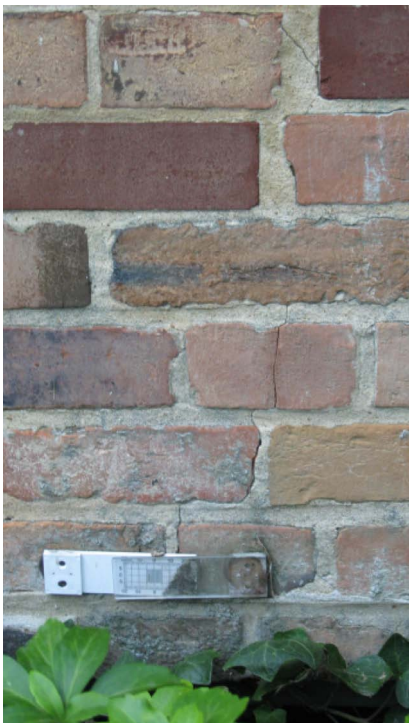
View to North Elevation [ABOVE]  
Detail view to east most settlement crack at north [LEFT]

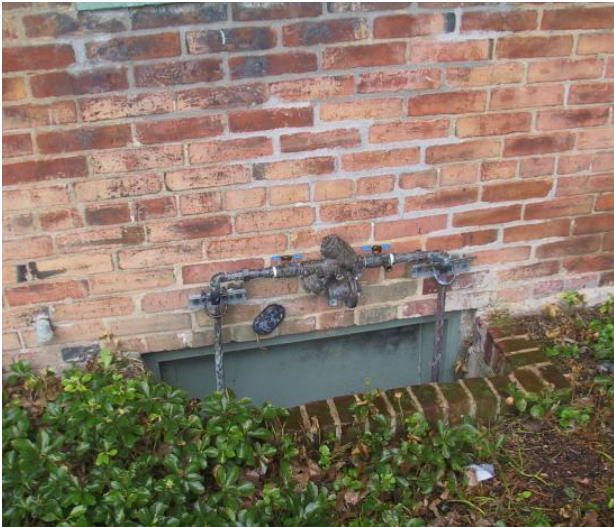
Detail images showing limited tuckpointing repair at brick masonry field [ABOVE and BELOW] and above wood cellar doors on north side [RIGHT].

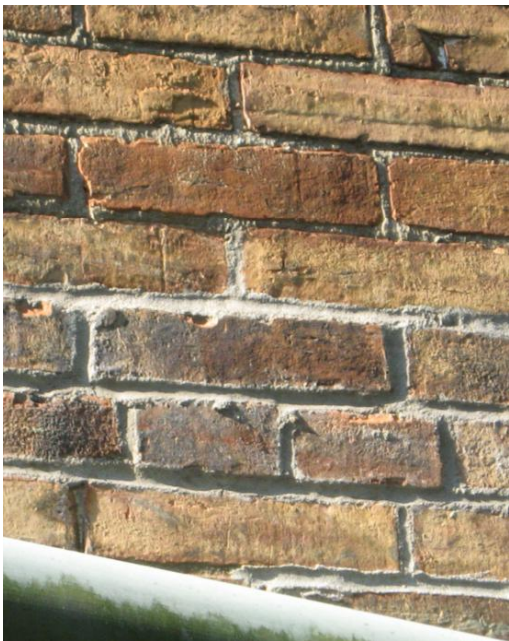
Detail image [ABOVE RIGHT] depicts degree to which ca. 1970 renovations are expected to have addressed deteriorated clay brick above first level window heads at north.

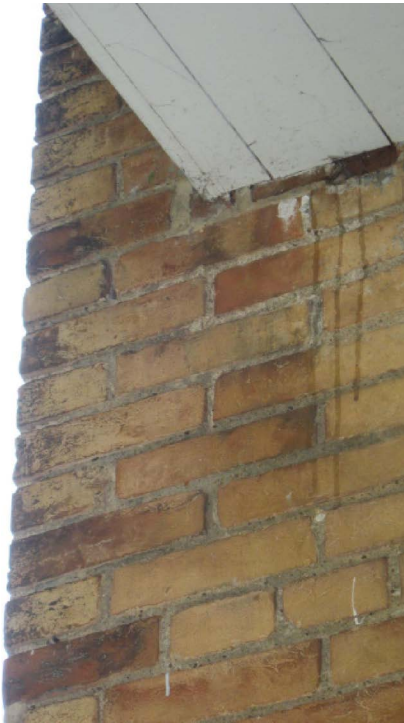
Exterior Clay Brick Masonry - Detail images depicting the condition of west facing clay brick masonry, including below second level west porch [LEFT], and at NW corner [ABOVE].

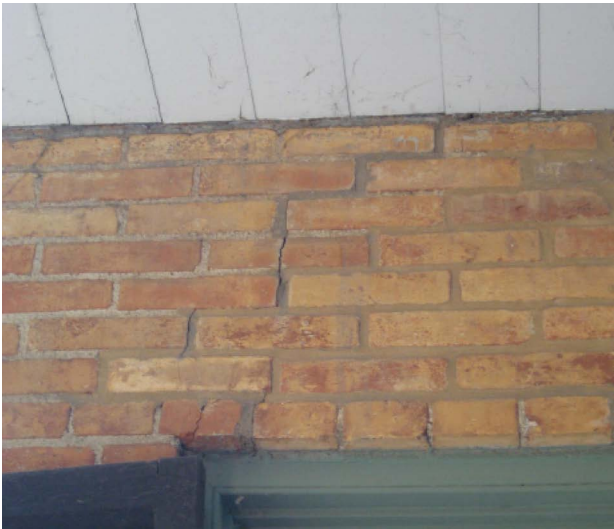
Exterior Clay Brick Masonry - Detail images depicting the condition of west facing clay brick masonry, including below roof overhang at attic level west porch [ABOVE], and at SW corner [RIGHT] where some tuckpointing has been done.
