Martin Franklin Hanley House  
 7600 Westmoreland Avenue  
 Clayton, Missouri 63105  
 LG Project No. 07268.002

Existing  
 Conditions  
 Assessment  
 16 July 07

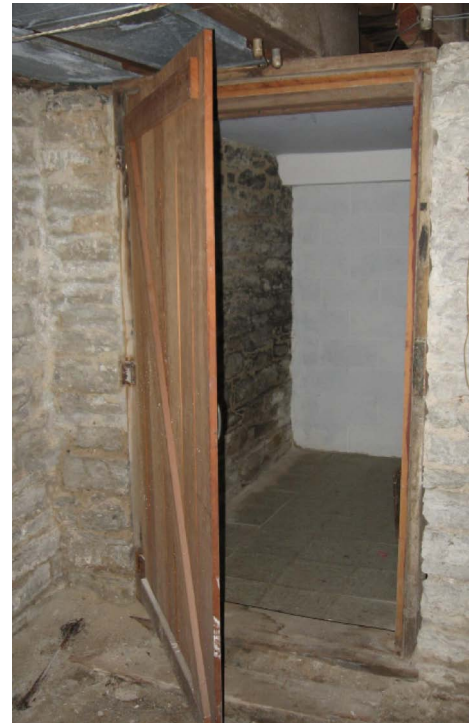
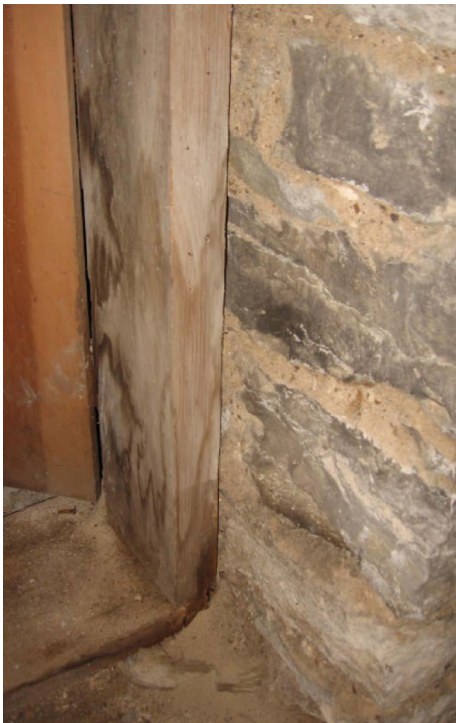
Detail images showing interior view to stone masonry foundation at south dirt floor area, including wood framing and trim members [RIGHT and BELOW RIGHT], and evidence of water infiltration through stone at west center door west jamb [BELOW LEFT].

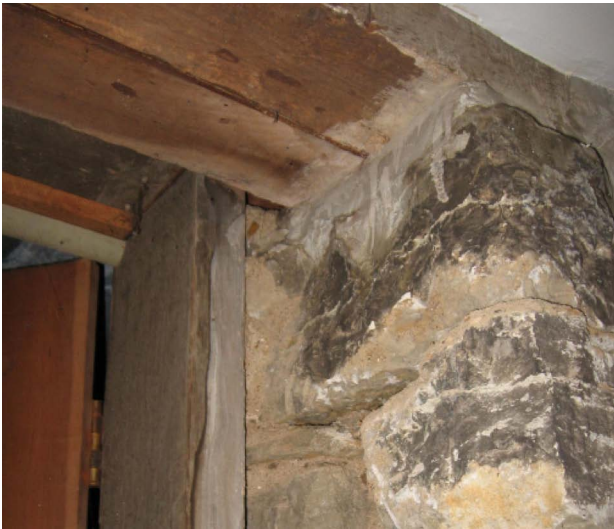
Interior Stone Masonry - Detail images depicting the condition of stone masonry foundation system, including head of west center door and lintel [ABOVE] to south dirt floor area, and at typical clerestory window head [RIGHT].

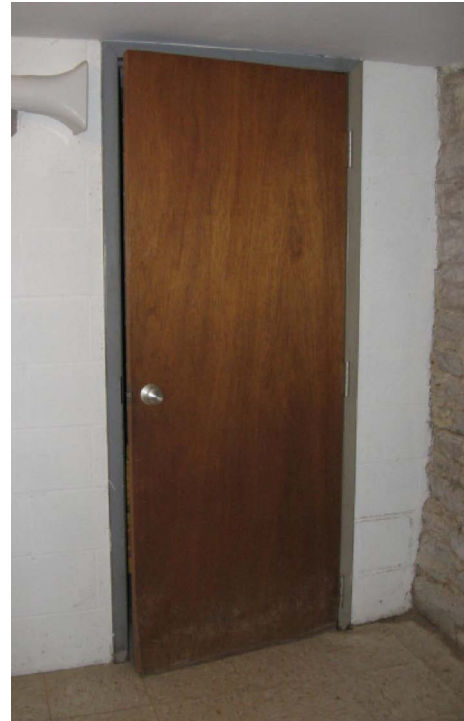
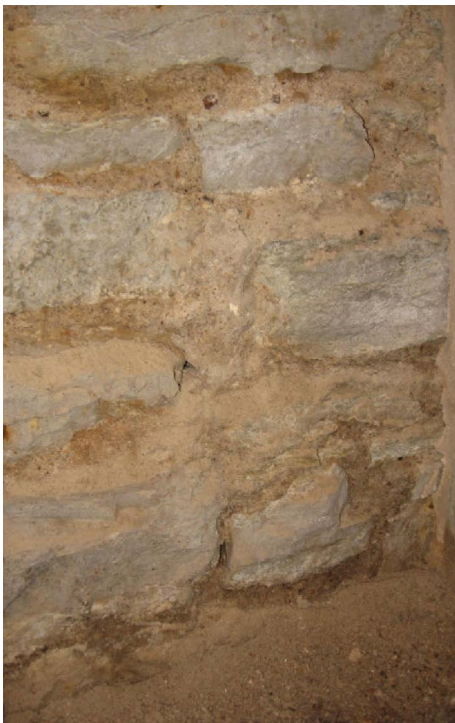
Existing interior stone masonry in lower level [ABOVE and BELOW TWO], and entry door to janitor's closet in lower level [RIGHT] - note low clearance of ceiling to top of modified door frame.

Interior stone masonry wall conditions at the central corridor in the home's lower level suggest that hydrostatic pressure has forced ground water through the stone foundation walls (original) and concrete floor slab (ca. 1969) in this area.

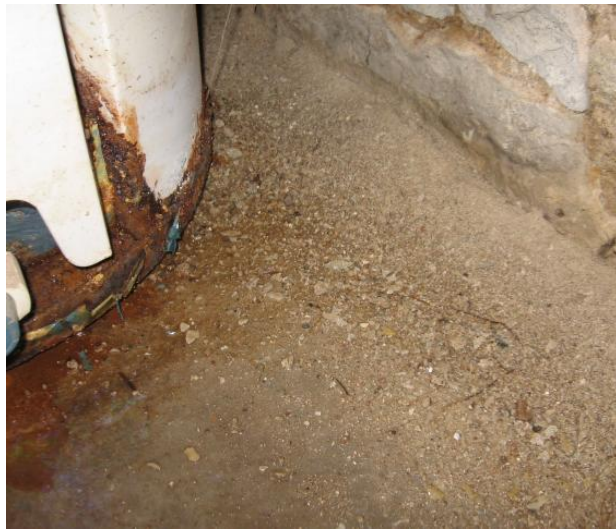
Existing ground level utility closet [ABOVE and LEFT] - note deteriorated domestic water heater and detritus on ground. The electric water heater has corroded through its tank, and is no longer serviceable.

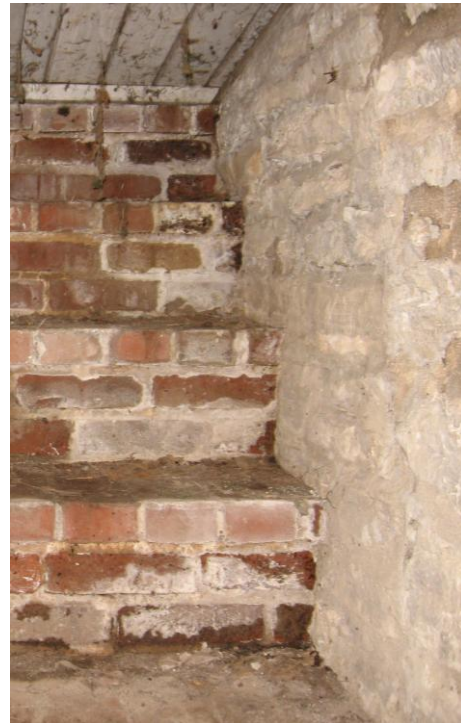
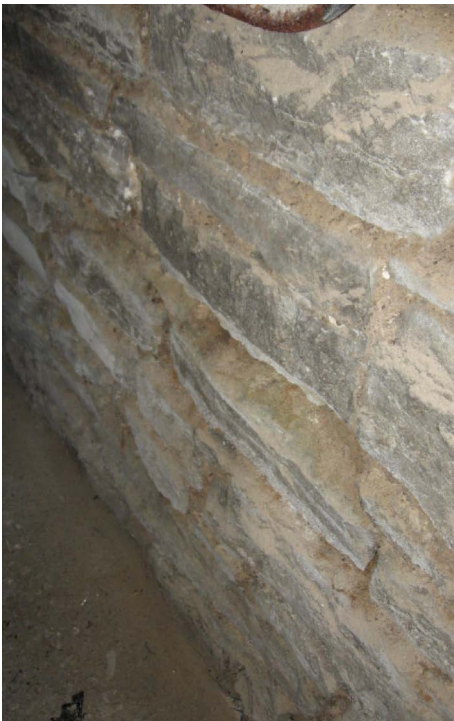
Interior Stone Masonry - Detail images depicting the condition of stone masonry foundation system, including settlement cracking at north wall [ABOVE LEFT], and view to masonry stair conditions at ground level cellar entry [RIGHT].

Detail images depicting the condition of stone masonry foundation system, including washed out mortar joints and effloresced stone units in mechanical room west wall [LEFT and ABOVE RIGHT]. Note the quantity of detritus on the floor, as well as the rusted base of HVAC equipment.

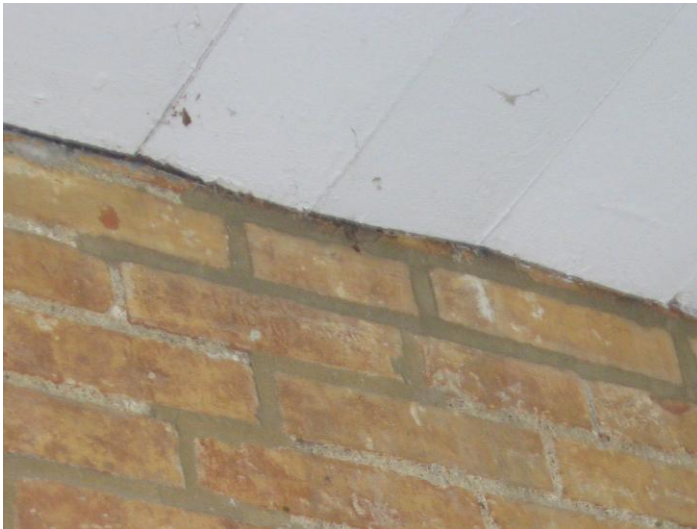
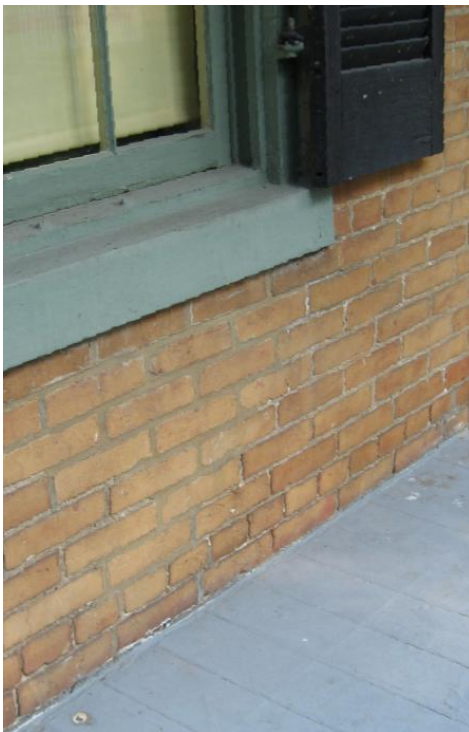
Exterior Wood Decks, Railings and Trim - Detail images depicting the condition of wood decking, trim, railings, and juncture to brick masonry at east two-level porch.

Exterior Wood Decks, Railings and Trim - Detail images depicting the condition of wood decking, trim, railings, and juncture to brick masonry at east two-level porch. At a minimum, this report would recommend the refurbishment of all wood carpentry items to include new finish.

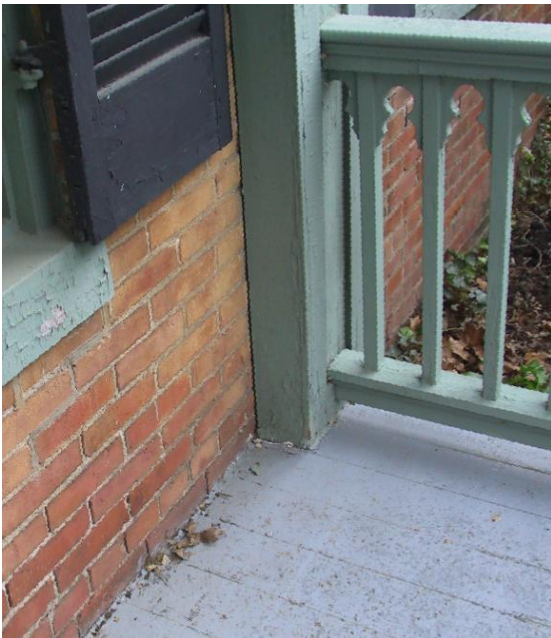
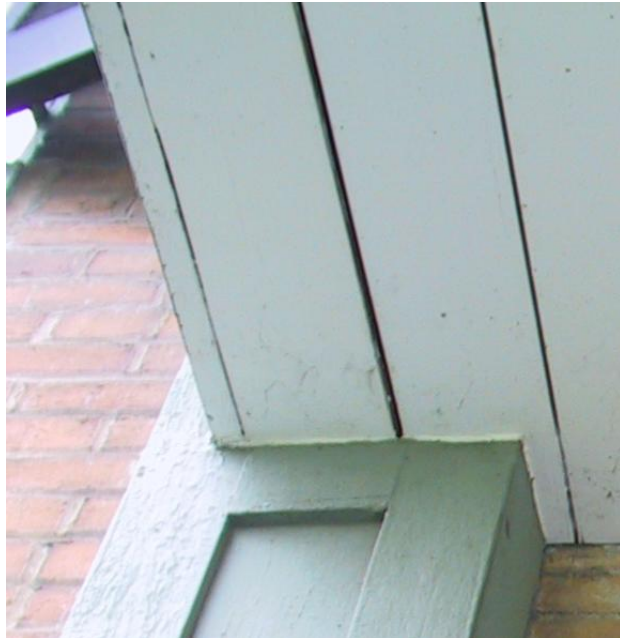
Exterior Wood Decks, Railings and Trim - Detail images depicting the condition of wood decking, trim, railings, and juncture to brick masonry at west two-level porch.

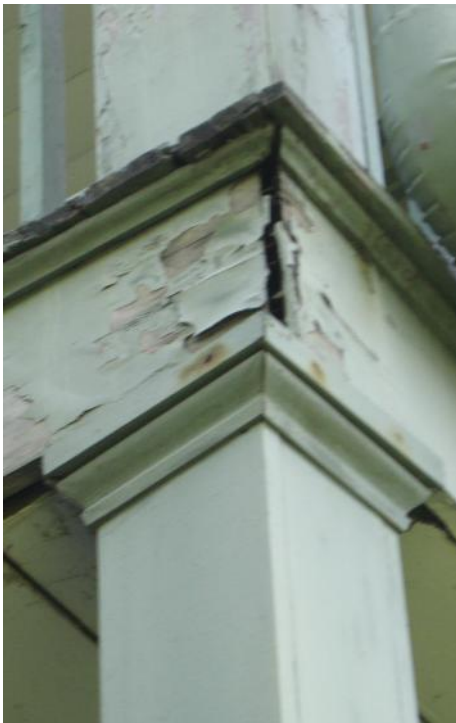
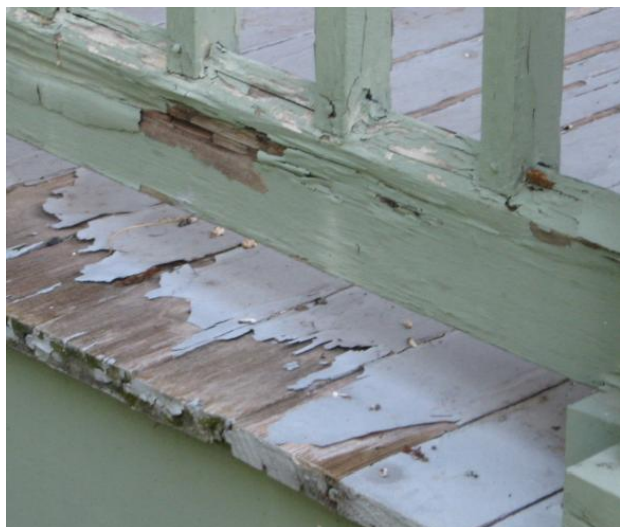
Detail images depicting the condition of wood decking, trim, railings, and juncture to brick masonry at west two-level porch. It is the understanding of this report that both the east and west porches were reconstructed ca. 1970.

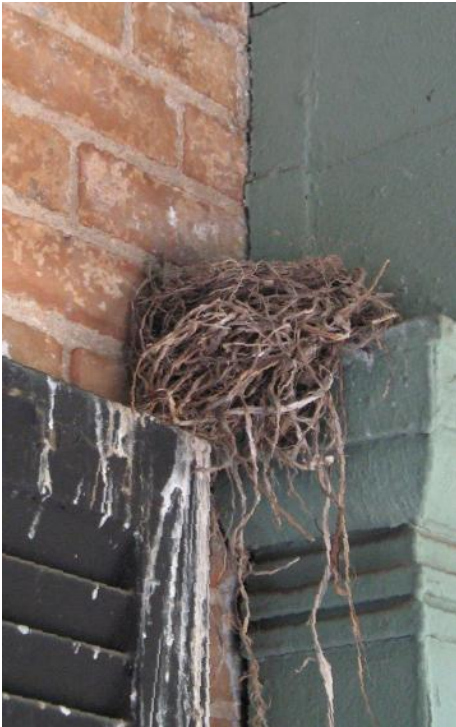
Detail view to typical cornice, column cap and trim area that would be recommended for anti-bird devices to be installed [LEFT].

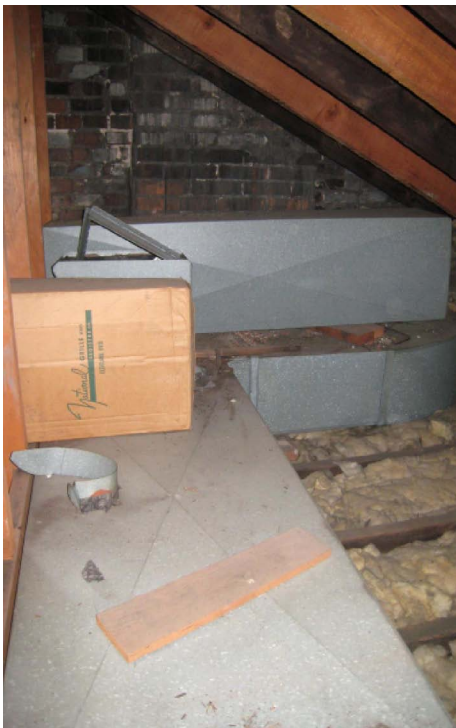
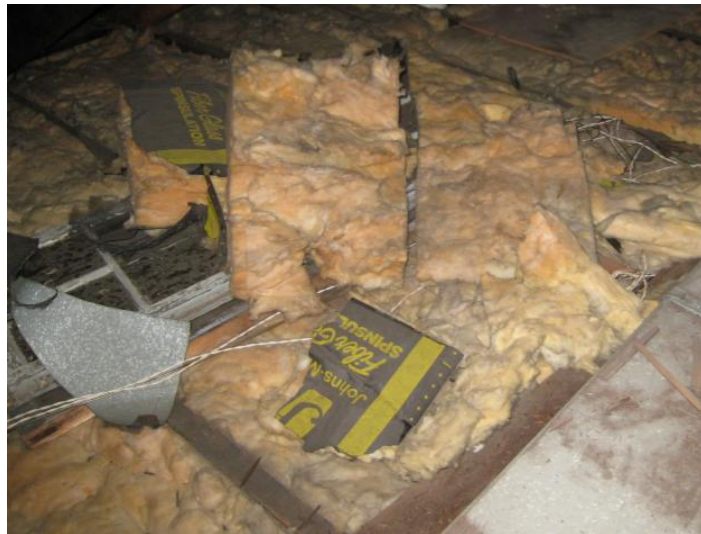
Detail images depicting condition of existing insulation in attic level floor joist spaces, sheet metal and other debris to be removed [LEFT and ABOVE] and supply air ducting design with partially insulated risers and main plumbing stack [BELOW RIGHT].

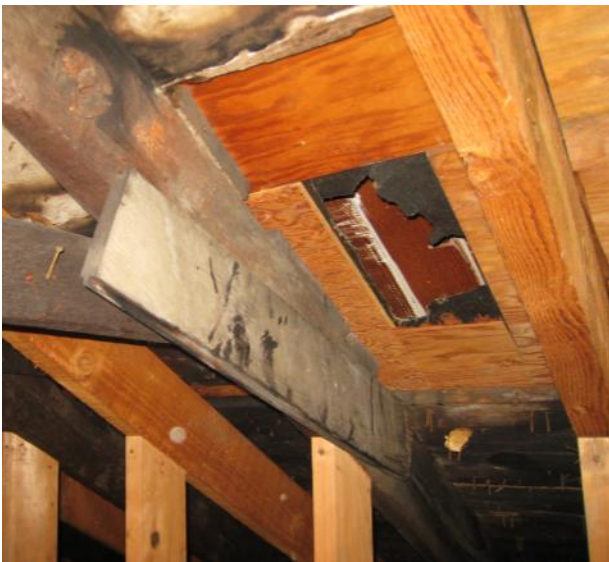
Detail image of obstructed roof hatch from attic level interior - hatch was likely concealed during ca. 1970 renovation work, and would be recommended for re-opening to perform future maintenance and / or roof replacement work.

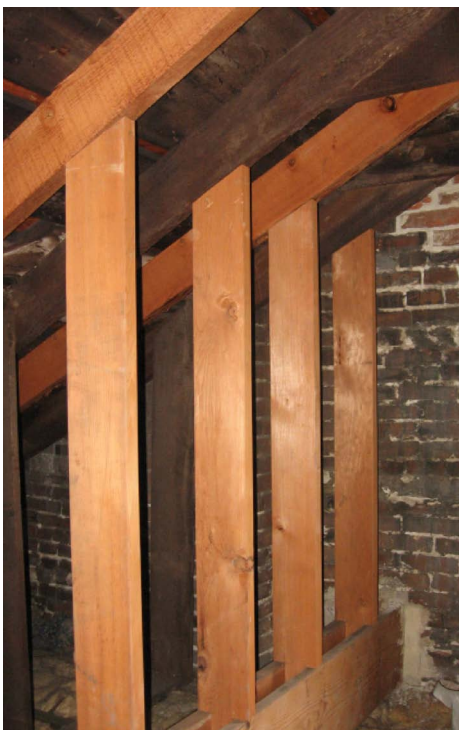
Roof Construction - Detail images show the existing roof system at attic level, including splice in typical double 2x12 beam running from north to south exterior bearing walls, and interior masonry conditions at attic level [TOP LEFT and ABOVE].

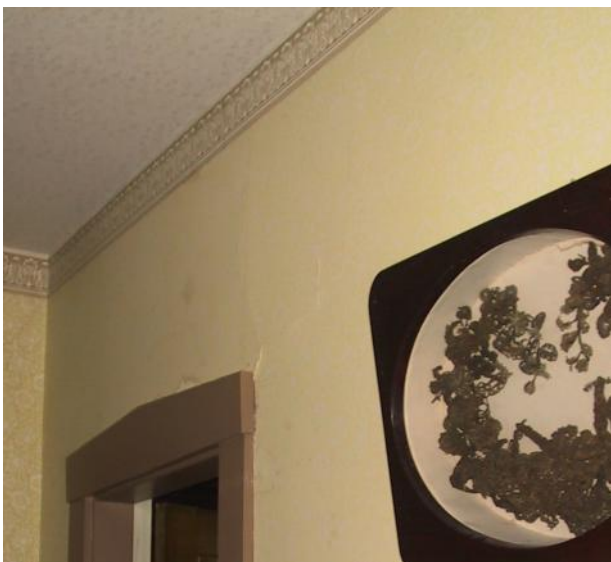
Cracks in existing plaster at 2nd floor (bottom).

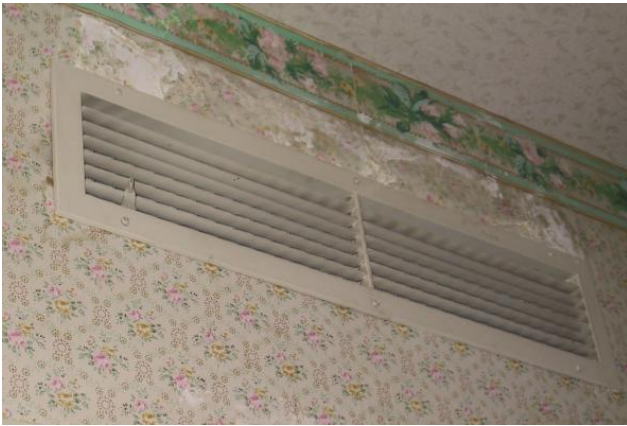
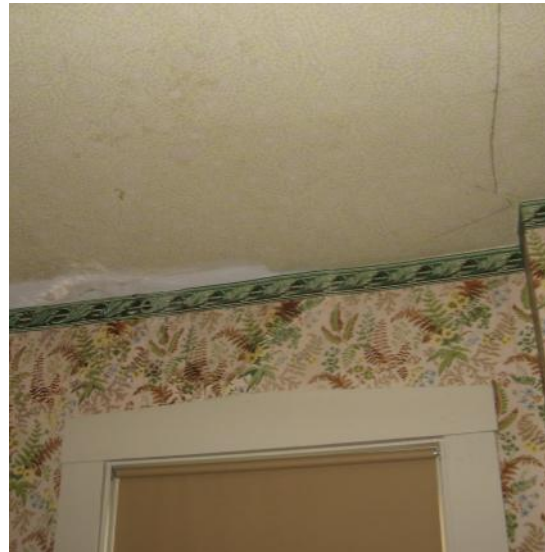
Deterioration of plaster at typical interior wall, believed to be due primarily to trapped condensation on sheet metal ducting and from metal supply air diffuser. There are also several cracks and areas of gassed plaster throughout Hanley House's interior which have been caused by structural movement, and by the routine and unchecked infiltration of storm water [ABOVE LEFT and ABOVE RIGHT].

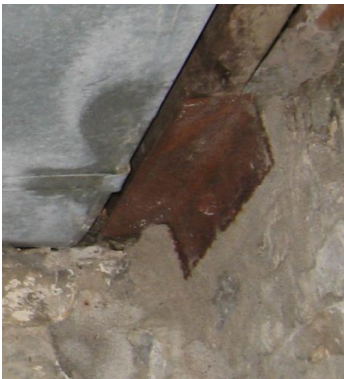
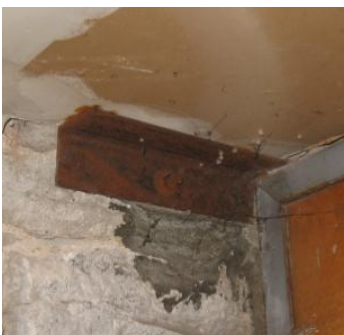
Detail images depicting ca. 1970 steel clip angles at first level floor framing.

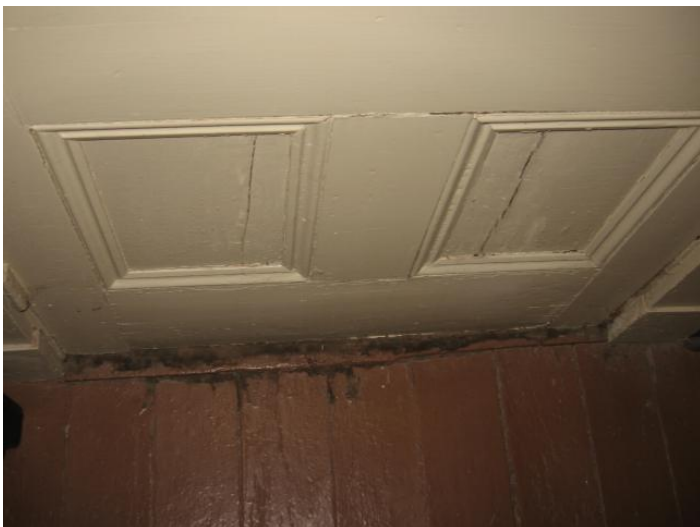
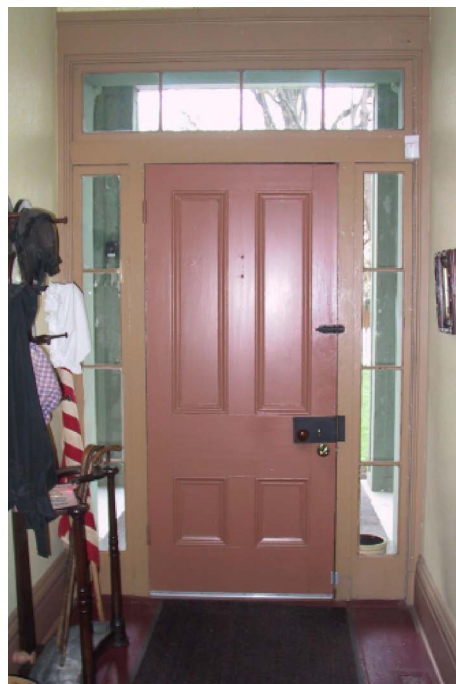
Typical exterior door conditions, at second level interior [TOP LEFT], first level main entry east [TOP RIGHT], and second level entry east [LEFT].

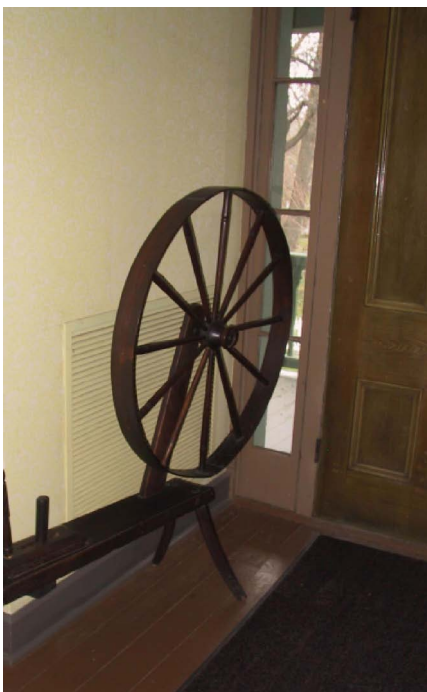
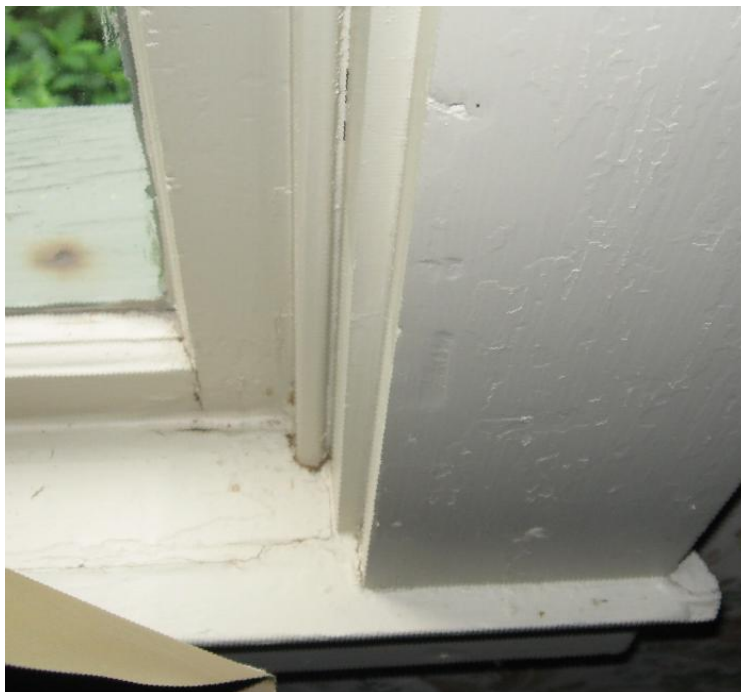
Interior Wood Trim - detail view to typical first level north (south side equal) window casing and trim [BOTTOM RIGHT].

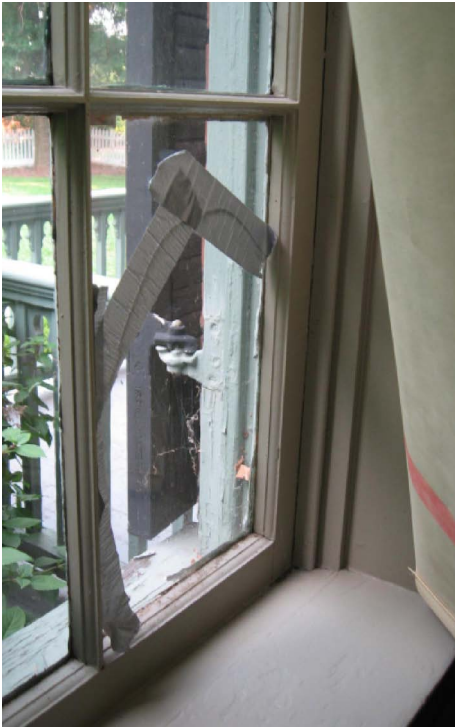
Interior windows and casing to be repaired.

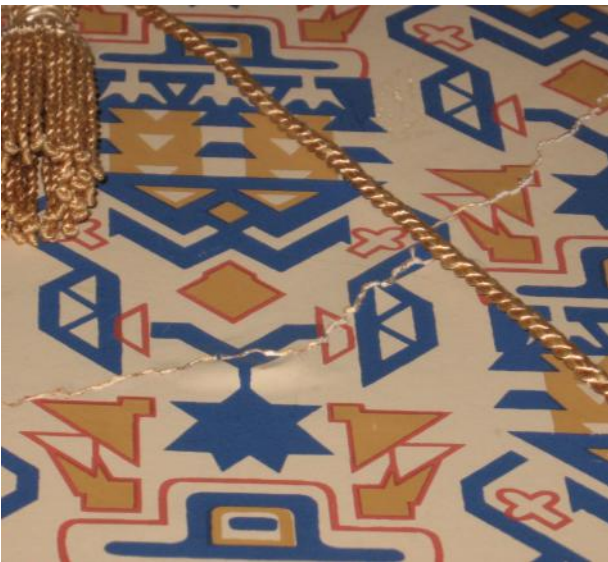
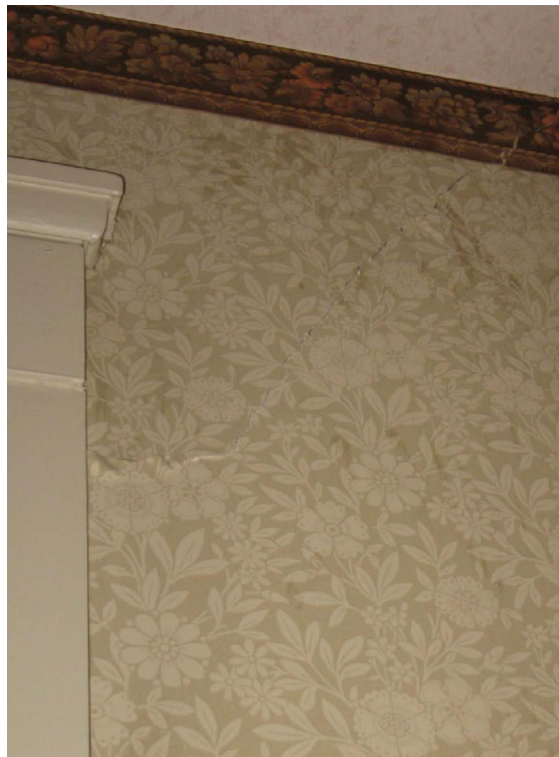
Detail image of interior plaster deterioration, including SW corner of Hanley House on face of flue adjacent to closet [ABOVE LEFT], and typical settlement cracking from corners of fenestration on first level [RIGHT].

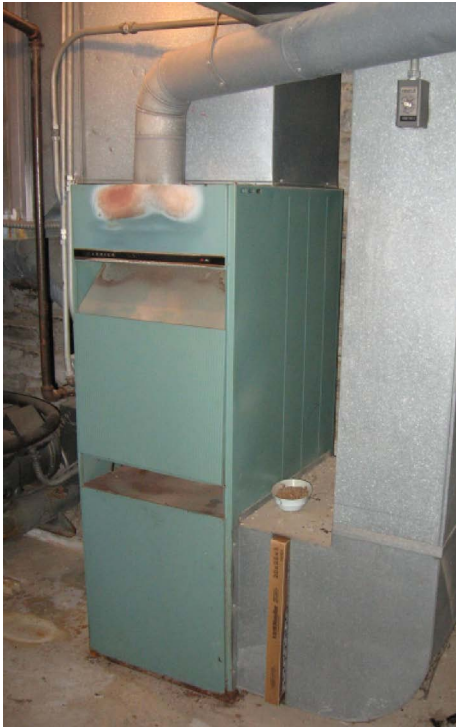
Detail views to typical existing furnace [LEFT] and water cooled condenser [ABOVE] units in ground level mechanical room, and existing typical floor drain in mechanical room [BELOW LEFT] for discharge of cooling water. These units are at the end of their serviceable life - it is the recommendation of this report that these units be replaced.

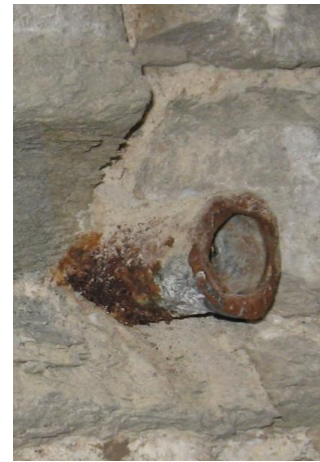
Electrical Distribution Panel and Circuitry - Detail view to existing non-code complying panel and meter [LEFT], and abandoned conduit in ground level west wall [ABOVE].

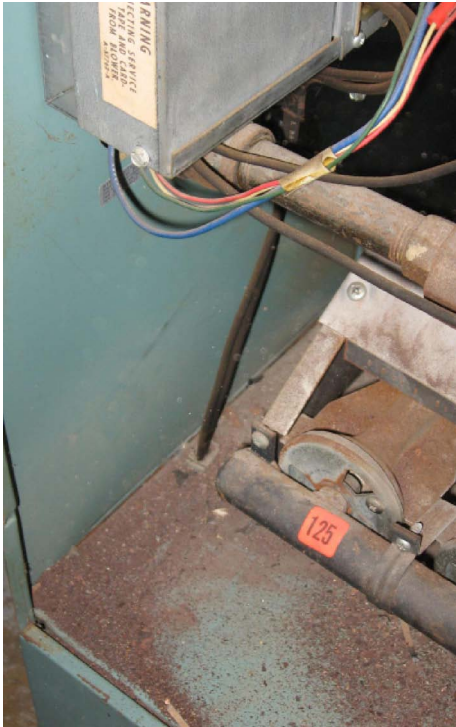
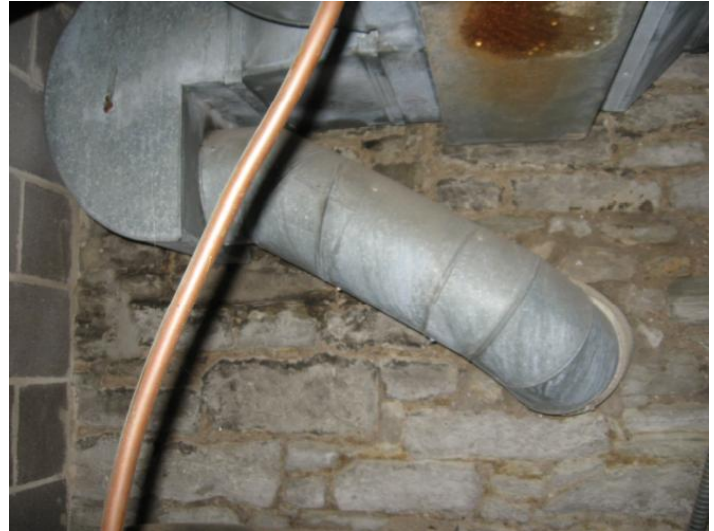
Existing duct routing.

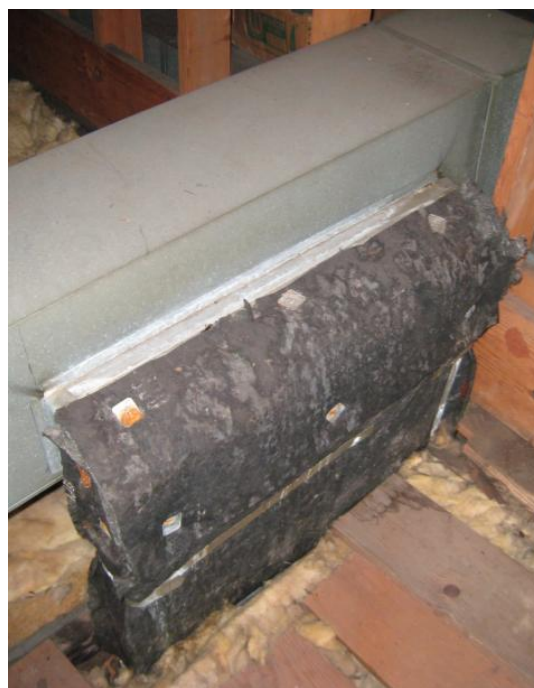
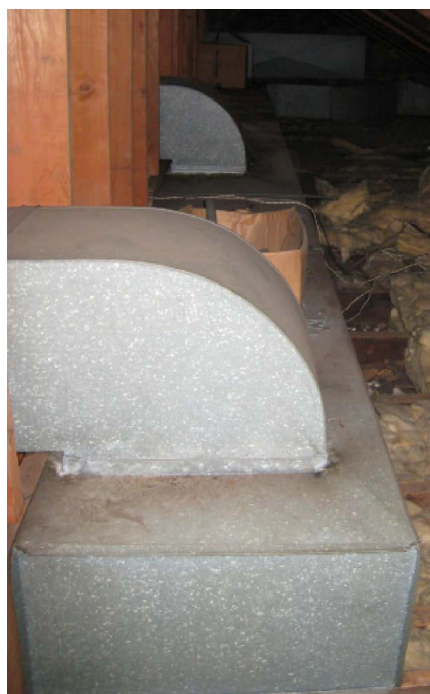
Miscellaneous duct conditions.

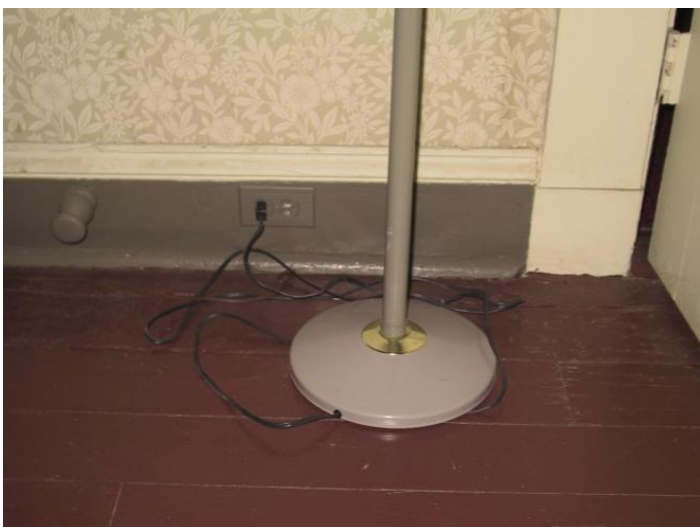
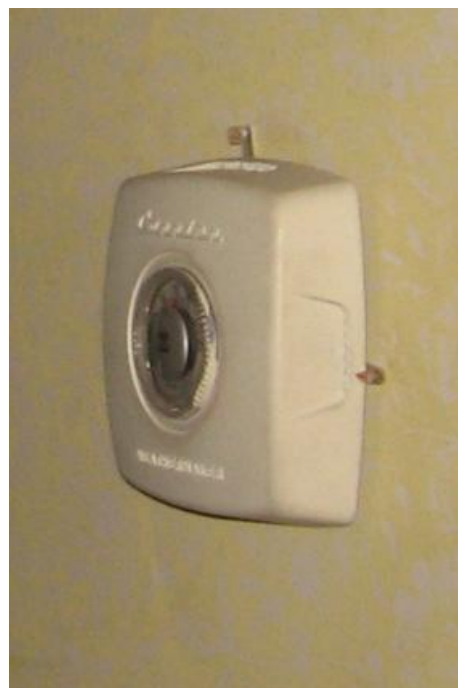
Electrical outlet conditions (above).  
Existing HVAC controls (right).

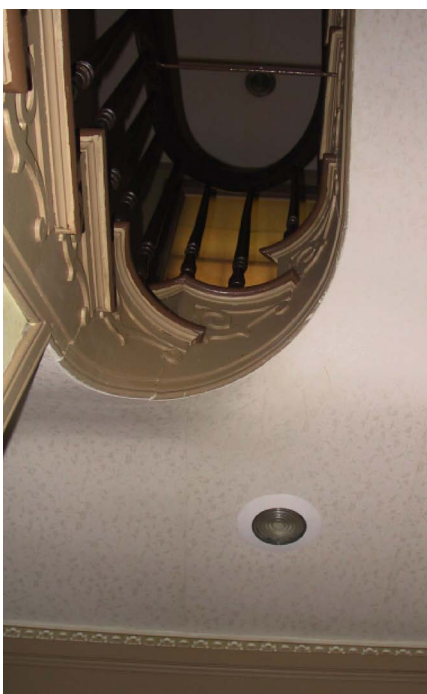
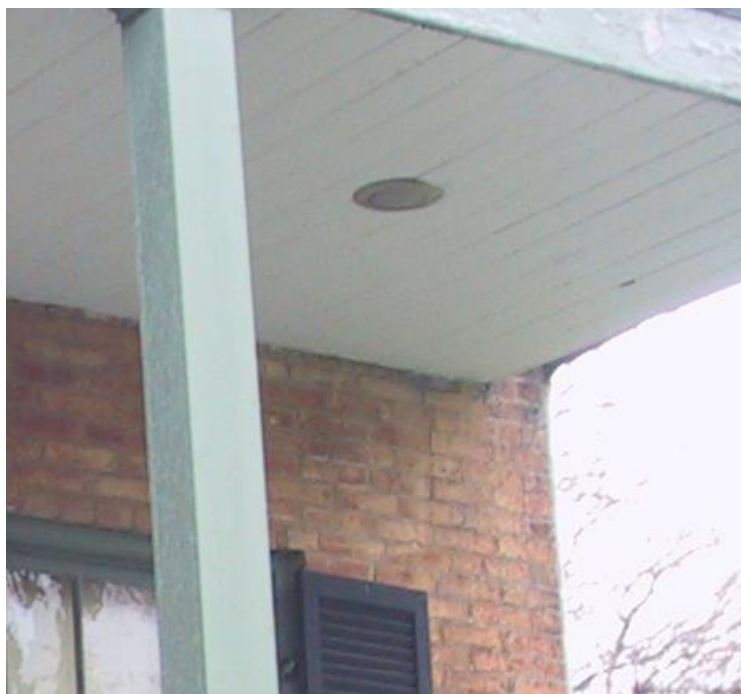
Existing can lighting to be removed, interior (left) and exterior (right).

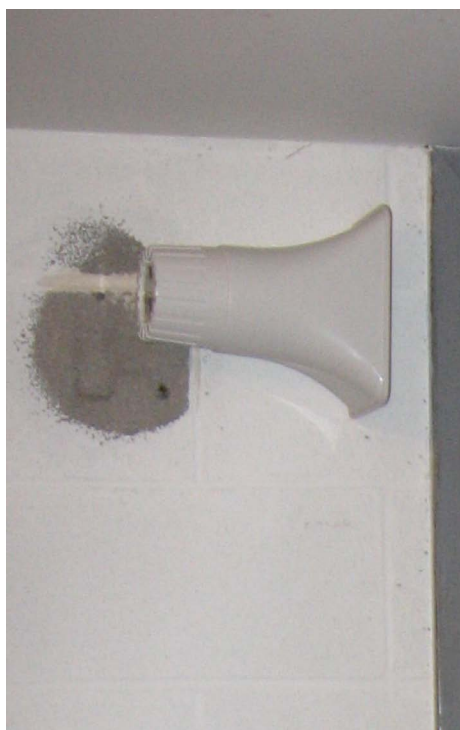
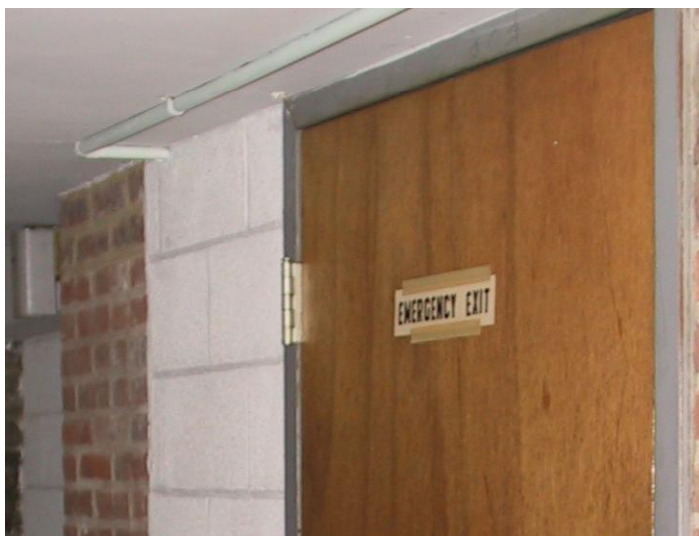
Existing fire alarm system and egress signage.

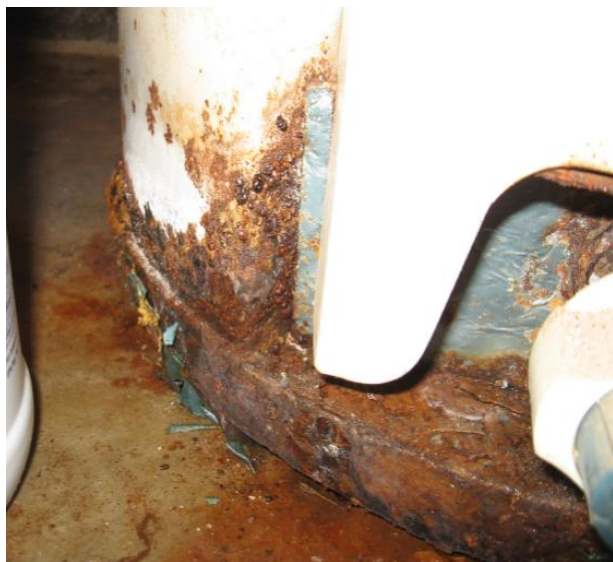
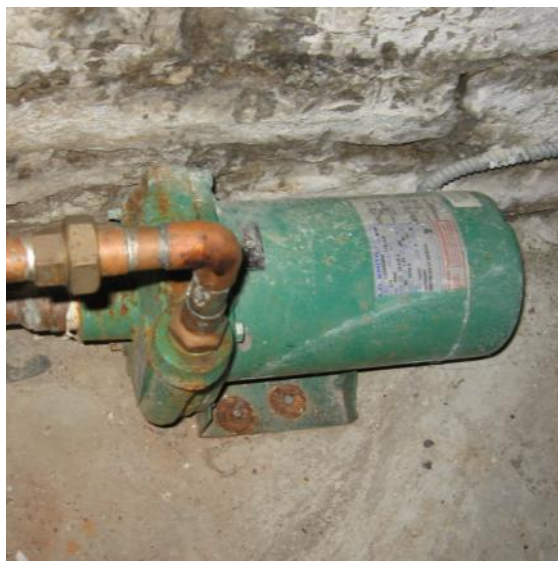
Existing domestic water heater (left) and booster pump (right).

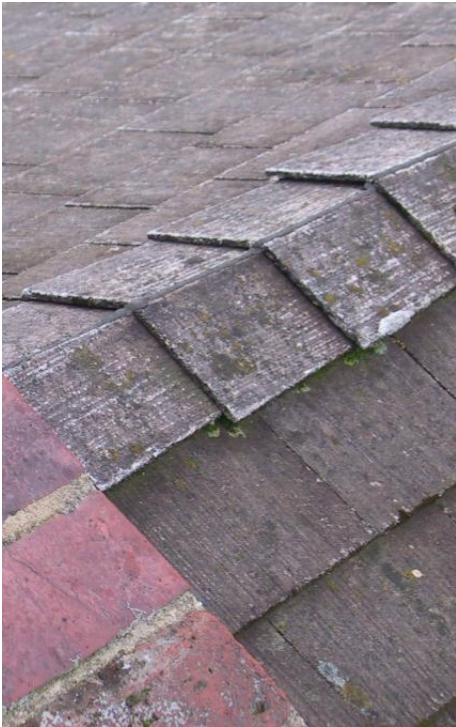
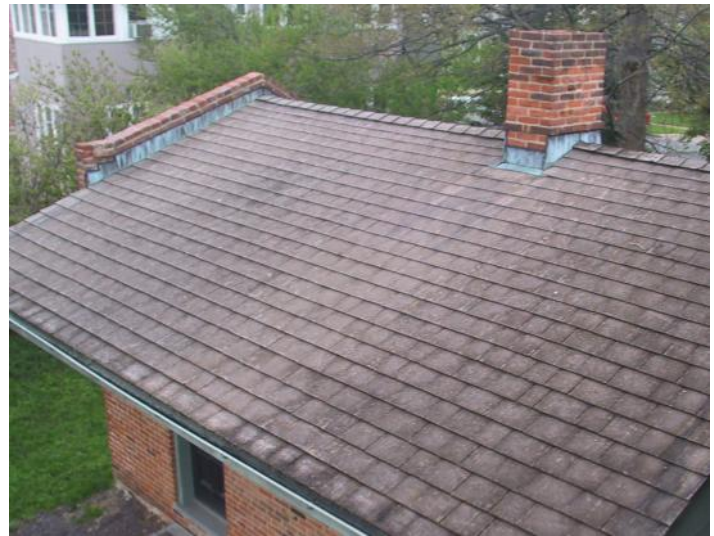
Existing roof of Summer Kitchen.

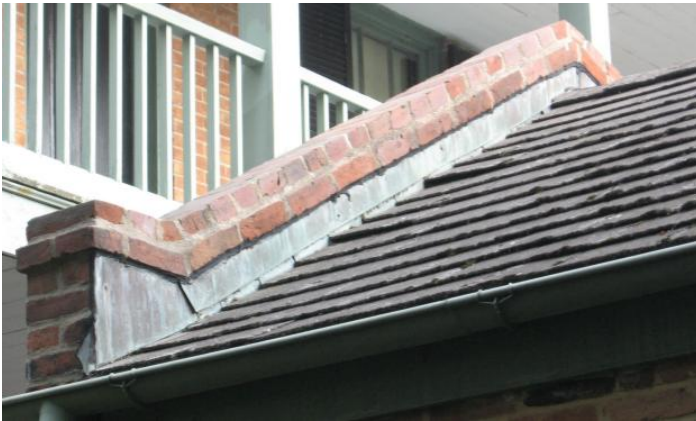
Existing parapet and chimney of Summer Kitchen.

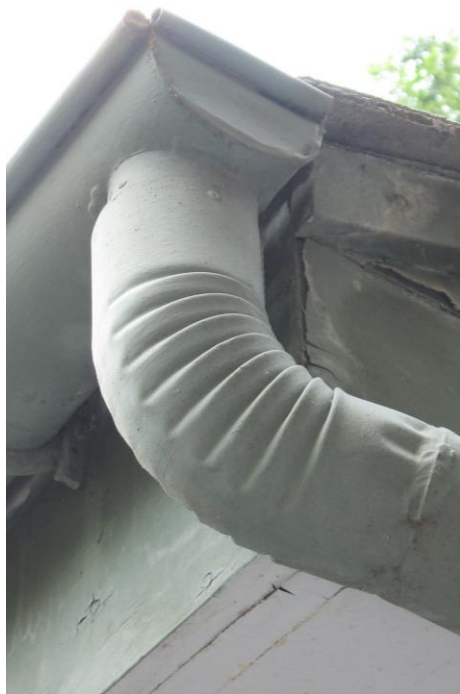
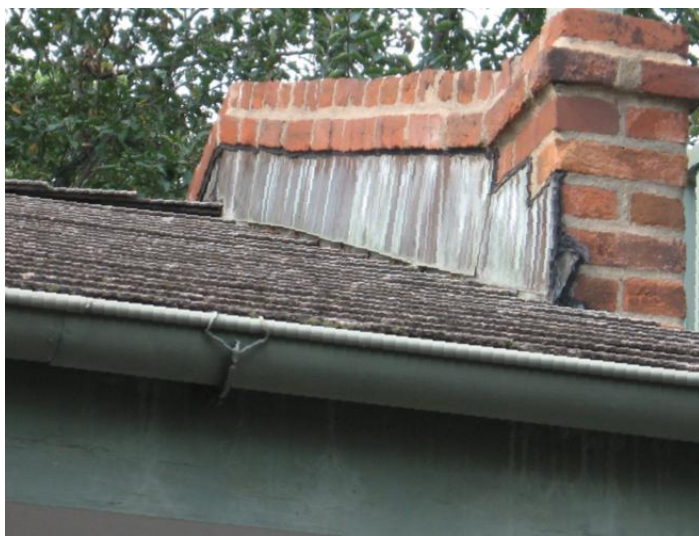
Existing gutter system and downspouts.

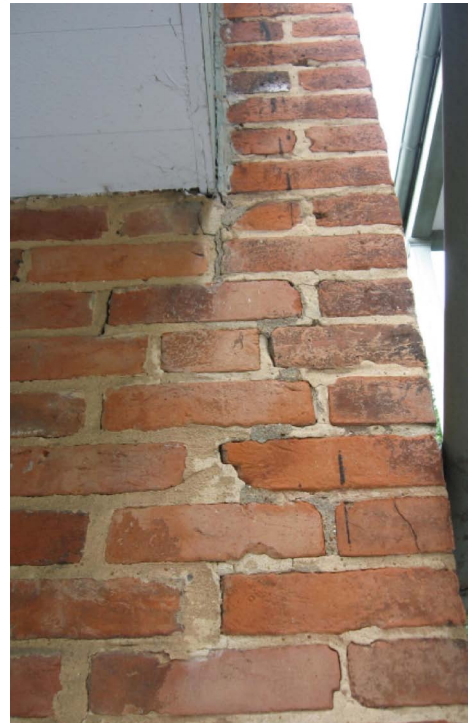
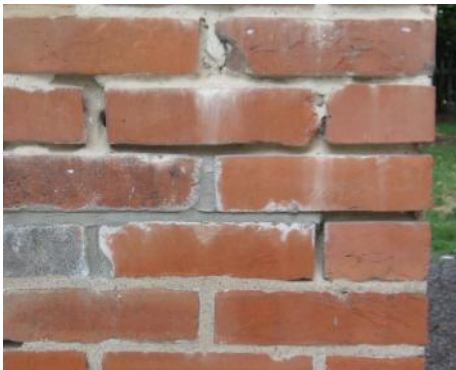
North Elevation Summer Kitchen - Above detail image shows deterioration of clay brick masonry due to impact from lawn sprinkler - masonry units are discolored and joints are failing. Detail image to left shows typical rotted wood cladding at eave and gutter.

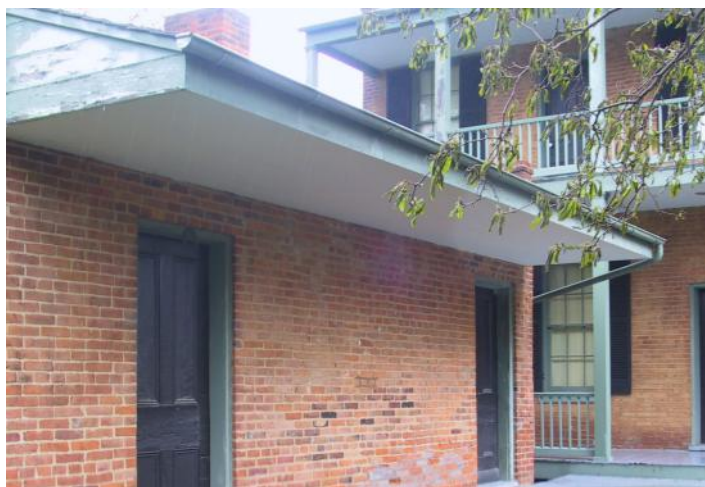
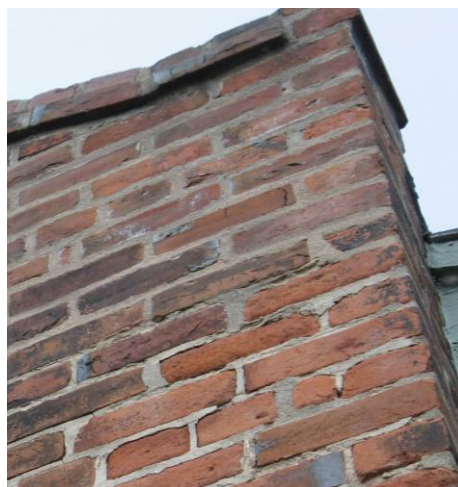
Brick existing conditions at Summer Kitchen.

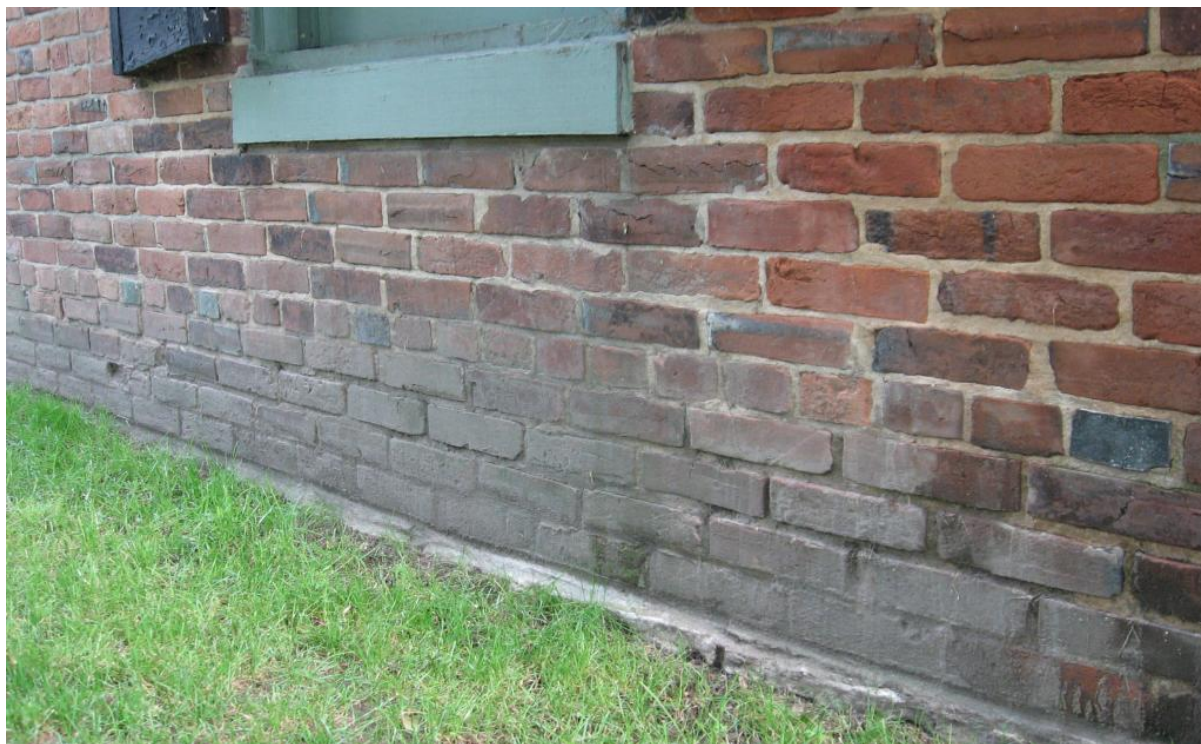
Brick existing conditions.

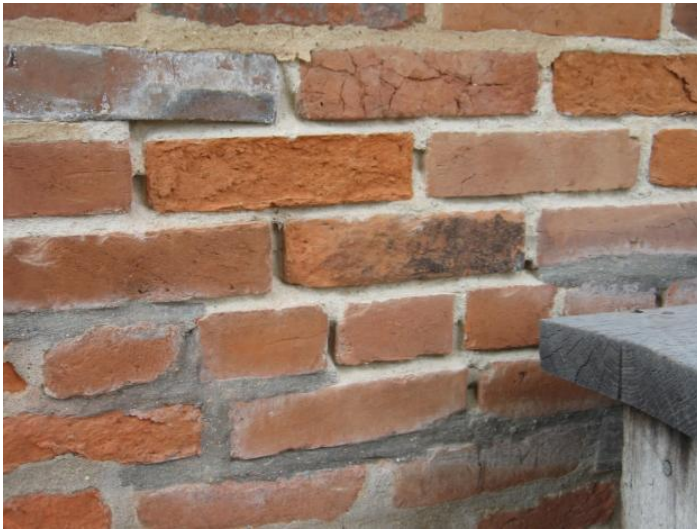
Brick existing conditions at Summer Kitchen.

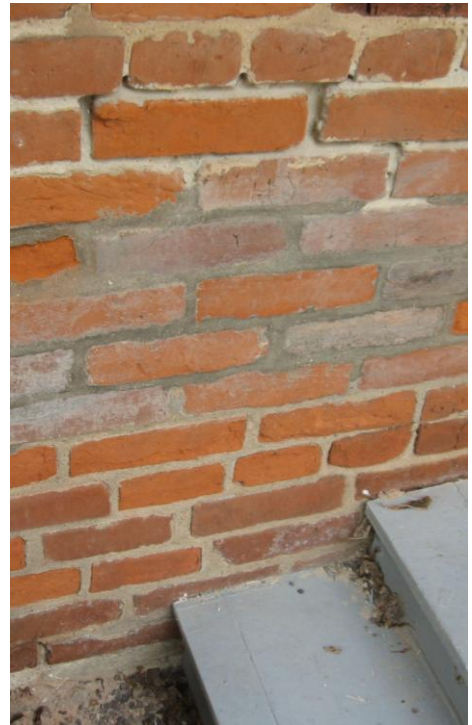
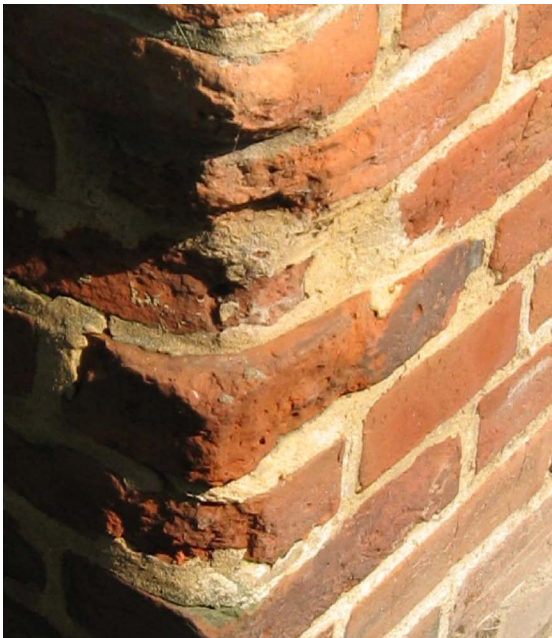
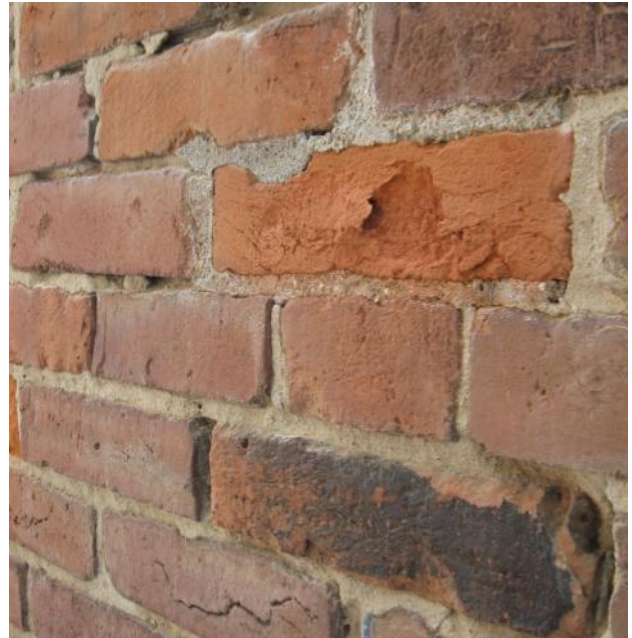
Brick existing conditions.

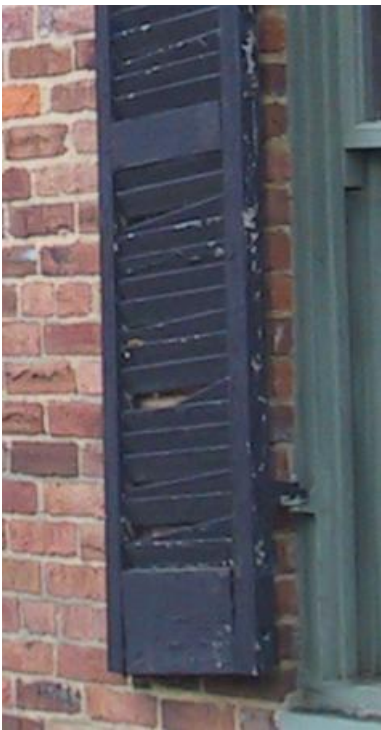
Exterior Windows and Wood Trim - Various images depicting wood shutters in need of repair at the Summer Kitchen.

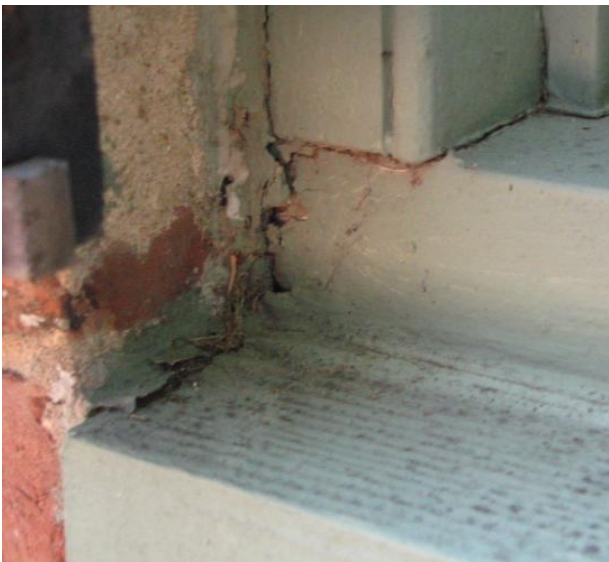
Summer Kitchen brick mould stops at subsill, which is strong evidence that these and possibly other windows throughout the Hanley House and Summer Kitchen were replaced during the ca. 1970 renovation scope.

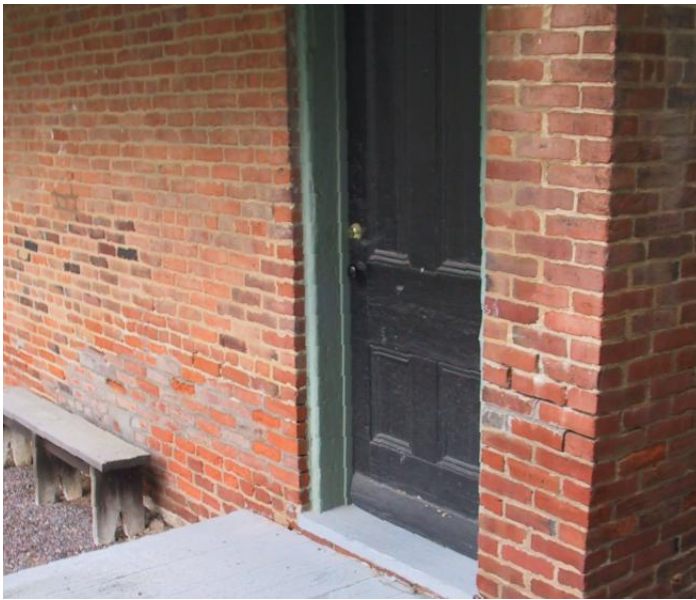
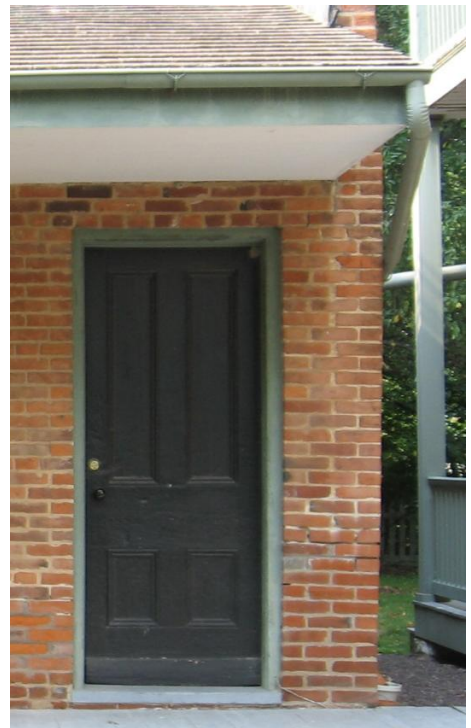
Exterior wood door and frame conditions at Summer Kitchen.
