Martin Franklin Hanley House  
 7600 Westmoreland Avenue  
 Clayton, Missouri 63105  
 LG Project No. 07268.002

Existing  
 Conditions  
 Assessment  
 16 July 07

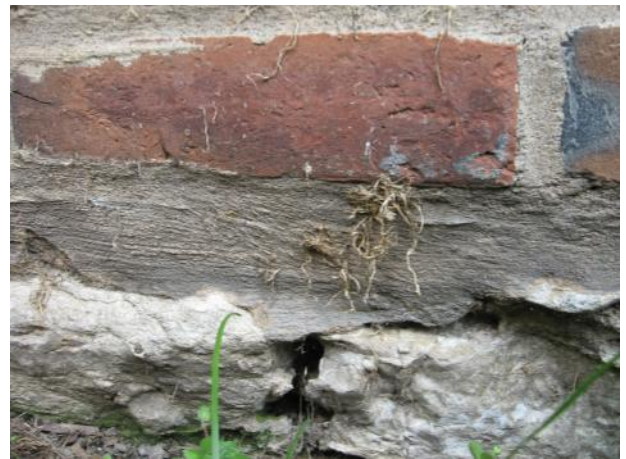
Stone foundation cracked and in need of repair.

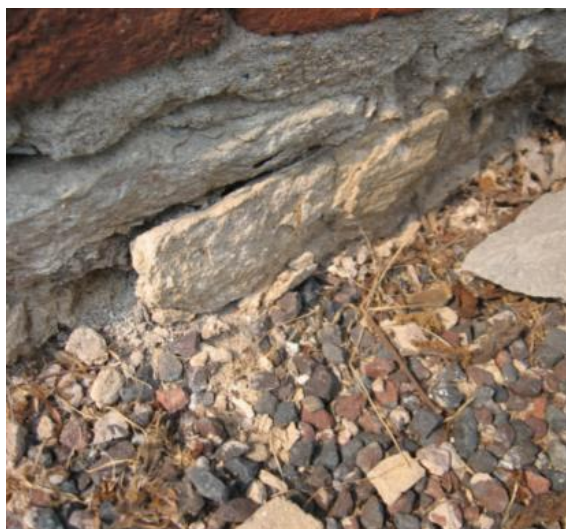
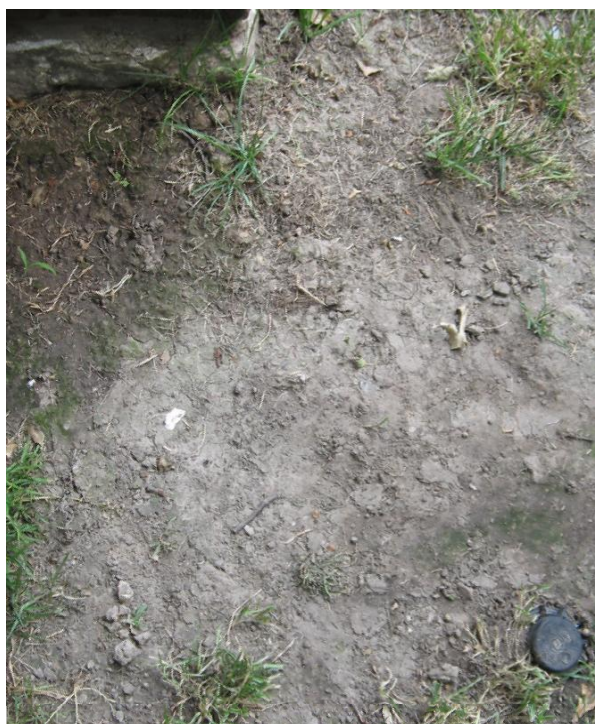
Stone foundation existing conditions.

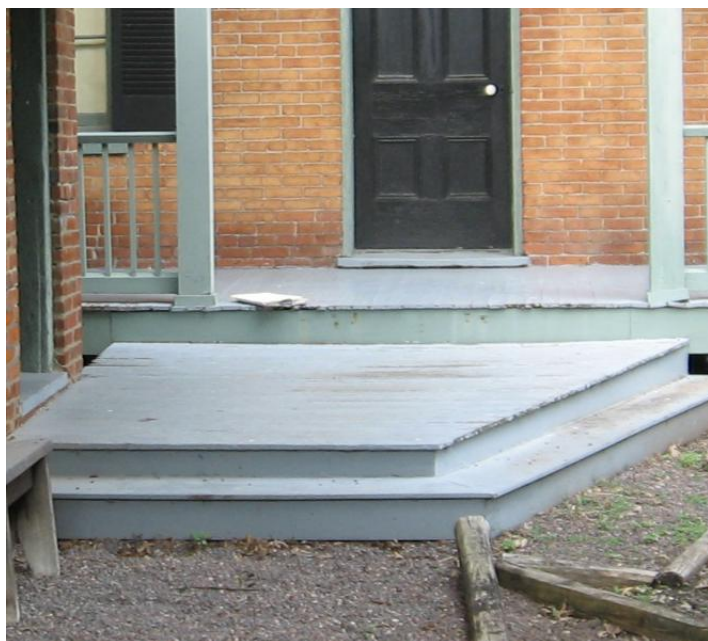
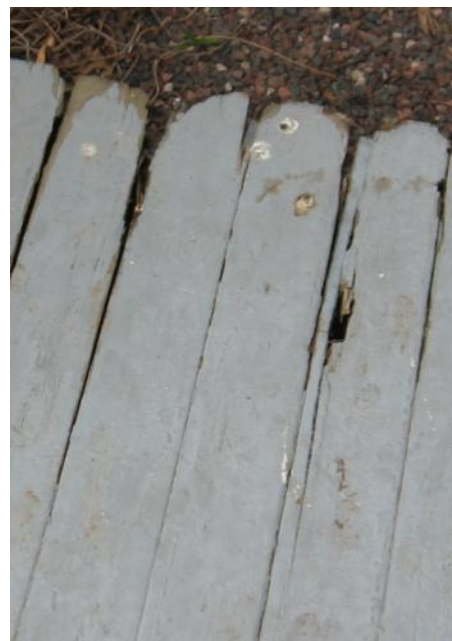
Exterior wood deck, existing conditions.
